# **DESIGN STATEMENT**

**24 Thomas Davis Street**

## BUILDING SURVEY REPORT

**24 Thomas Davis Street, Blackpool, Cork T23 KHP6**

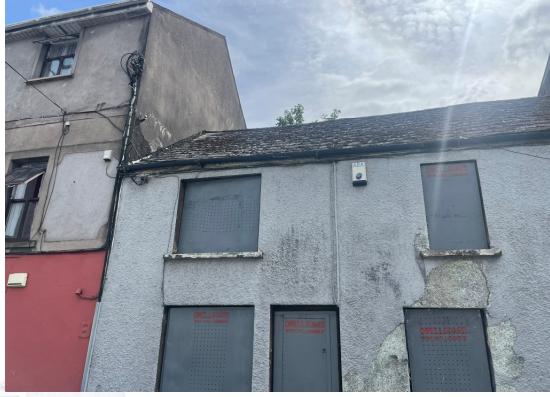
ROOF FINISHES	<ul style="list-style-type: none"> <li>- Sagging visible on the roof structure. Structural issue noted with the roof</li> </ul>

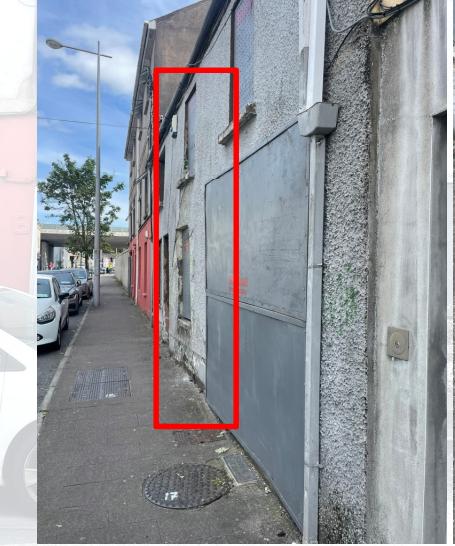
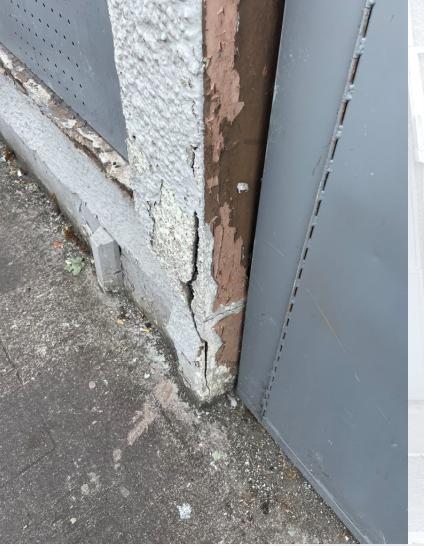
<ul style="list-style-type: none"> <li>- Asbestos slate roof covering in poor condition</li> <li>- Fascia detail and rainwater guttering in poor condition.</li> <li>- Remedial works required to the roof structure</li> </ul>
EXTERNAL WALLS	<ul style="list-style-type: none"> <li>- Solid brick external walls, no cavity or no insulation</li> <li>- Original wet plaster finish externally. Plaster falling off the walls in areas and will need to be hacked off to prevent a hazard onto the public footpath</li> <li>- Large structural defect on front wall; visible wall movement near front door. The wall is bulging in an outwards motion. The movement is a result of deterioration on the roof timbers, timber lintels over windows / doors and settlement on first floor joists.</li> </ul>

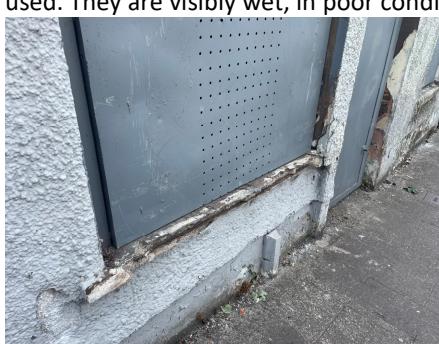
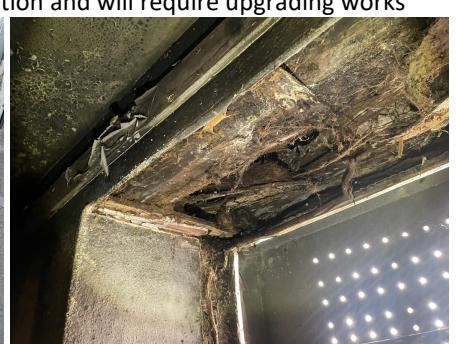
<ul style="list-style-type: none"> <li>- From inside the building, there are 2no. locations where lintels are visible. Timber lintels used. They are visibly wet, in poor condition and will require upgrading works</li> </ul>

<ul style="list-style-type: none"> <li>- Ground floor cills are in poor condition and will need to be removed</li> <li>- Remedial works required to the external walls.</li> </ul>

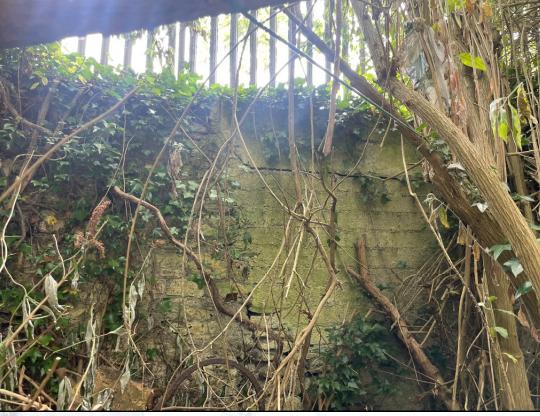
WINDOWS AND DOORS	<ul style="list-style-type: none"> <li>Windows / doors outdated, damaged and in poor condition.</li> <li>New windows / doors required to the property. Note first floor windows should be fire escape windows. First floor low sill heights present a fall hazard therefore under any new design, the sill heights should be increased to 800mm min. off floor level.</li> </ul>
BOUNDARIES	<ul style="list-style-type: none"> <li>Front building line</li> <li>Rear high large stone boundary walls.</li> <li>Cracking visible on eastern rear boundary wall which will require repairs.</li> </ul>

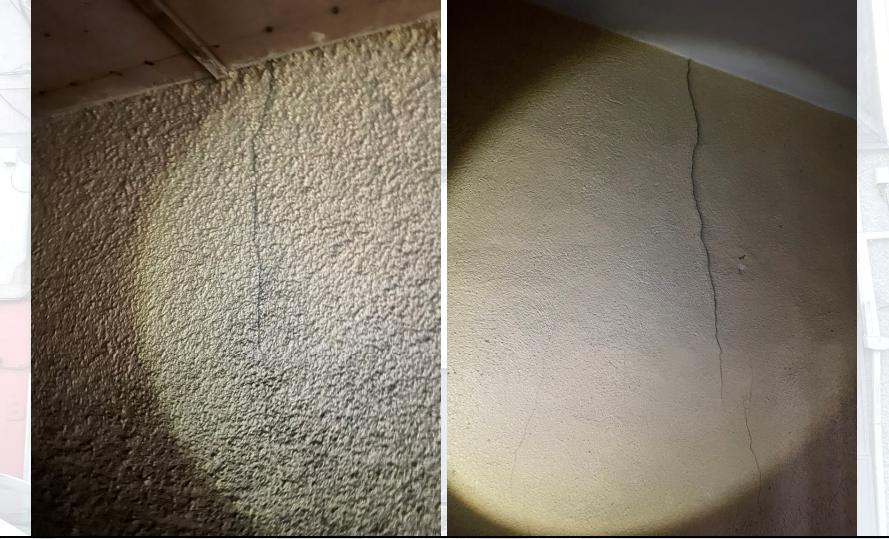
ROOF VOID	<ul style="list-style-type: none"> <li>- Roof is in poor condition</li> <li>- No felt noted.</li> <li>- Rot noted on several rafters</li> <li>- The roof should be fully replaced as part of remedial works to the house</li> </ul>
EXTERNAL WALLS	<ul style="list-style-type: none"> <li>- Walls have original smooth render or cladded with cork boarding or laminate boarding. There is damp on the external walls. I advise you remove all wall linings, dryline the walls with an insulated plasterboard and new skim render. Clean down the damp with a disinfectant.</li> </ul>
INTERNAL WALLS	<ul style="list-style-type: none"> <li>- Masonry walls to the ground floor</li> <li>- Combination of stud walls and masonry walls to the first floor</li> <li>- Large structural crack visible on the party wall on ground and first floor. The cracks will require remedial work. Unclear if underpinning works will be needed unless trial hole excavation works can be carried out.</li> </ul>

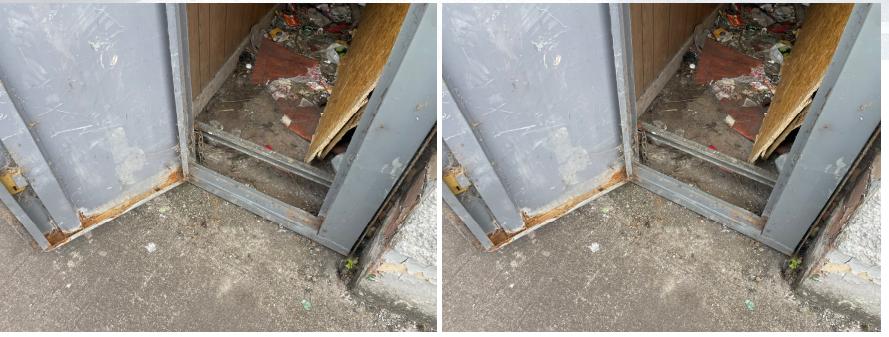
FLOORS	<ul style="list-style-type: none"> <li>- Solid concrete floors to the ground floor. No insulation or damp proof layers.</li> <li>- There is visible settlement on the floor.</li> <li>- There is a rising damp issue. The floor is not at an adequate height over the front external footpath or rear yard. The floor level would need to be adjusted and tanking works undertaken.</li> </ul>

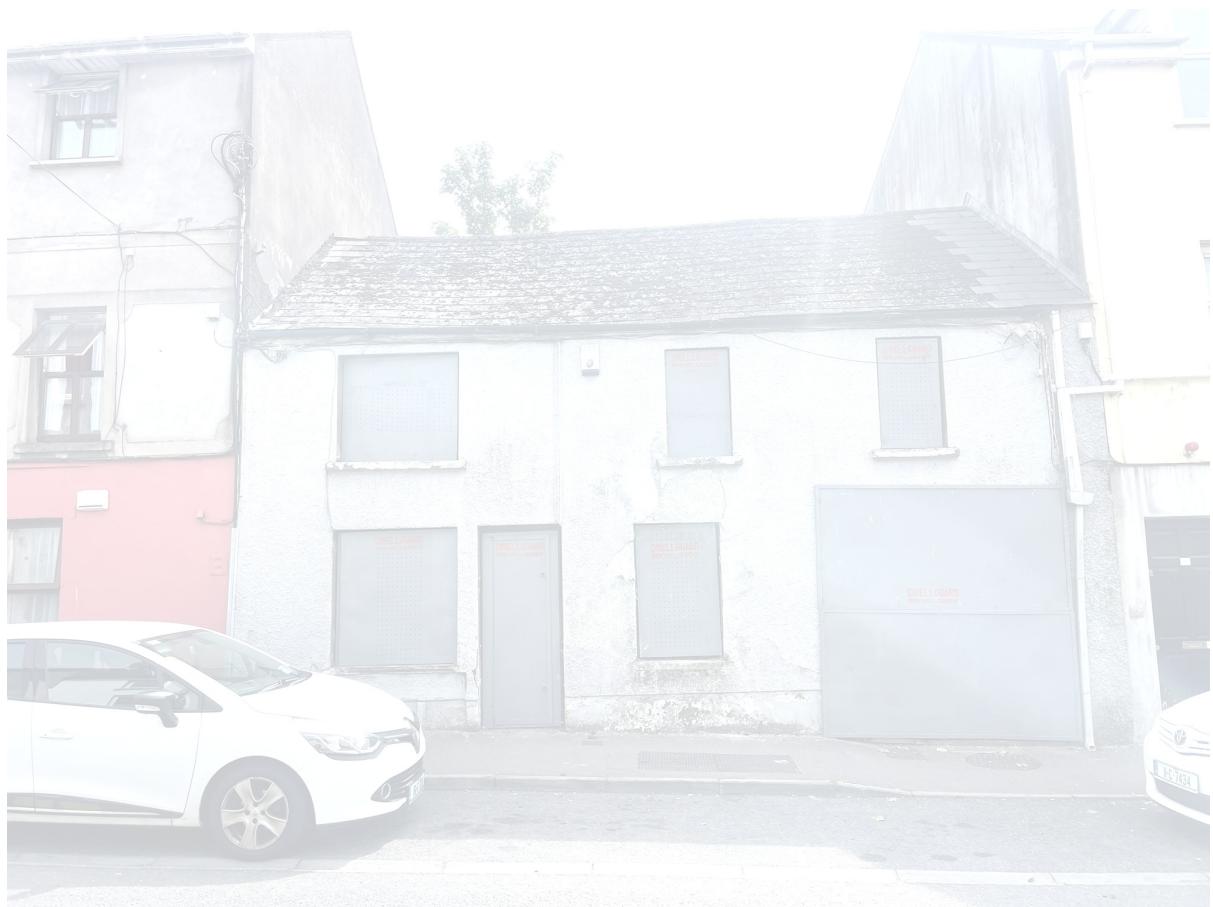
<ul style="list-style-type: none"> <li>- First floor joists have settled and large springing evident when walked on. The floor structure would need to be replaced</li> <li>- Part of the first floor extends over an arch / lane. The soffit material is in disrepair and will need to be replaced. If keeping this design, the underside will need to be upgraded to achieve 60min fire separation</li> </ul>
CEILINGS	<ul style="list-style-type: none"> <li>- Smoke stained linings to the ground and first floor which will all need to be removed</li> </ul>

INTERNAL JOINERY	<ul style="list-style-type: none"> <li>- Will require full removal of all doors, architraves, skirtings, sill boards and similar.</li> </ul>
FIREPLACE	<ul style="list-style-type: none"> <li>- None</li> </ul>
VENTILATION	<ul style="list-style-type: none"> <li>- The house is not vented. As part of any remedial / refurbishment or dwelling replacement works, all rooms will require ventilation as per the building regulations</li> </ul>
SERVICES	<ul style="list-style-type: none"> <li>- All services are turned off.</li> <li>- As part of any remedial / refurbishment or dwelling replacement works, the house would need to be rewired and replumbed in the new</li> </ul>
