Tree Survey Report

**Bishop Lucey Park
Cork**

DATE: 19 June 2021
REPORT 6844_RP01

Bishop Lucey Park, Cork
Tree Survey Report

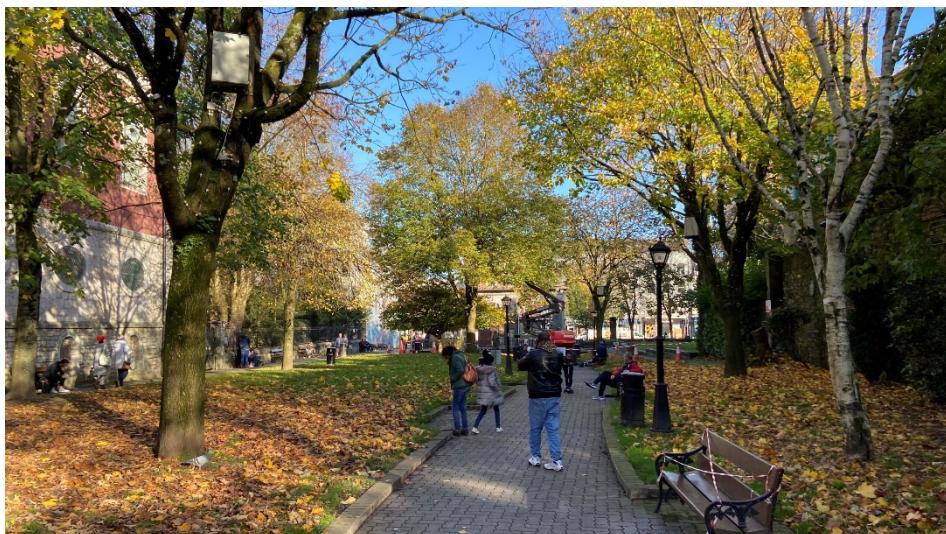
Figure 2- View towards Grand Parade with Norway Maple (T-192) on left

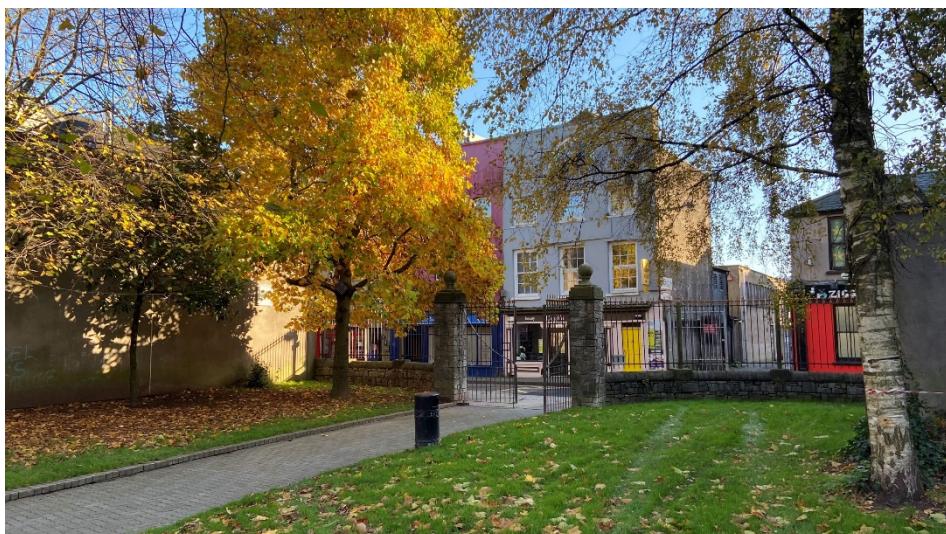
Figure 3- View towards Tuckey Street with Liriodendron (T-202) and Birch (G-5) in view

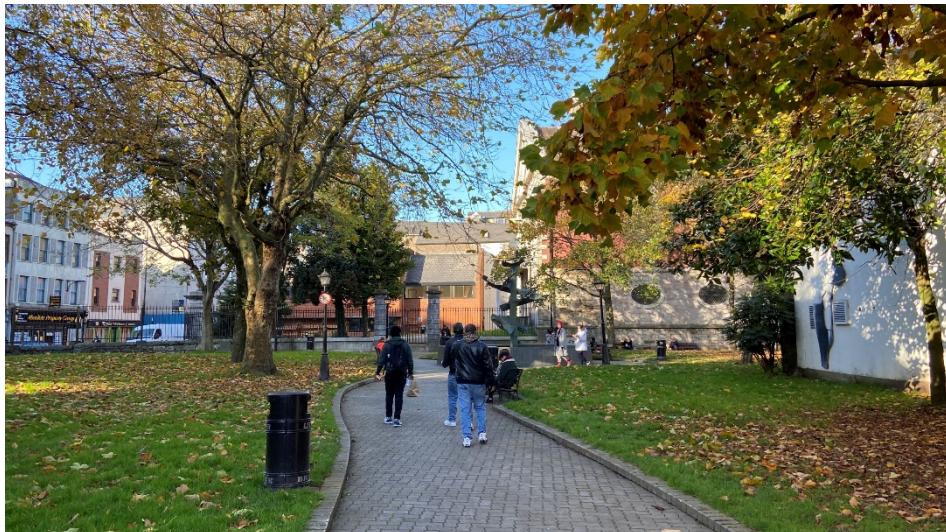
Figure 4- View from Tuckey Street entrance with London Plane (T-202) and Tree of Heaven (T-203) on left

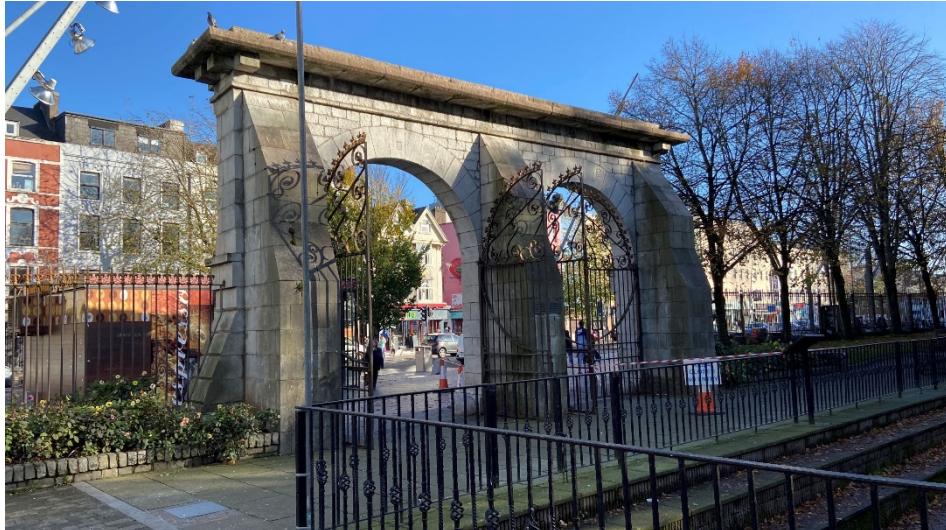
Figure 5- View at Grand Parade entrance with Limes (G2) on right

Type	No.	Species	Age	Ht m	Dbh mm	St	Cr	N	S	E	W	ERC	Phys Cond	Structural Condition/Comments	Preliminary Recommendations	RPA m	Cat
G	4 Tree 189-191 & 193	<i>Tilia spp.</i> (Lime)	EM	11 to 13.5	300	1	3	4	4	4	4	20+	Fair	Fair. Linear group of four trees. Some damage to surface roots. Some potentially weak unions as main stems fork and crown develops. Tree 193 has long vertical bark wounds to stem on south and north sides.	Consider managing as pollards from around 6m. Consider removing and replacing tree 193.	3.6	B2
T	192	<i>Acer platanoides</i> (Norway Maple)	M	17	450	1	5	7	7	6.5	6.5	10+	Fair	Fair/Poor. Medium sized tree with tight union as stem forks at 3 to 4m. Fork maybe weak and liable to breakage as tree grows larger.	Crown reduce by 2-3m. Prune periodically to maintain as smaller tree.	5.4	C2
T	194	<i>Acer pseudoplatanus</i> (Sycamore)	EM	14	385	1	3	5	4	5	6.5	20+	Good	Fair/Poor. Good vitality. Medium sized tree with tight union as stems fork at 5 to 6m. Fork appears stable at present.	No urgent works needed.	4.62	B2

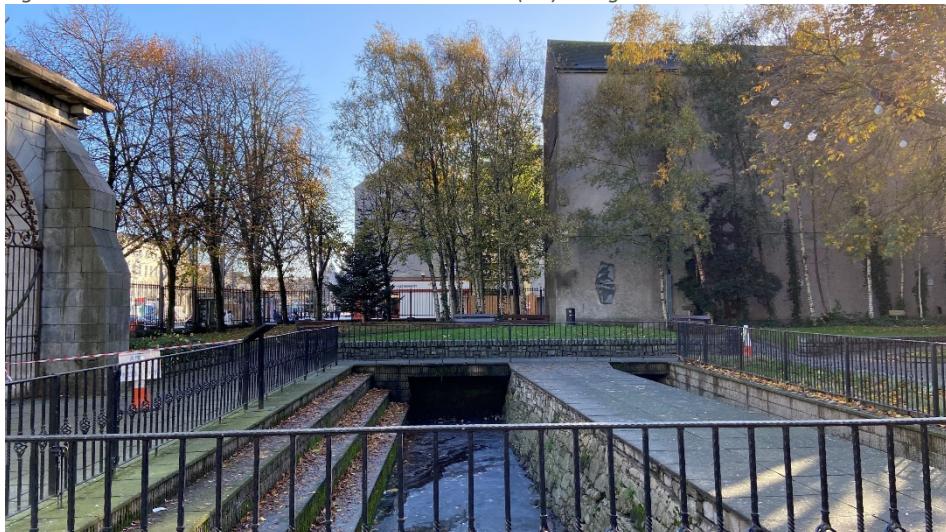
Figure 5- View at Grand Parade entrance with Limes (G2) on left, Birch (G1) centre and Birch (G3) on right

Type	No.	Species	Age	Ht m	Dbh mm	St	Cr	N	S	E	W	ERC	Phys Cond	Structural Condition/Comments	Preliminary Recommendations	RPA m	Cat
G	1 Trees 126- 141	Betula pendula (Silver Birch)	EM	14	80 to 220	1	3	3	3	3	3	10+	Fair	Fair. Cluster of Birch trees established at 1-1.5m spacing. Slender, upright form. Some smaller stems suppressed.	Thin out weaker stems.	2.64	C2
G	2 Trees 142- 150	Tilia spp. (Lime)	EM	10 to 13	270 to 350	1	3	4	4	4	4	20+	Fair	Fair. Linear group of Lime trees inside fence at approx. 4m spacing. Mostly fair condition, however some tight unions as tree stems fork. Tree 145 in corner has some storm damaged branches. Lighting wires on stems and branches. Some damage to surface roots.	Manage trees as pollards to control tree size and spread and help prevent branch breakage.	3.6	B2
G	3 Trees 151- 181	Betula pendula (Silver Birch)	EM	12 to 18	100 to 250	1	3	3	3	3	3	10+	Fair	Fair. Slender, upright form. Memorial planting of Birch trees established at 1.5m spacing. Group include thinner stems 100mm dbh and less, however, most are 150 to 250mm dbh. Group includes 2 Myrtle bushes. Some of the trees are becoming tall/large for planting location.	Thin out 6 weaker stems and single dead stem. Review annually. Group may benefit from further thinning in coming years.	2.4	B2
