Glenview House - Blackpool

Conservation Report & Heritage Impact Assessment:

Glenview, Cork

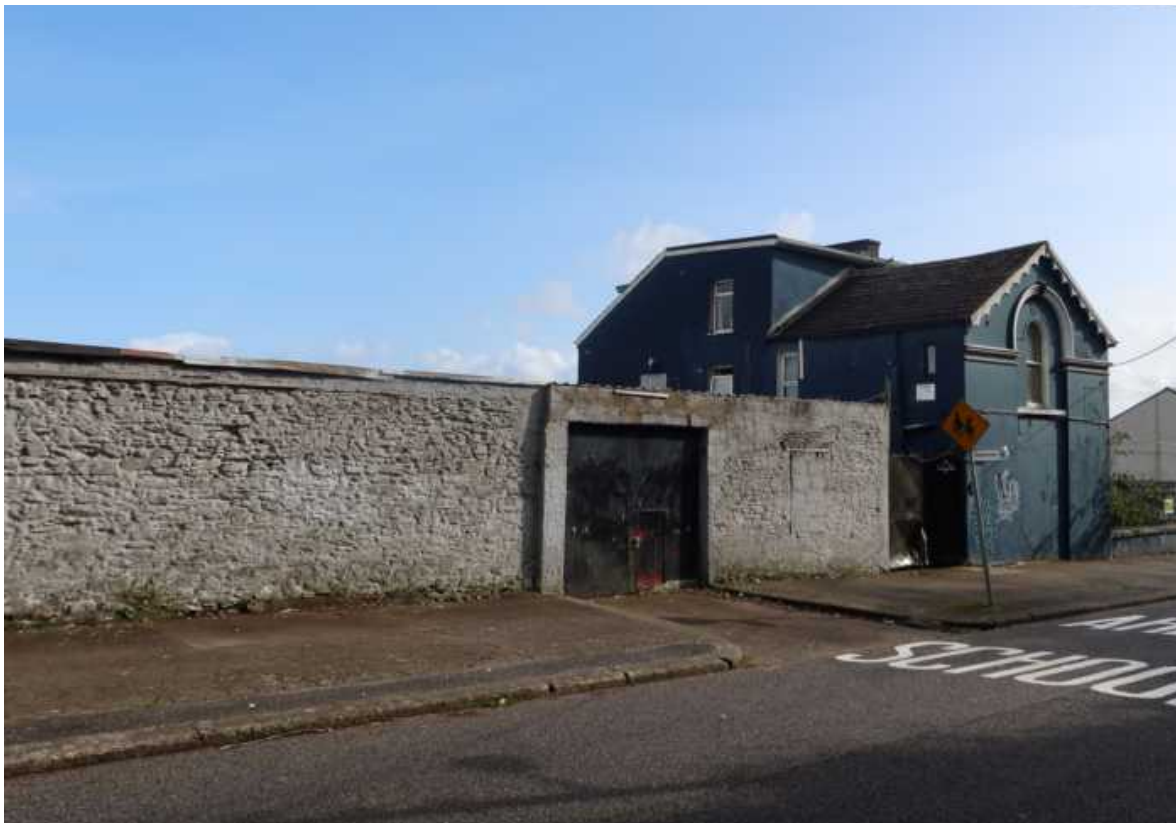
The exterior of the site below and around the building is overgrown and access is limited without more clearance. Without survey being carried out on overgrown site and at bottom of site, the only other 'Historic' remnants that are quite apparent on site other than the house are the remaining walls of what would have presumably been ancillary farm buildings to the North of the house. There is a flat roofed structure behind but the original stone wall to the roadside remains.

• Fig 20. Roadside to North of House with stone wall of original ancillary buildings.

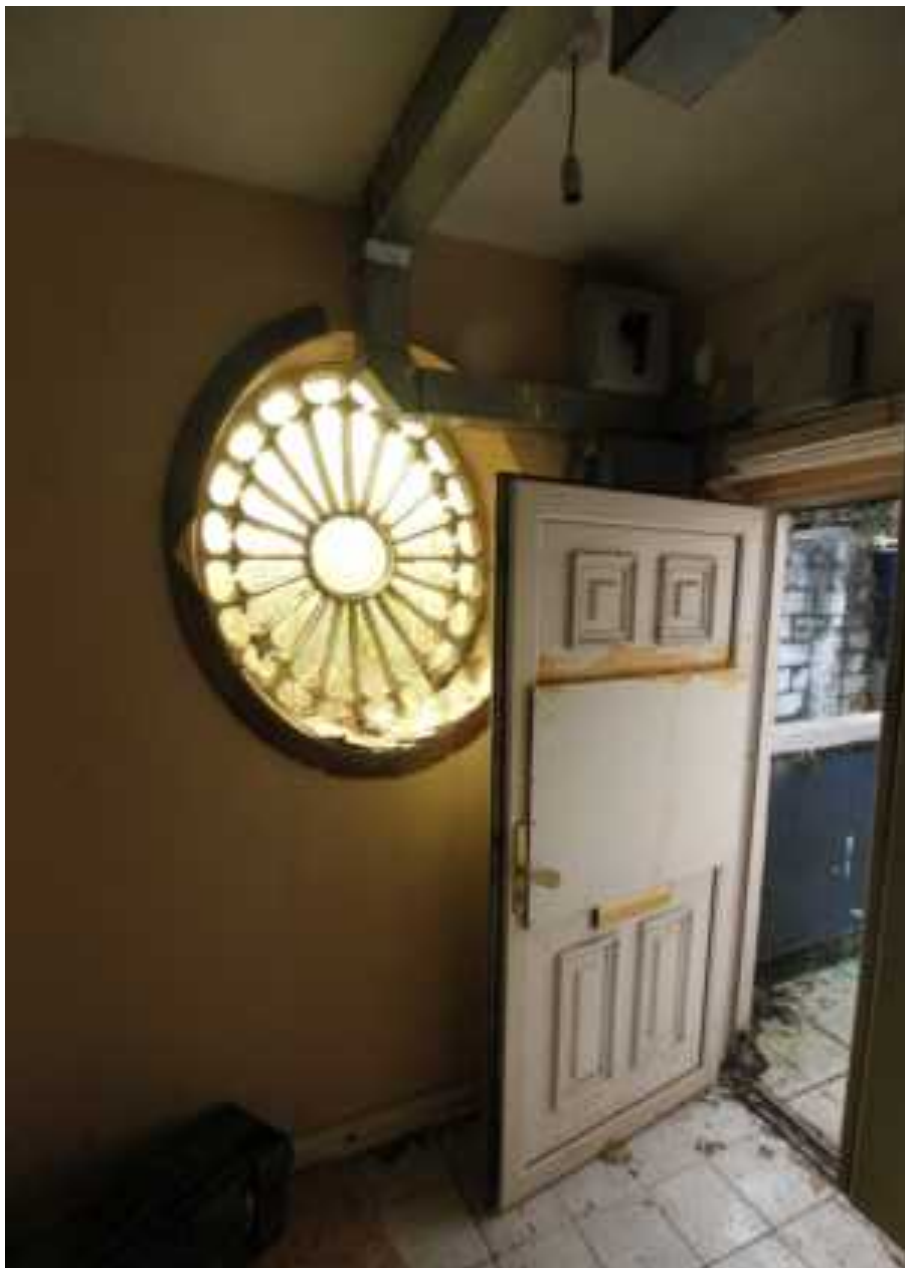
Window by GF1:

The only original remaining window in the building is inside the ground floor door GF1.

• Fig 39. Sole remaining original window inside door GF1.

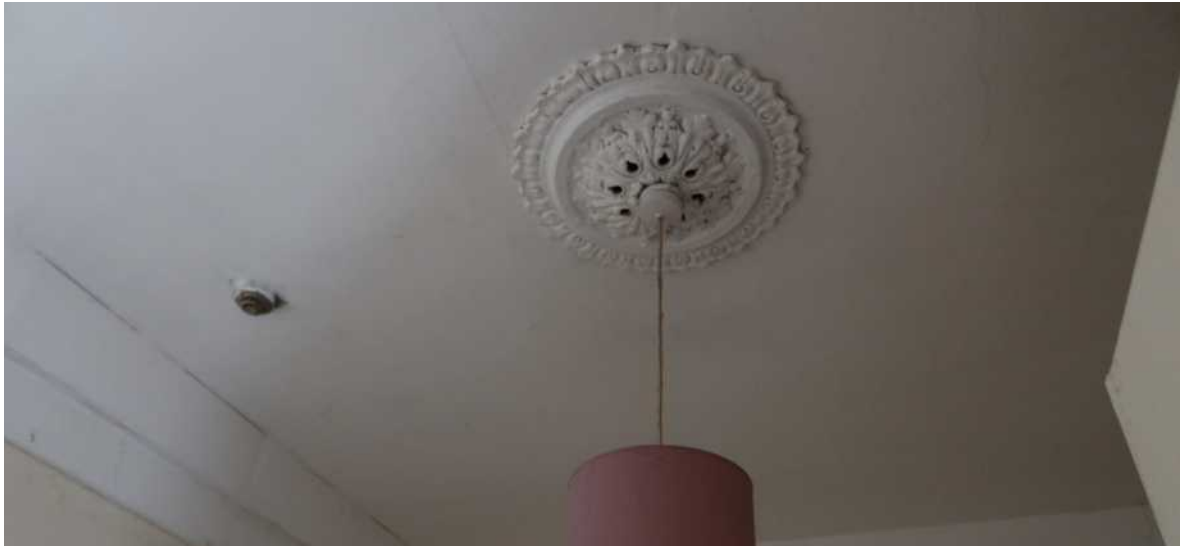
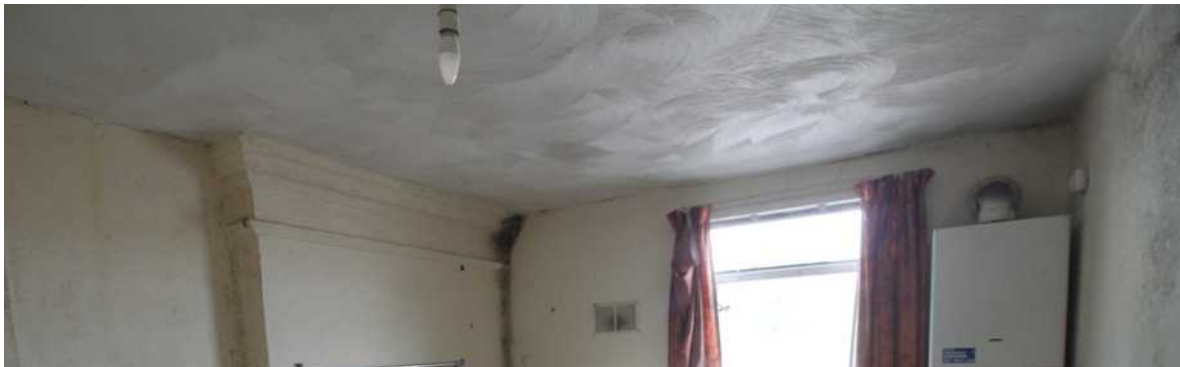
Ceiling rose in room inside door GF2, most likely one of the main rooms (living room) in original house: Cornice even in this room is gone. The structure on left of ceiling may be indicative of a far greater loss, and that could be all joist end rotten on entry into external wall and supported in this and many other areas, with internal beam added later. Small last section below of original cornice and picture rail.

• Fig 40 & 41. Sole remaining ceiling rose and below section of an earlier cornice.

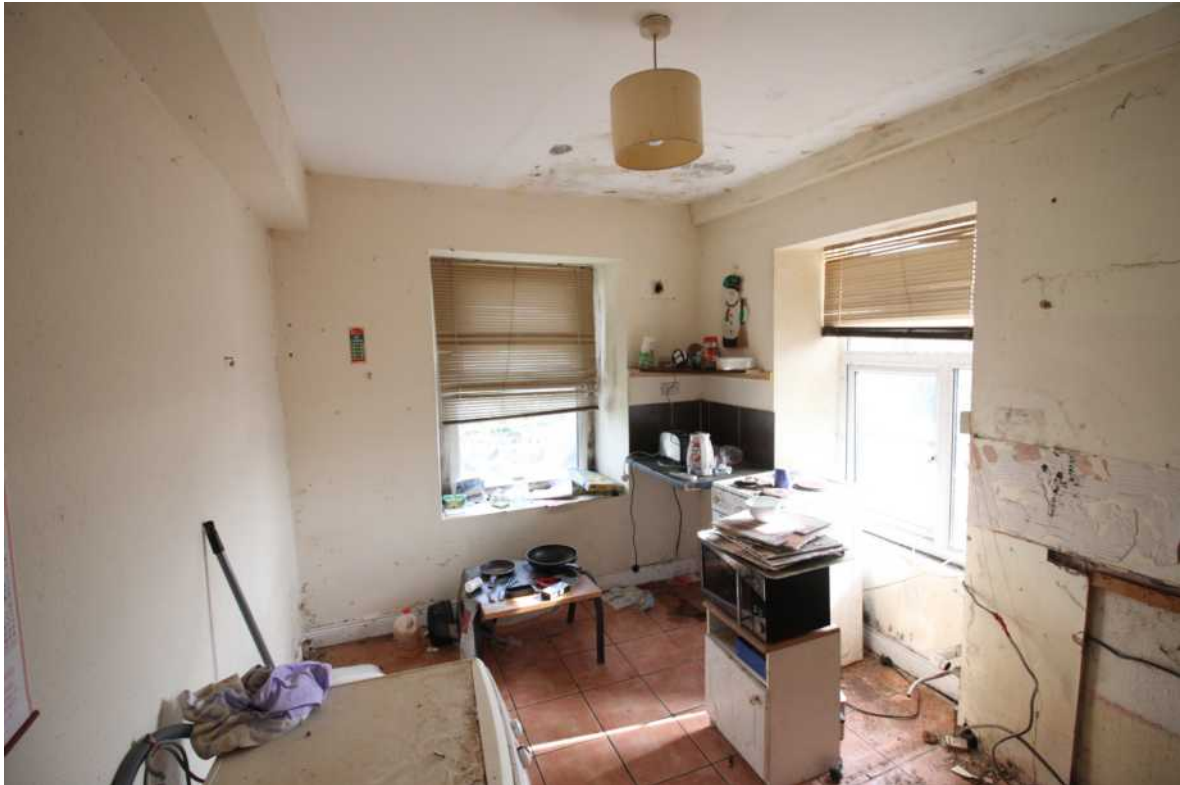
• Fig 42. Typical kitchen and evidence of damp/ mould in corners.

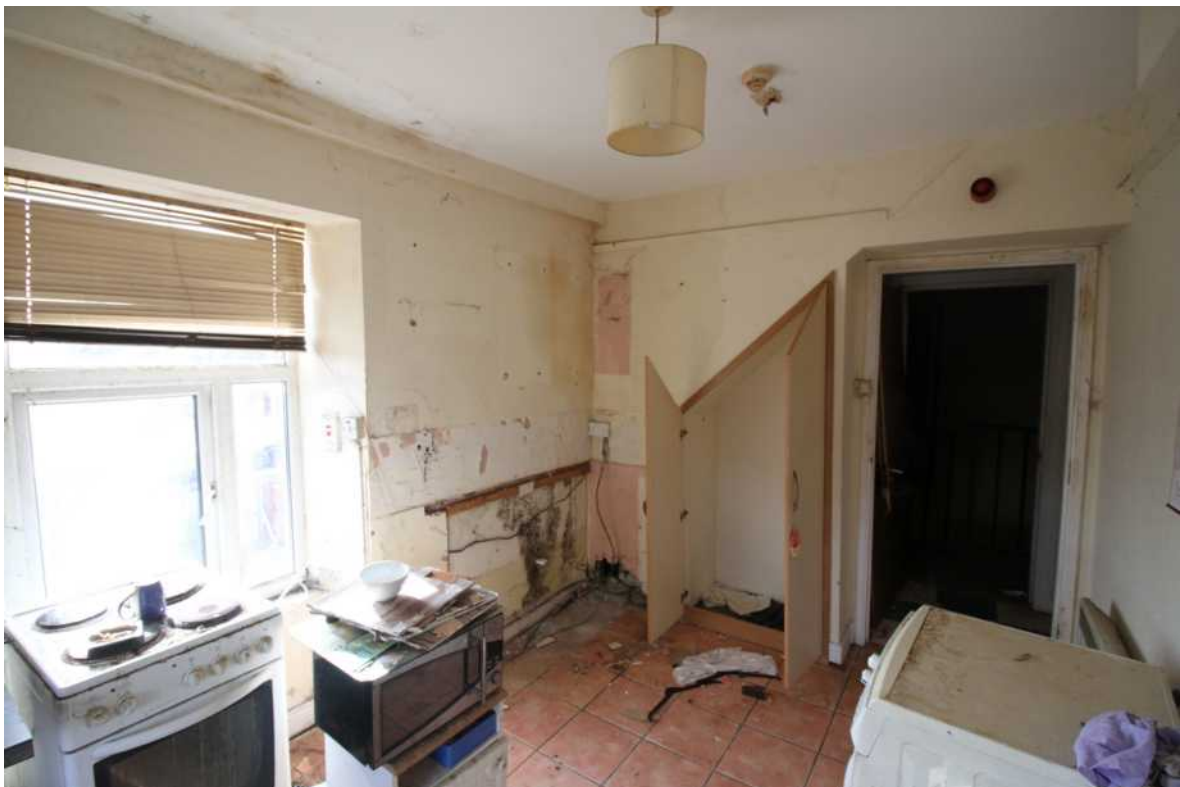
• Fig 43. Typical kitchen and evidence of damp/ mould in corners.

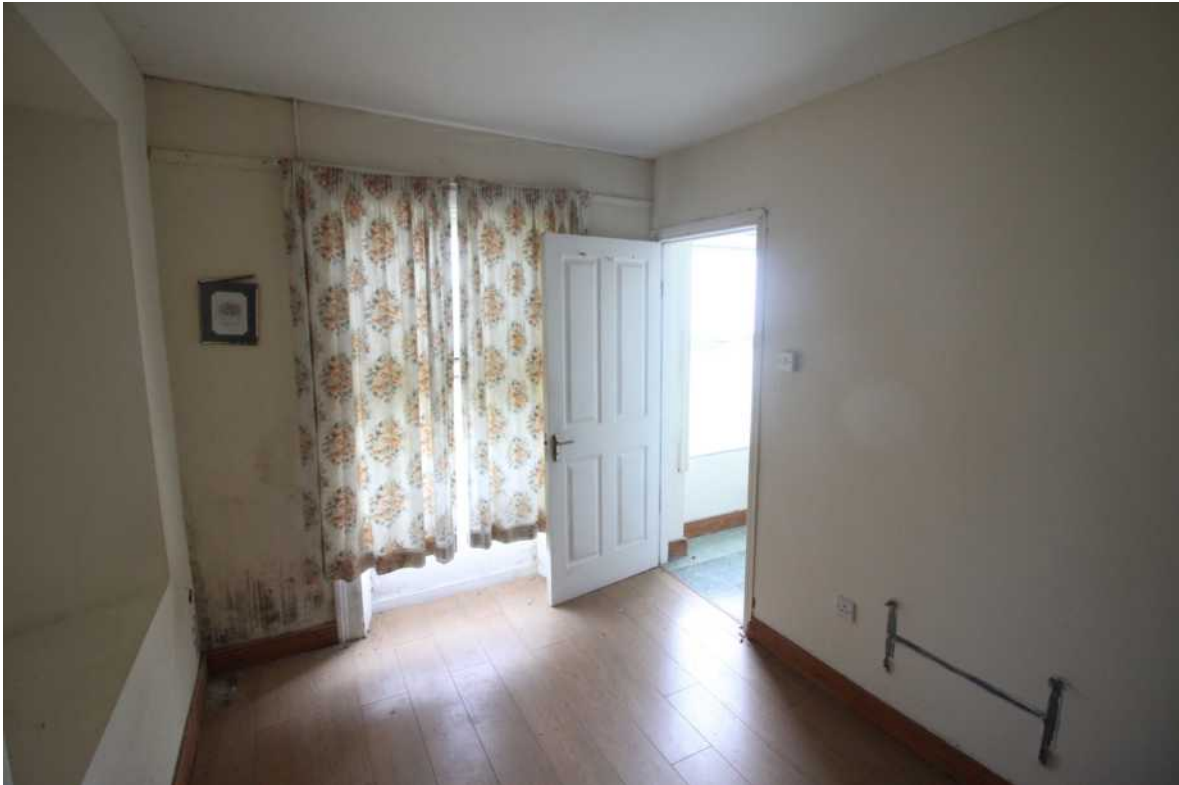
• Fig 42. Bedroom and evidence of rising damp/ mould on external walls.

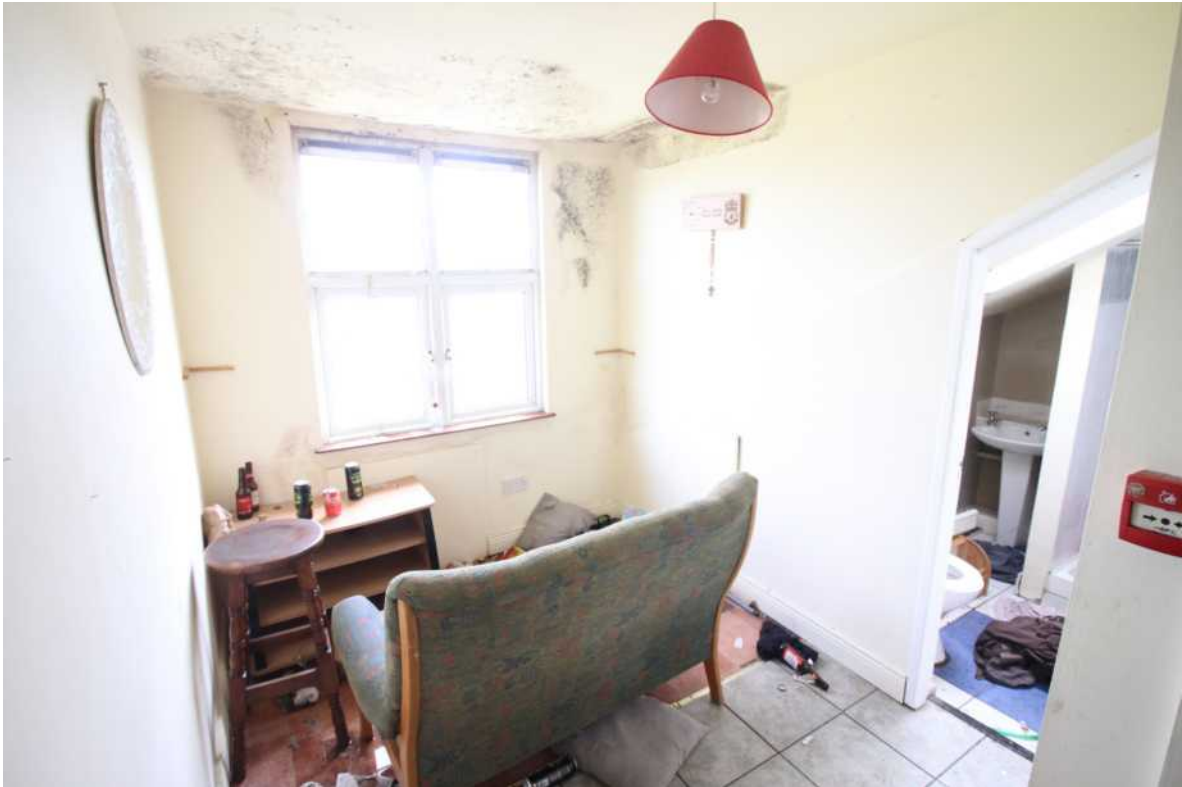
• Fig 45. Living room with damp and mould under flat roof/ at external wall.

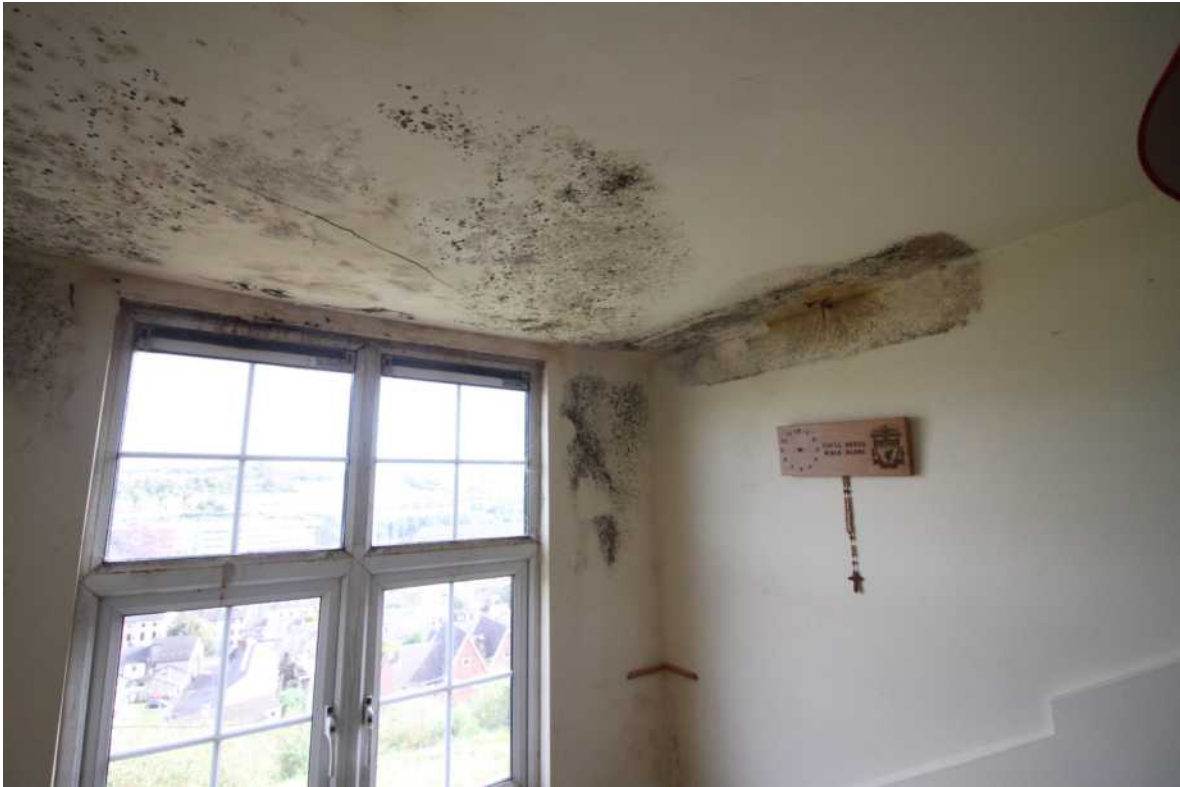
• Fig 46. Living room rear First floor, overlooking Blackpool, with evidence of roof issues.

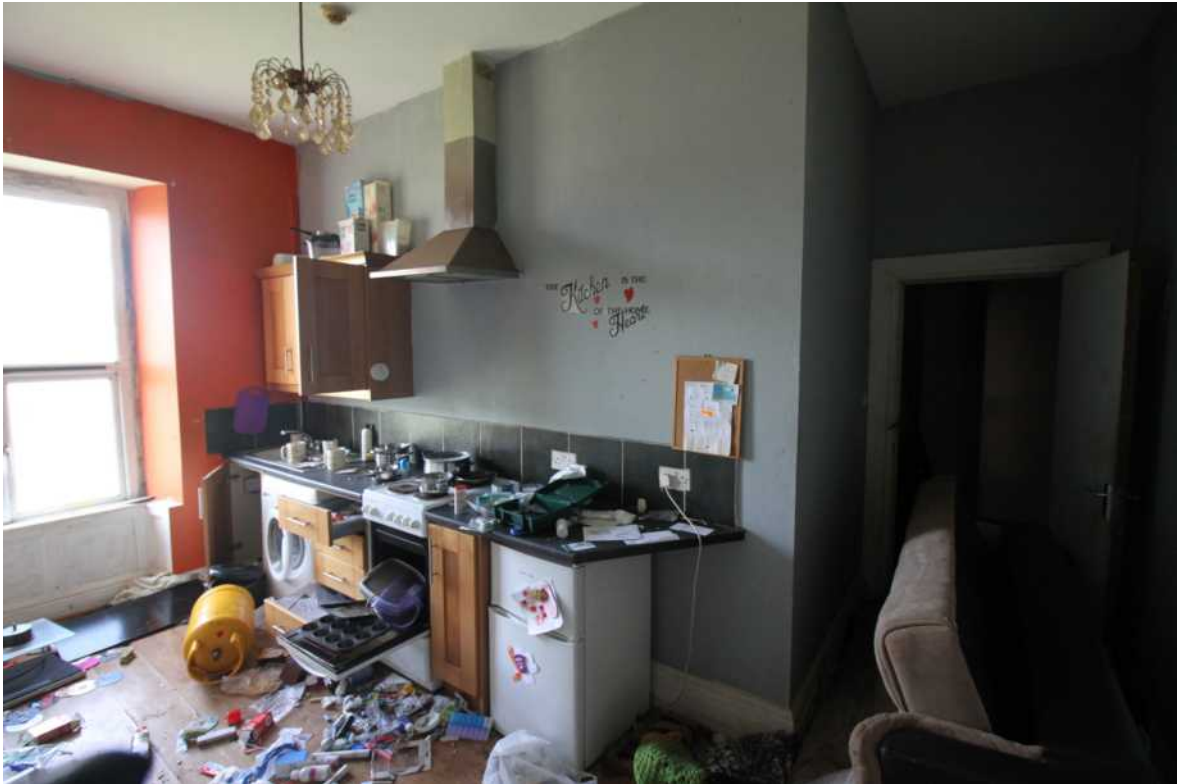
• Fig 89 -92. Typical apartment interiors and damp/ mould issues .

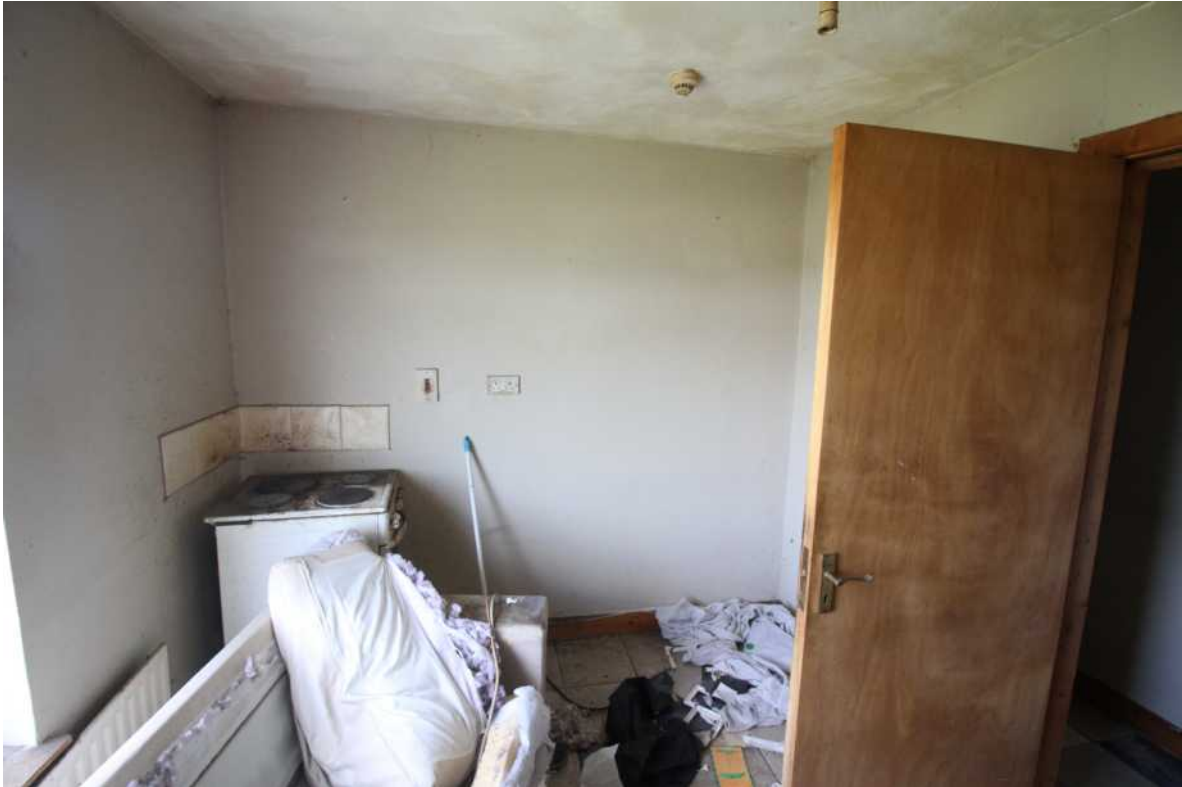
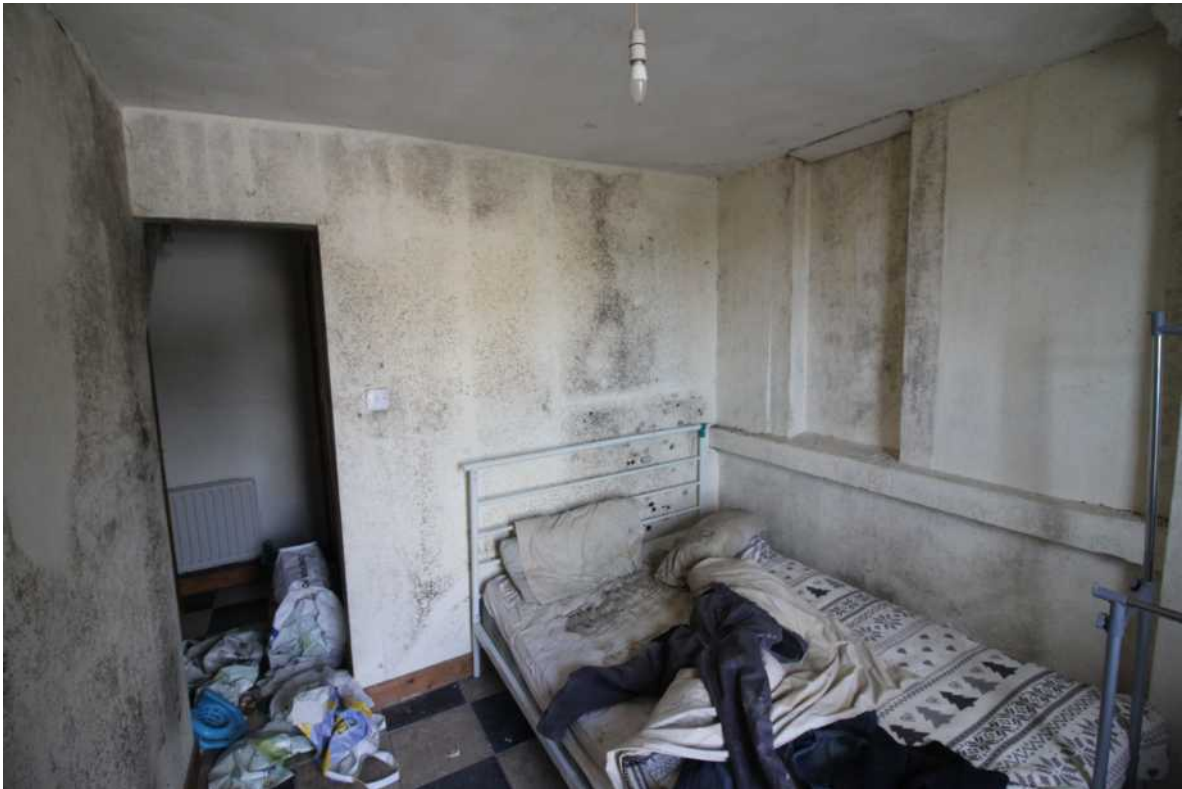
• Fig 100 & 101. Bedroom with common mould issues.

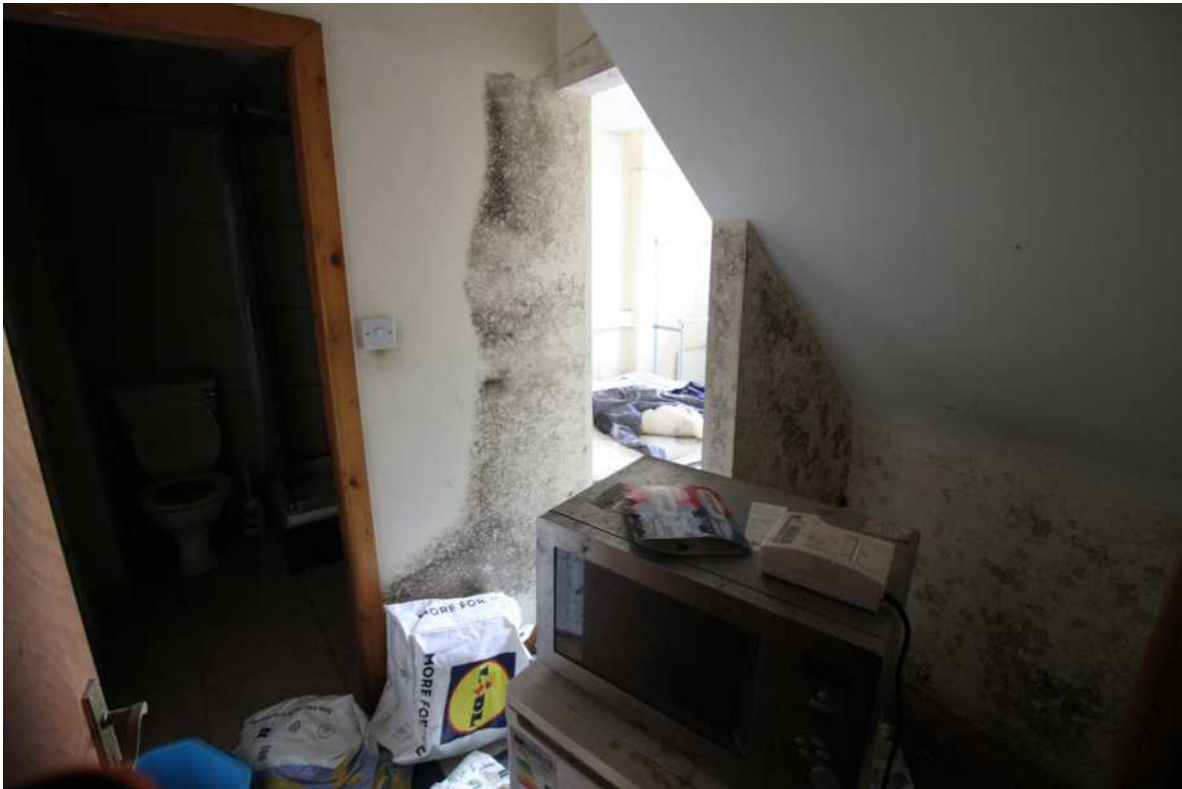
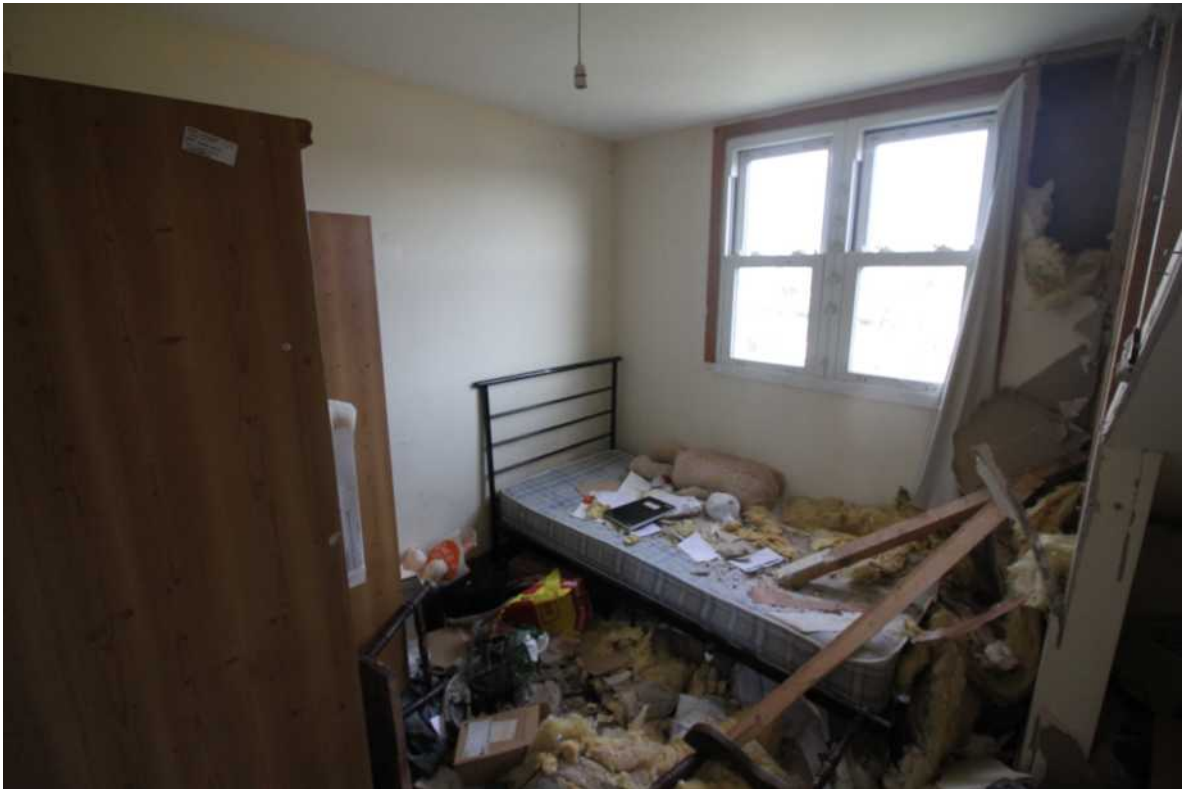
• Fig 102 & 103 Bedroom Top level rear apartment with roof failure.

Similarly on exterior, windows are all gone and replaced with poor PVC/ aluminium windows and doors, roof has been replaced and resulted in artificial slates, and most if not all rainwater goods are replaced with modern goods. With some sections of the roof letting water in to interior (possibly with lead having been removed?) the deterioration will likely be fairly rapid.
