For: Cetti Ltd.

Proposed Residential Development,
Scairt Cross.

Stage 1 and 2 Road Safety Audit

July 2024

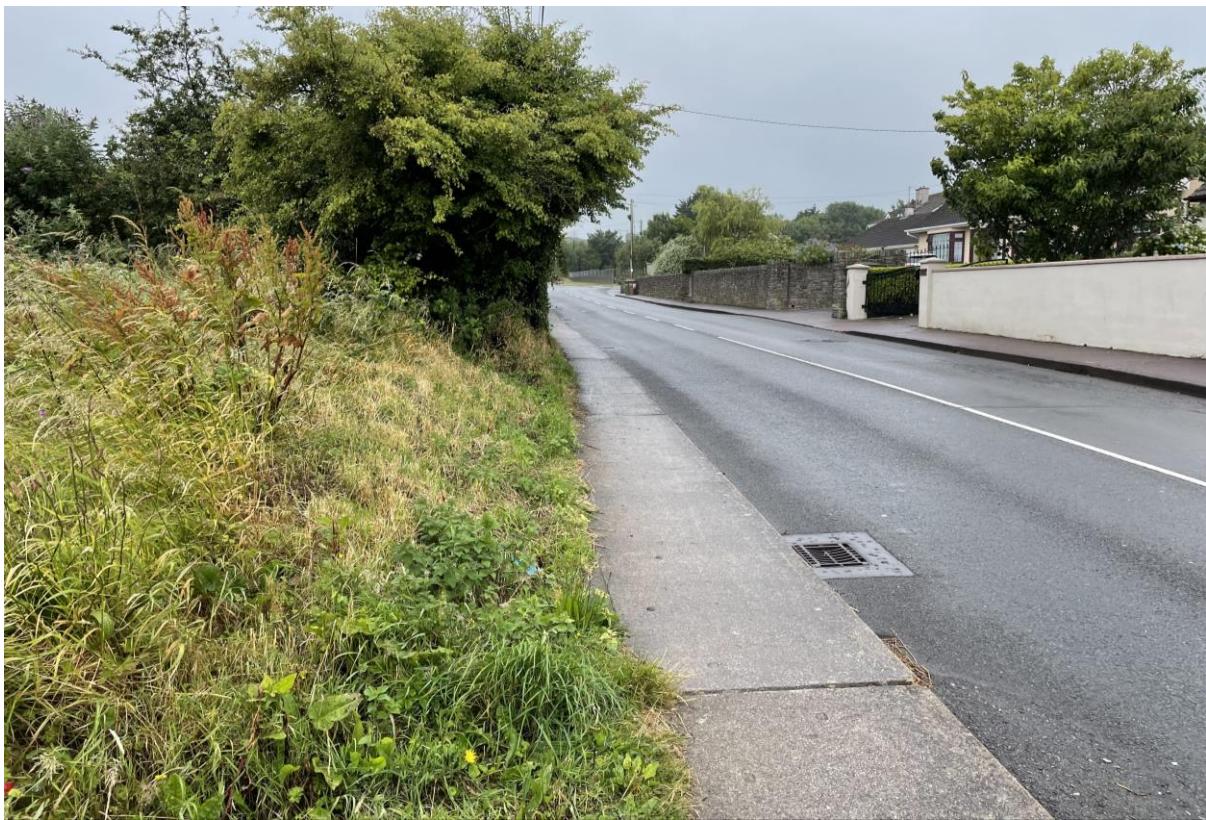
Photo A1 Site boundary along the nearside road edge (Scairt Road) at proposed entrance, looking south.

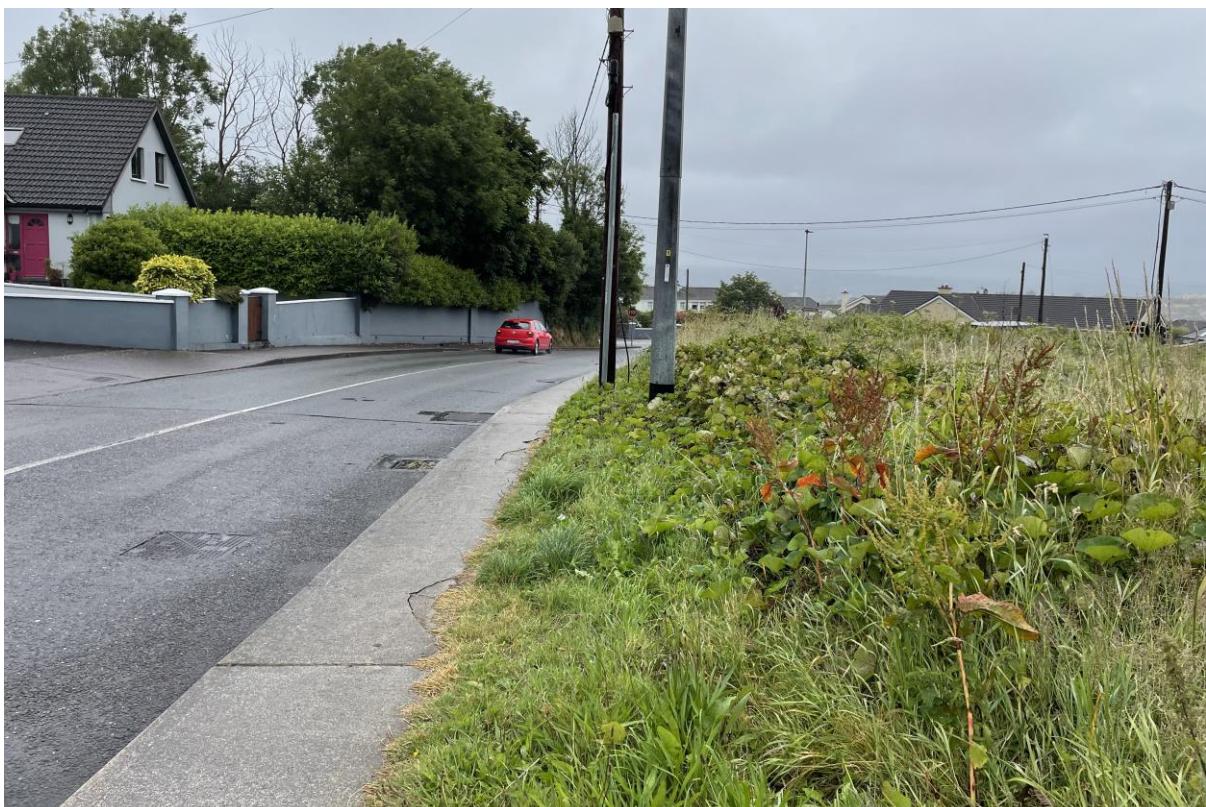
Photo A2 Site boundary along the nearside road edge (Scairt Road) at proposed entrance, looking north.

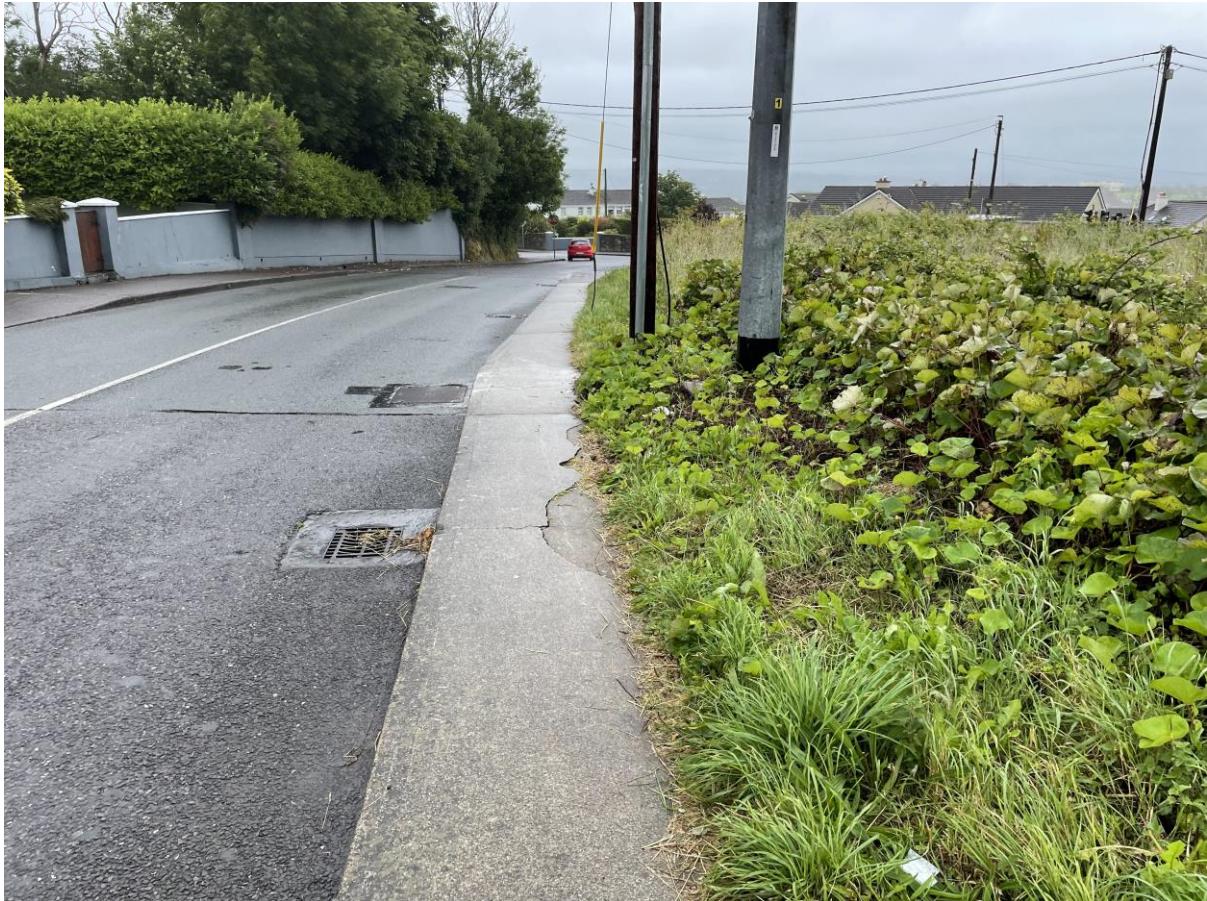
A number of utility poles were observed at the rear of the existing narrow footpath, where it is intended to construct a new 2m wide footpath. No reference to these poles is made in the drawings provided to the audit team. The poles, if not relocated, would represent a hazard to vulnerable road users, particularly visually impaired users and may lead to falls. See photo A3 in Appendix A.

Photo A3 Utility Poles close to footpath edge and damaged footpath

Relocate all poles off the proposed footpath to ensure that the footpath space is not restricted.

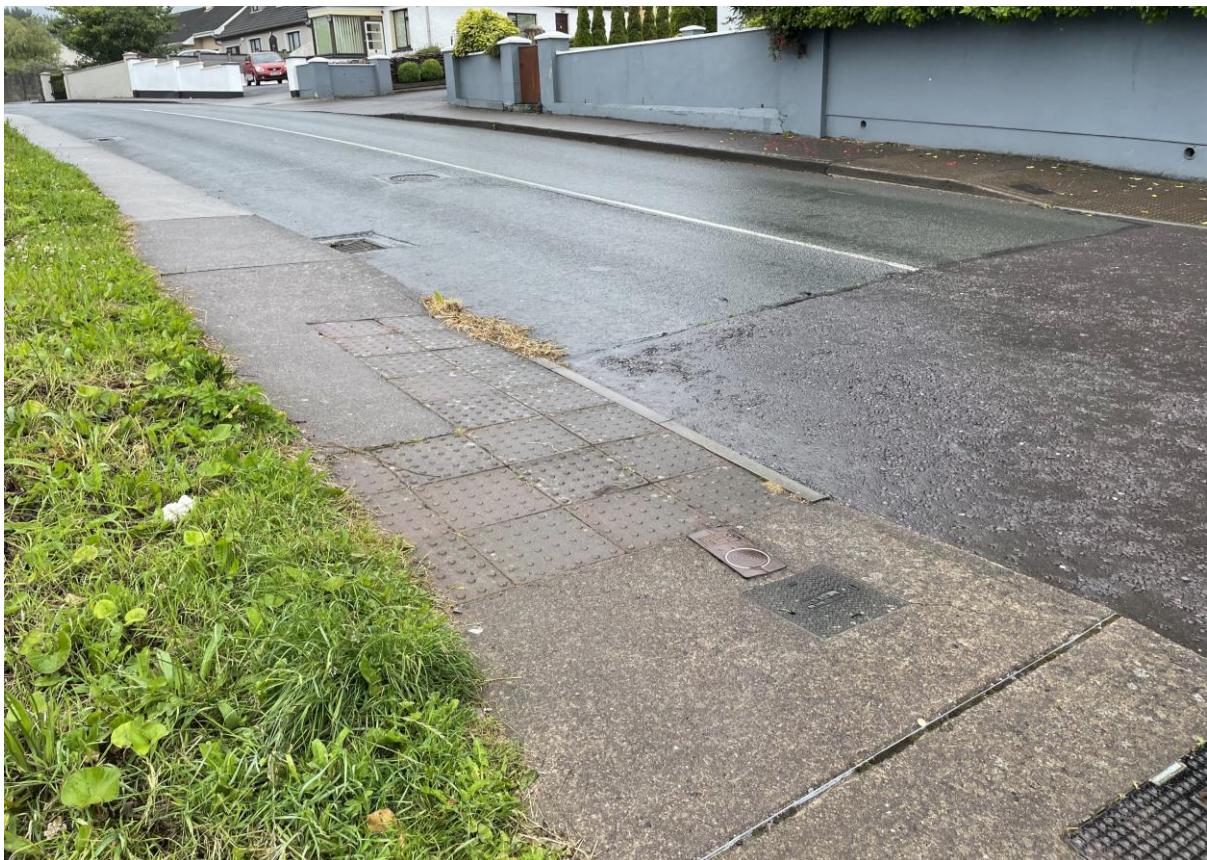
An uncontrolled crossing is located on along Scairt Hill just north of the proposed development entrance. This crossing incorporates red (discoloured) tactile slabs, laid in an L-shape, with a tail to the rear of the footpath. This slab layout is appropriate to a controlled type crossing, not an uncontrolled arrangement and may mis-lead visually impaired pedestrians, inferring that they have priority at the crossing, leading to collisions with passing vehicles.

Photo A4 Existing Pedestrian Crossing on Scairt Road

Provide appropriate tactile paving at the crossing if the footpath is to be re-constructed. The Local Authority should also replace the tactile paving on the opposite side of the road. See photo A4 in Appendix A.
