Architectural Heritage Impact Assessment

Proposed residential development at Glyntown, Ballinglanna, Cork

September 2024

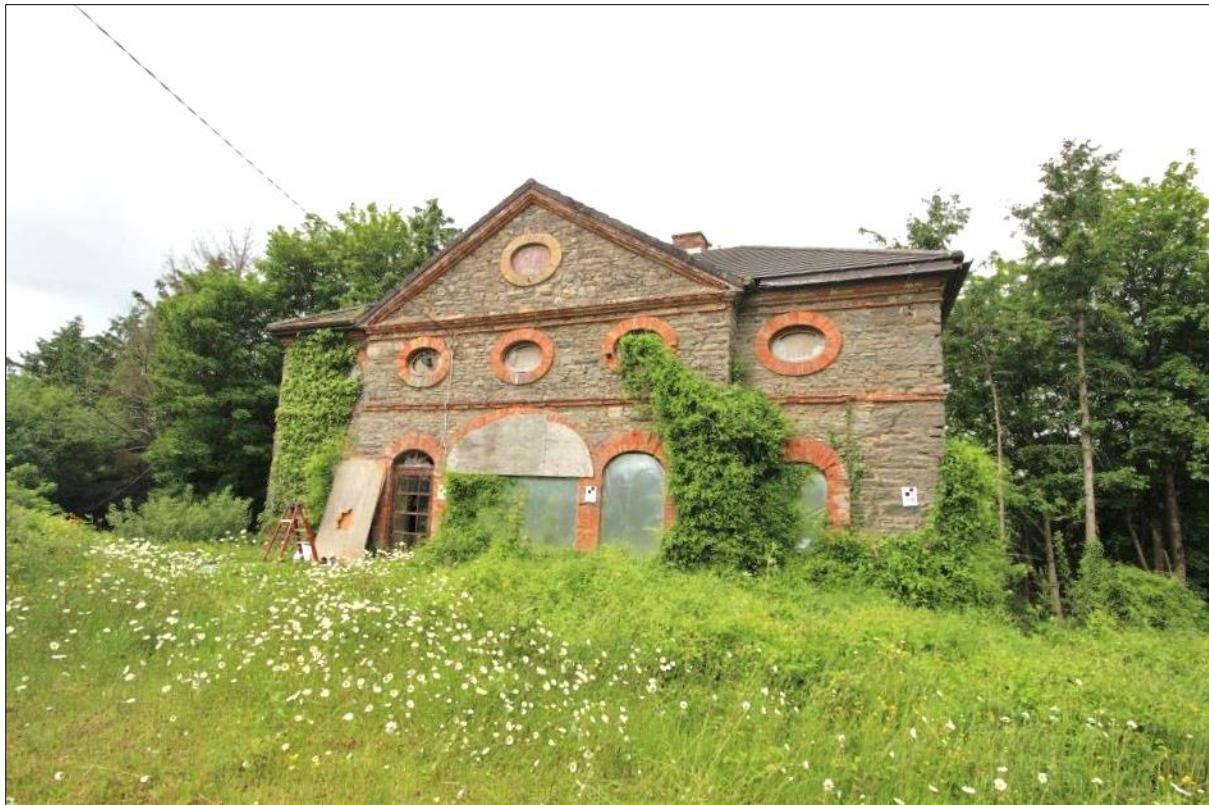
Plate 1: General view to front of house

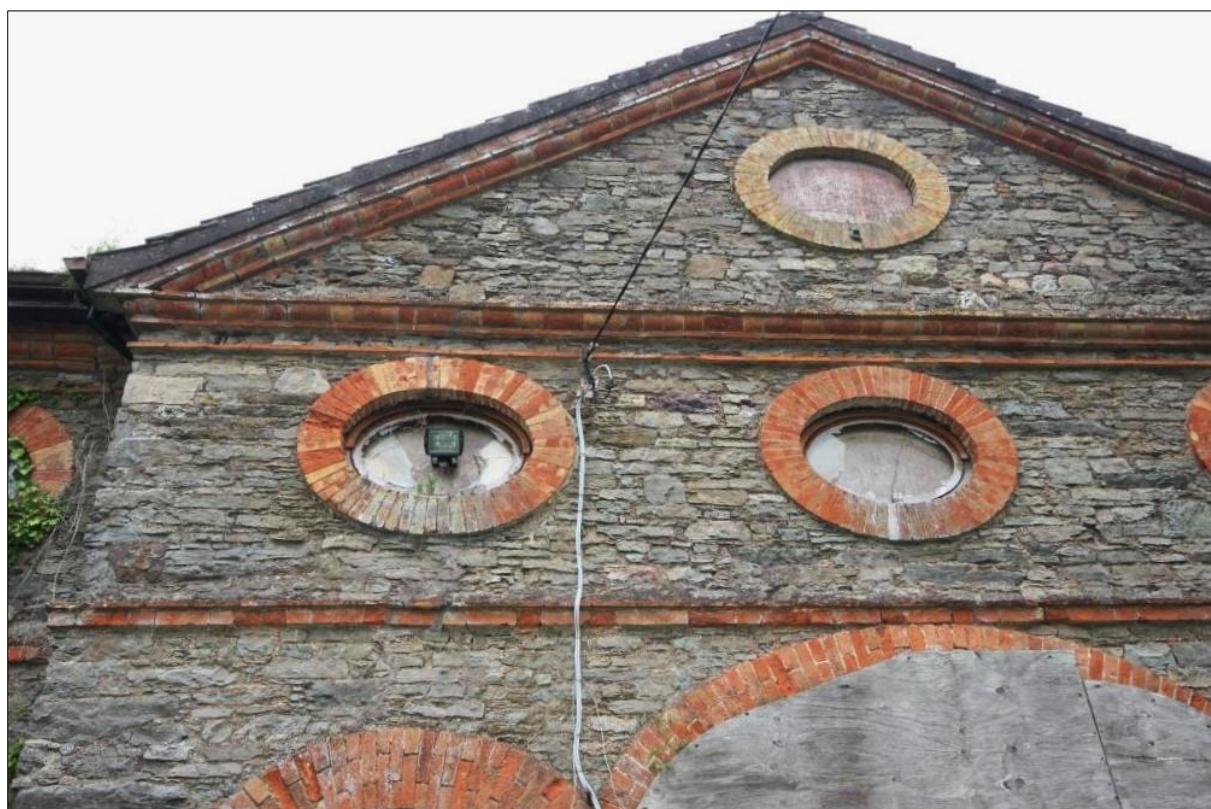
Plate 8: Detail of windows to first floor level on front elevation

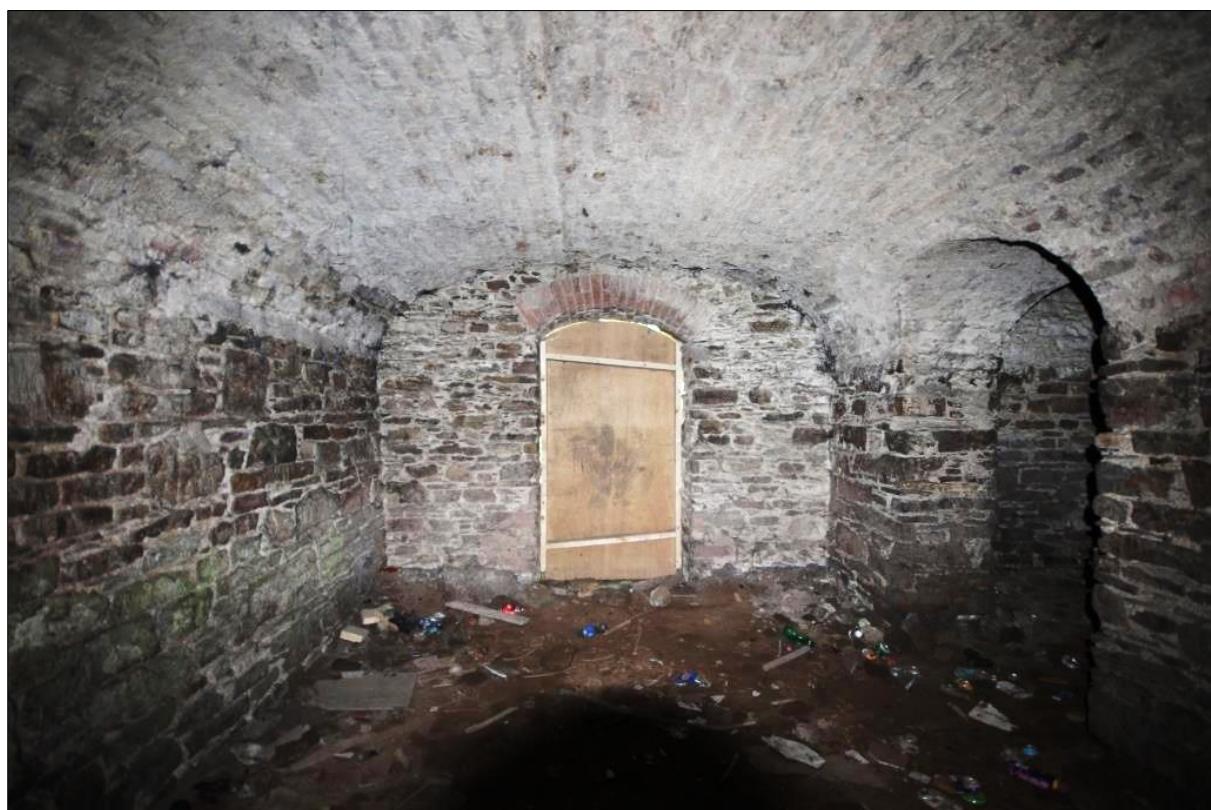
The lower ground floor level is occupied by a series of storerooms with low brick barrel vaulted roofs (see Plates 10 – 13 in the Appendix to this report). The floor is generally of an earth surface but one room, LGF02, was noted to retain some cobbles. The arch between LGF01 and LGF05 has lost some bricks from its apex. The walls are of exposed stone and some sections of the brick barrel vaulting is lime rendered.

Plate 10: Lower ground floor level LGF01 looking east

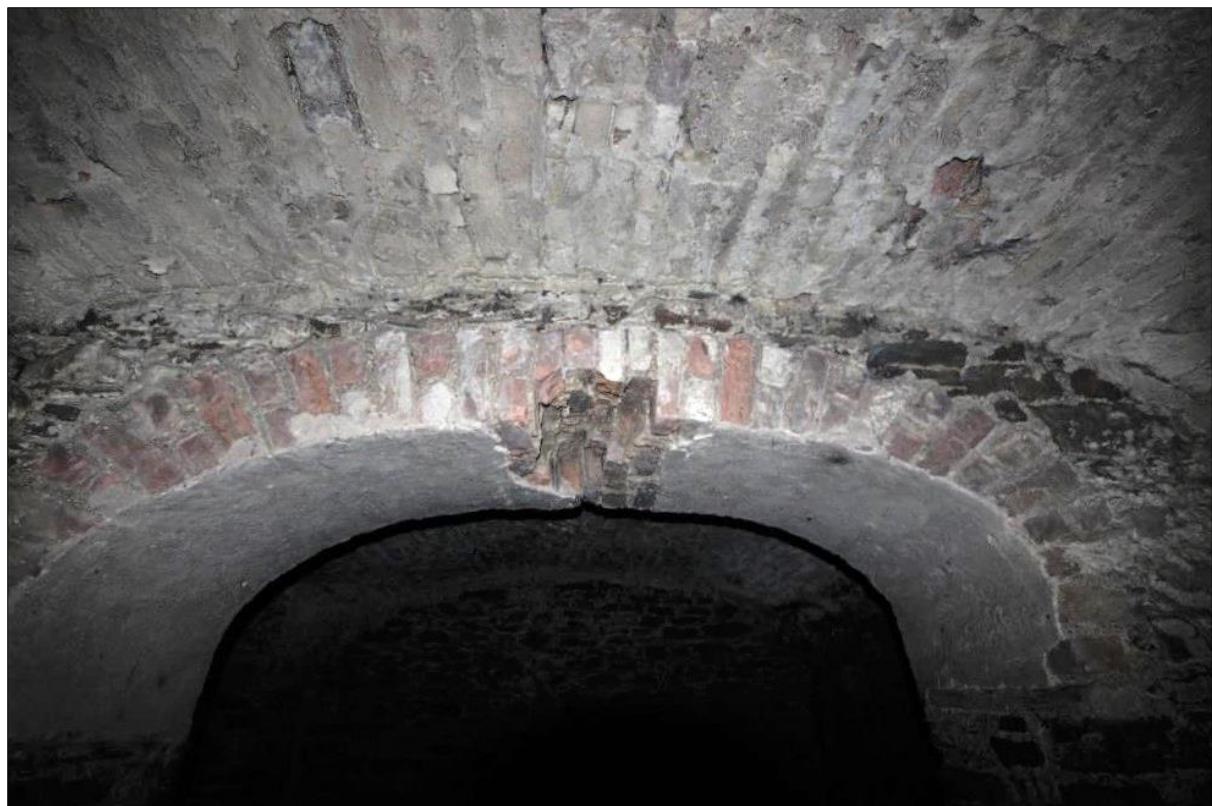
Plate 13: Missing bricks in arch on lower ground floor level LGF01

- A conservation consultant/architect will supervise the works to ensure that any required repairs/interventions to the original masonry and brick fabric is in accordance with conservation best practice.
- Any repointing or renewal of pointing or bedding mortar will be executed in a suitable lime mortar with a sand/grit mix that complements the appearance of the building. The appointed conservation consultant/architect shall review and approve samples of any repointing works.
- Traditional-style painted timber windows and doors will be used on the elevations to respect the character of the building. The façade has been designed with suitable vertical battened doors which reflect the original use as a coach house/stable. The appointed conservation consultant/architect shall review and approve all joinery detail proposed for the exterior of the building.

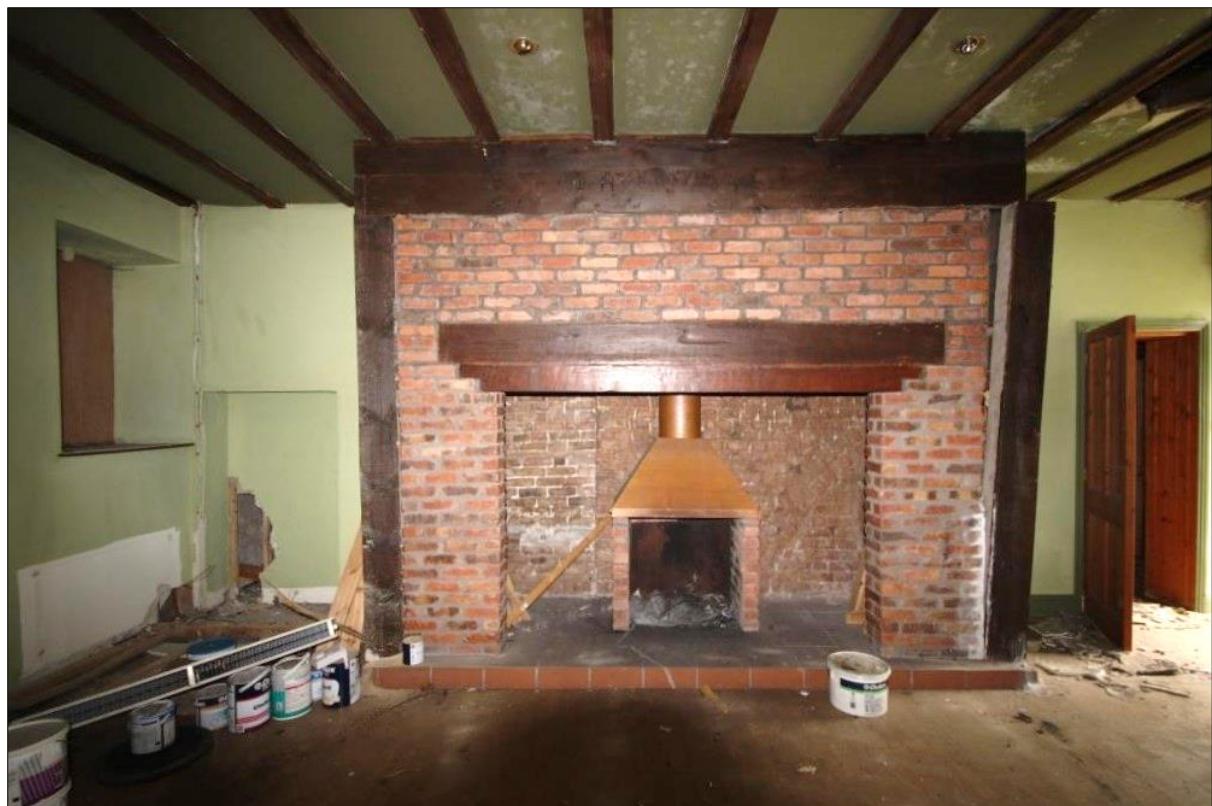
Some of the original brick wall is exposed but a large modern fireplace has been inserted into the room. The ceiling has exposed replacement joists and plasterboard (see **Plates 16-19**).

Plate 17: Modern brick fireplace built up against original brick wall in GF02

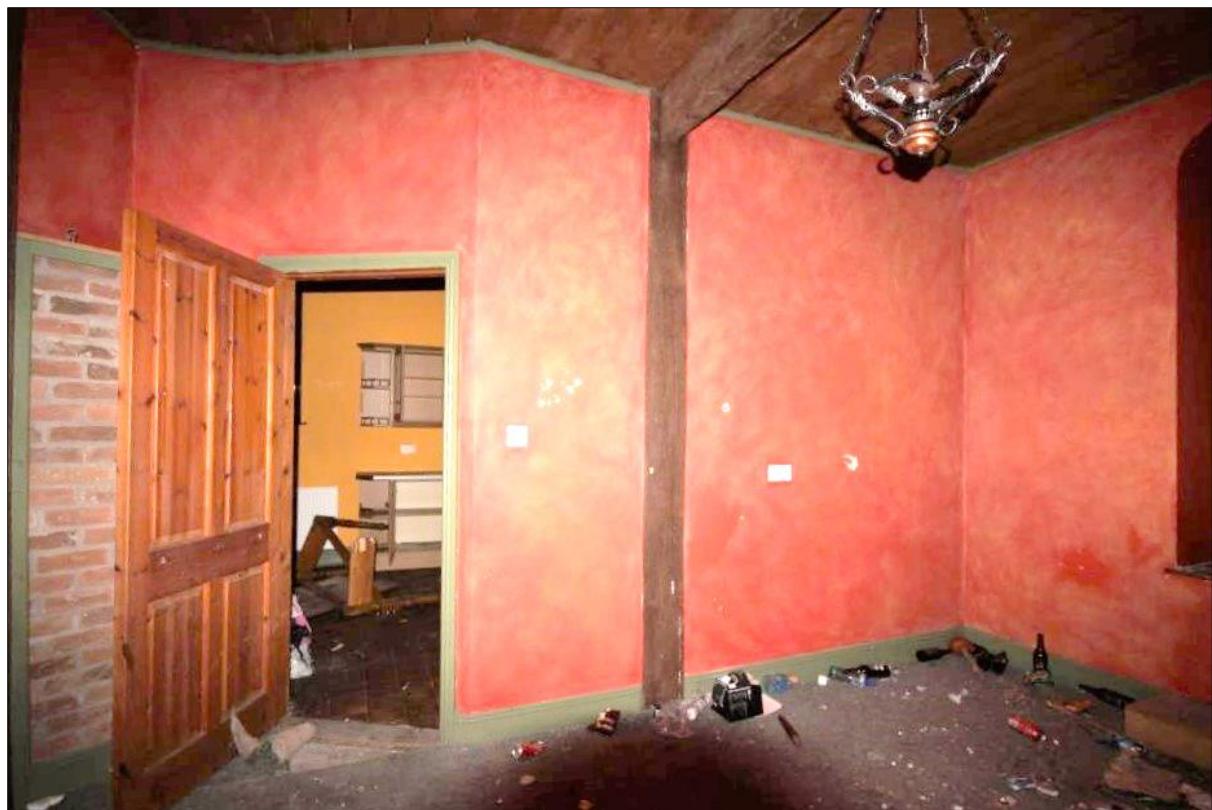
GF03 is located to the front and has a similar replacement entrance door in the front elevation; the room is lit by two original round-headed openings with modern replacement windows. A section of modern brick wall has been inserted into the room (see **Plate 20**).

Plate 20: Ground floor room GF03 looking to GF04

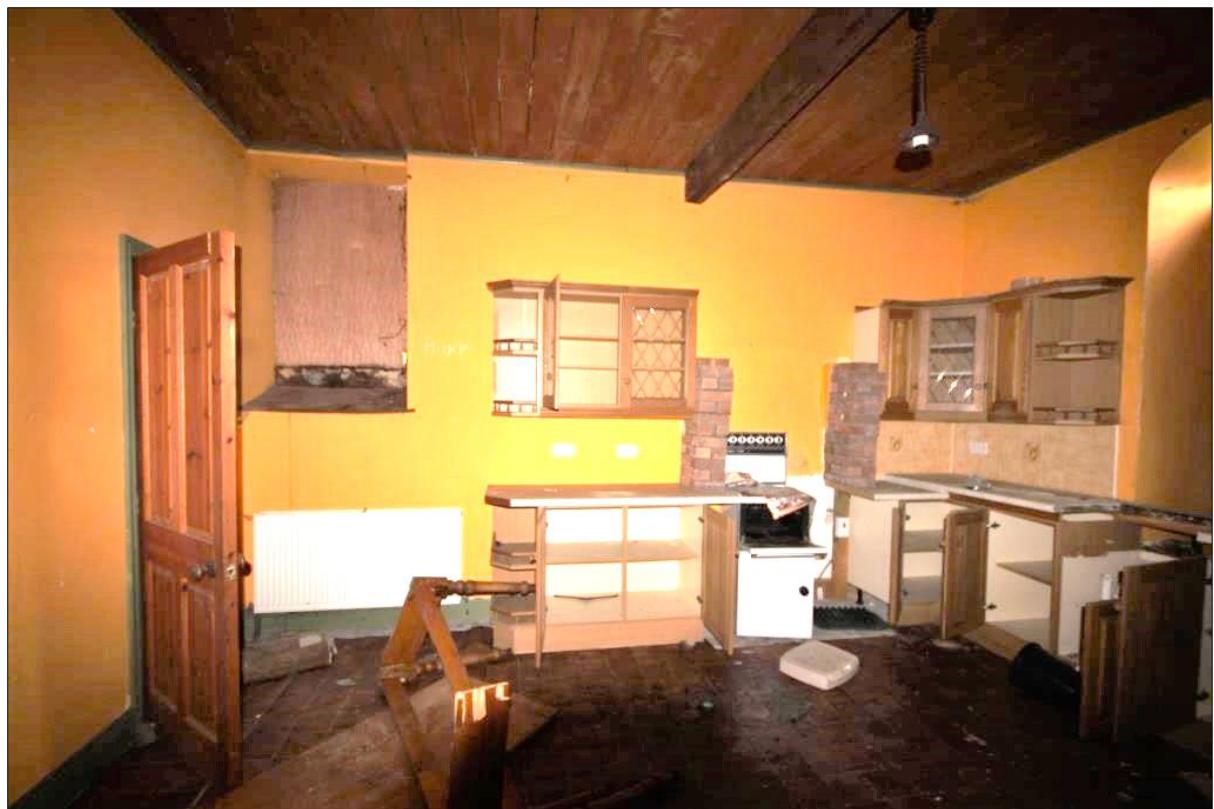
A modern doorway leads to a room to the rear GF04 which was previously in use as a kitchen. The room is lit by two original window openings with modern replacement frames. A modern

brick-built fireplace has been inserted into the corner of the room. A modern door leads to the central hallway (see **Plate 21**).

Plate 21: Ground floor room GF04
