For: PROGRESSIVE COMMERCIAL

Proposed Railyard Development,
Albert Quay, Cork

STAGE 1 ROAD SAFETY AUDIT
March 2024

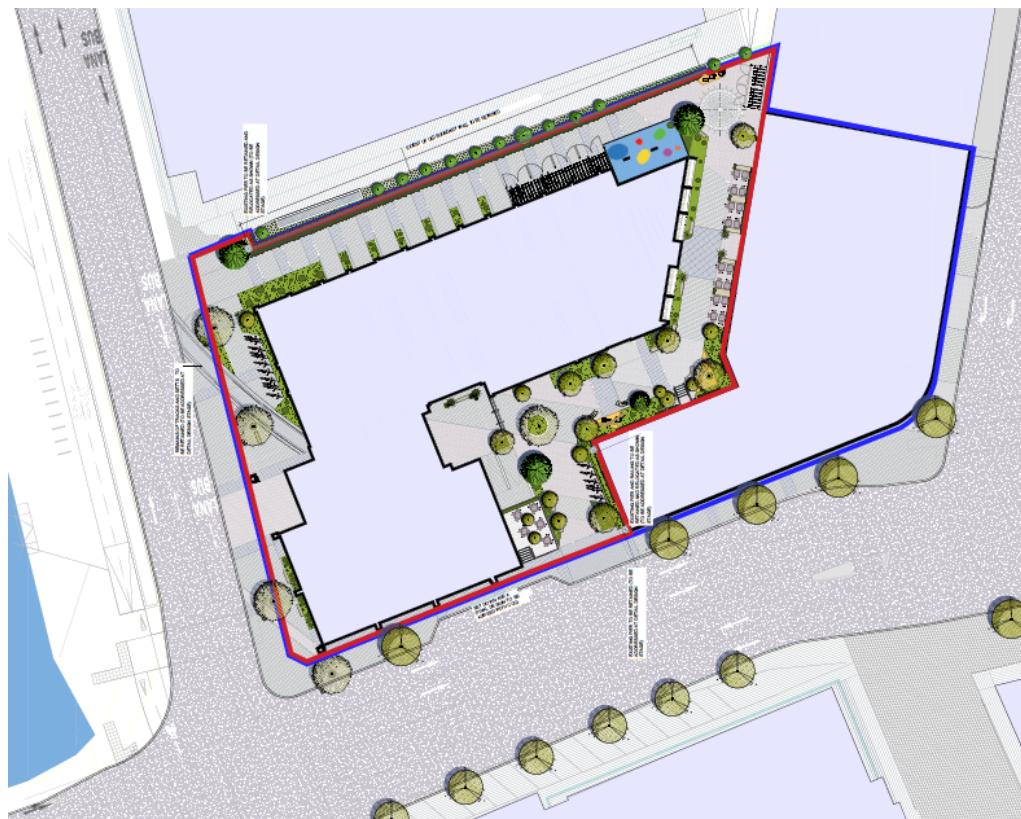
Figure 1.2: Proposed Development Site Layout (Credit: CSR Landscape Architects)

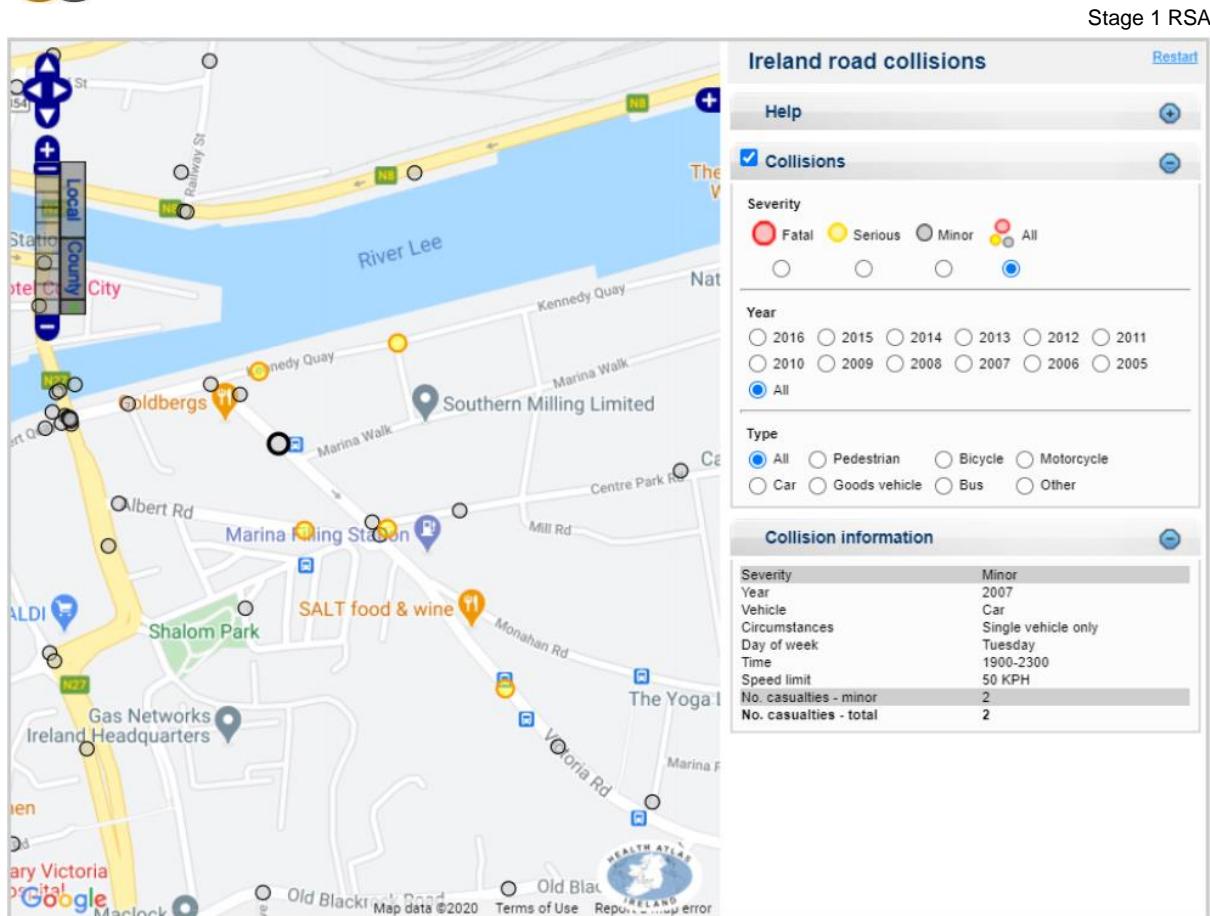
No previous Road Safety Audit reports were provided to the audit team for reference to the development. The Road Safety Authority collision database is currently unavailable due to GDPR considerations. A map showing historic collisions at the location (from the RSA Collision database, collected as part of a previous report is included in figure 1.3 below for reference purposes. Details of the collisions is not available. The map shows a significant cluster of collisions at the junction of Albert Quay and the N27. A more detailed Collision Investigation would be advisable to ascertain the statistical significance of any current collisions trends, and the likelihood of any increase in collision risk which might arise as a result of the development proposals.

Figure 1.3: Historic RSA Collisions Map

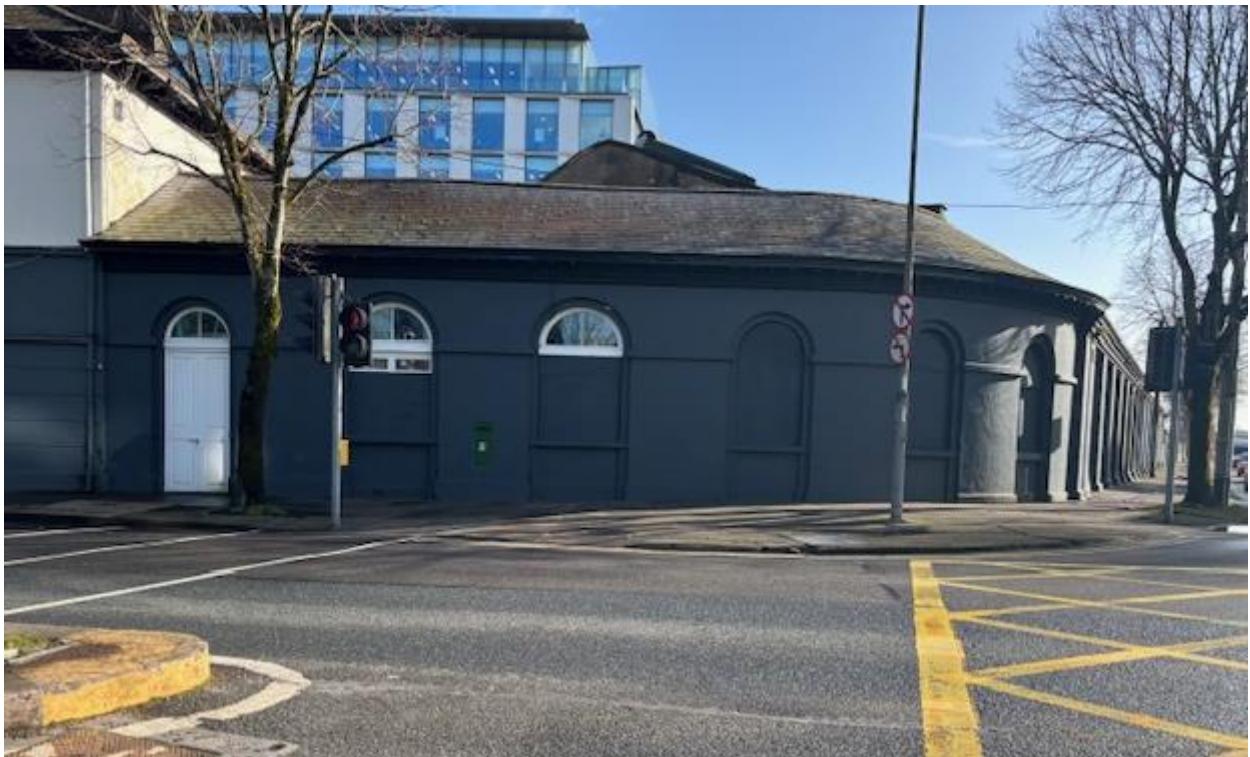
The existing footpath along the N27 is in poor condition. The footpath surface is broken in a number of locations, owing to the effect of tree roots, service channels and a lack of maintenance. A number of disused dropped kerbs were also noted.

Failure to provide a safe pavement surface may cause pedestrians to trip due to protruding joints and upstands. This presents a particular hazards for visually impaired users. See photos A1 to A3 in appendix A.

Photo A1 – Existing Footpath Damaged adjacent to the development site

Carry out footpath replacement or repair works to improve the existing. Ensure that any existing dropped kerbs, not intended to serve as a vehicle access route or pedestrian crossing, should be removed and replaced with full height kerbs.

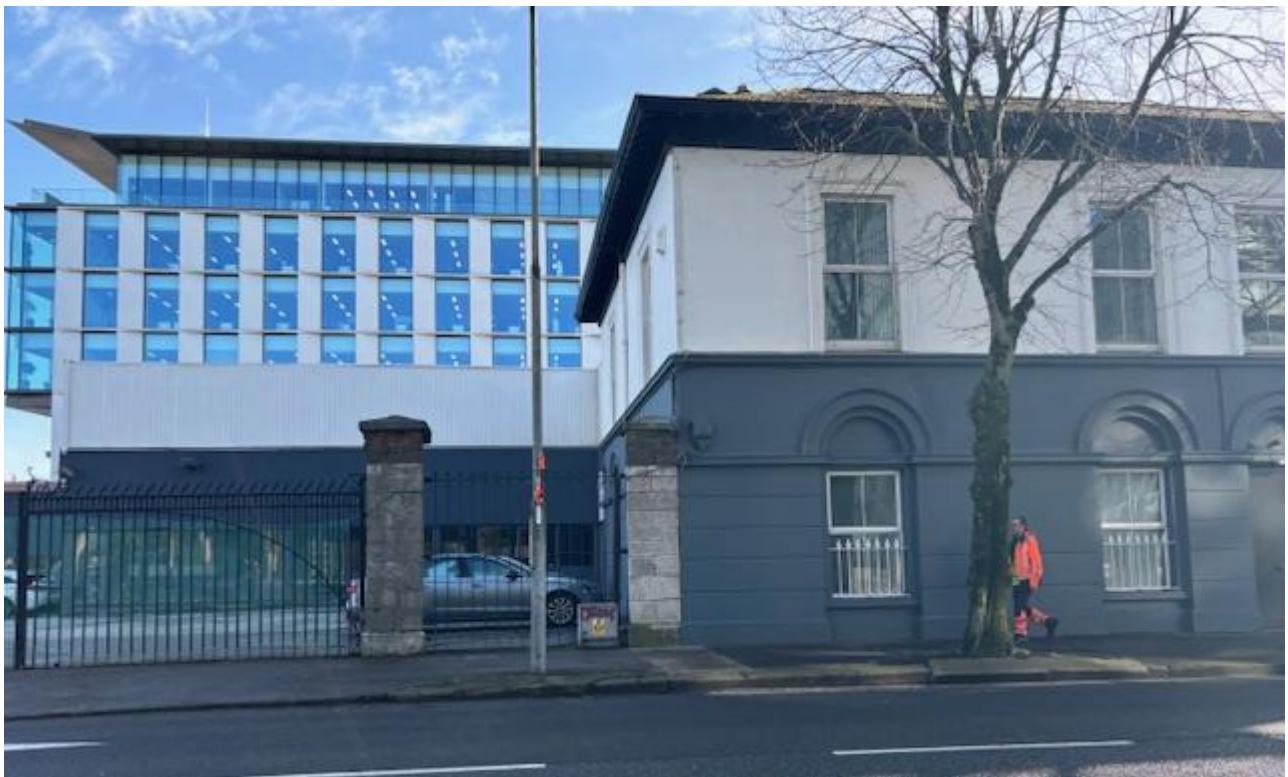
Photo A2 – Existing Footpath Damaged adjacent to the development site

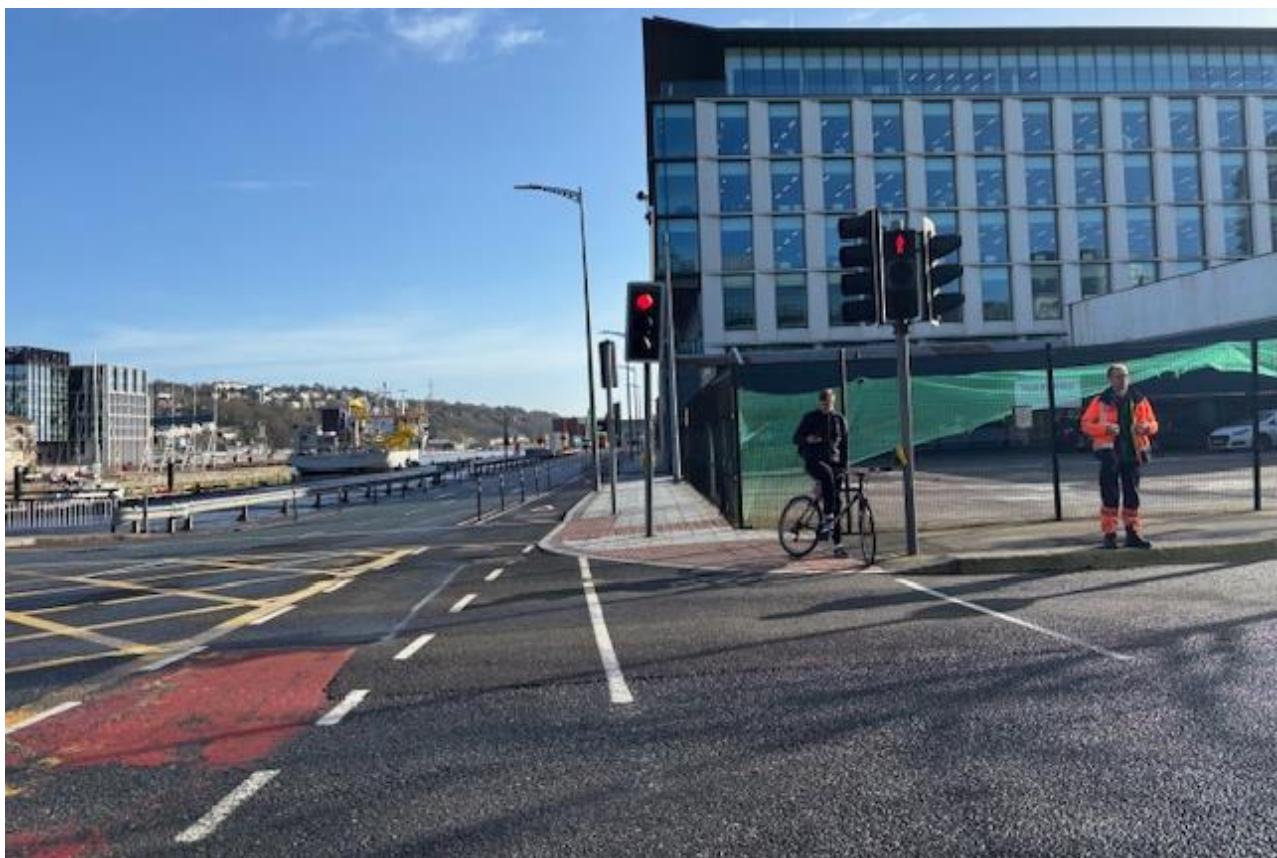
Existing tactile paving serving the pedestrian crossings at the adjoining junction are not shown on the drawings provided to the audit team. Whilst this is likely to be a drafting error it should be made clear that this tactile paving forms part of the pedestrian crossing infrastructure and should not be removed. See photo A3 in appendix A.

Photo A3 – Existing tactile paving at pedestrian crossing adjacent to the site.
