DESIGN STATEMENT

Part 8 for 'Weighmaster's House'

2 Church St., Shandon, Cork.

Proposed Refurbishment, alterations and change of use of 'Weighmaster's House' to community and creative space.

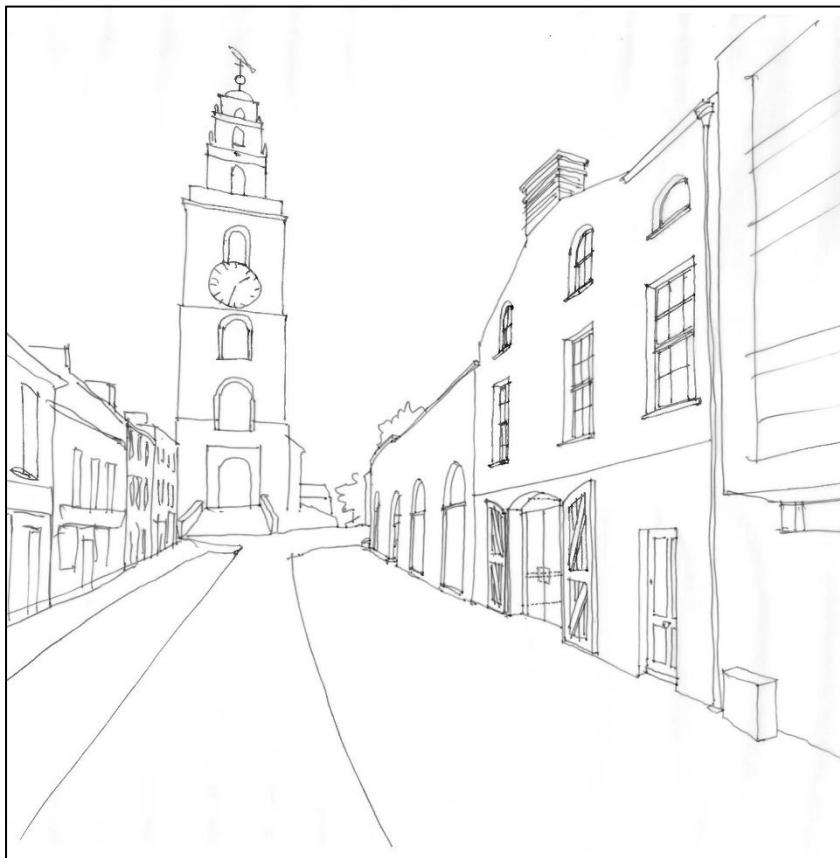
Fig. 1: Proposed Street Elevation to Weighmaster's House, Church Street, Cork.

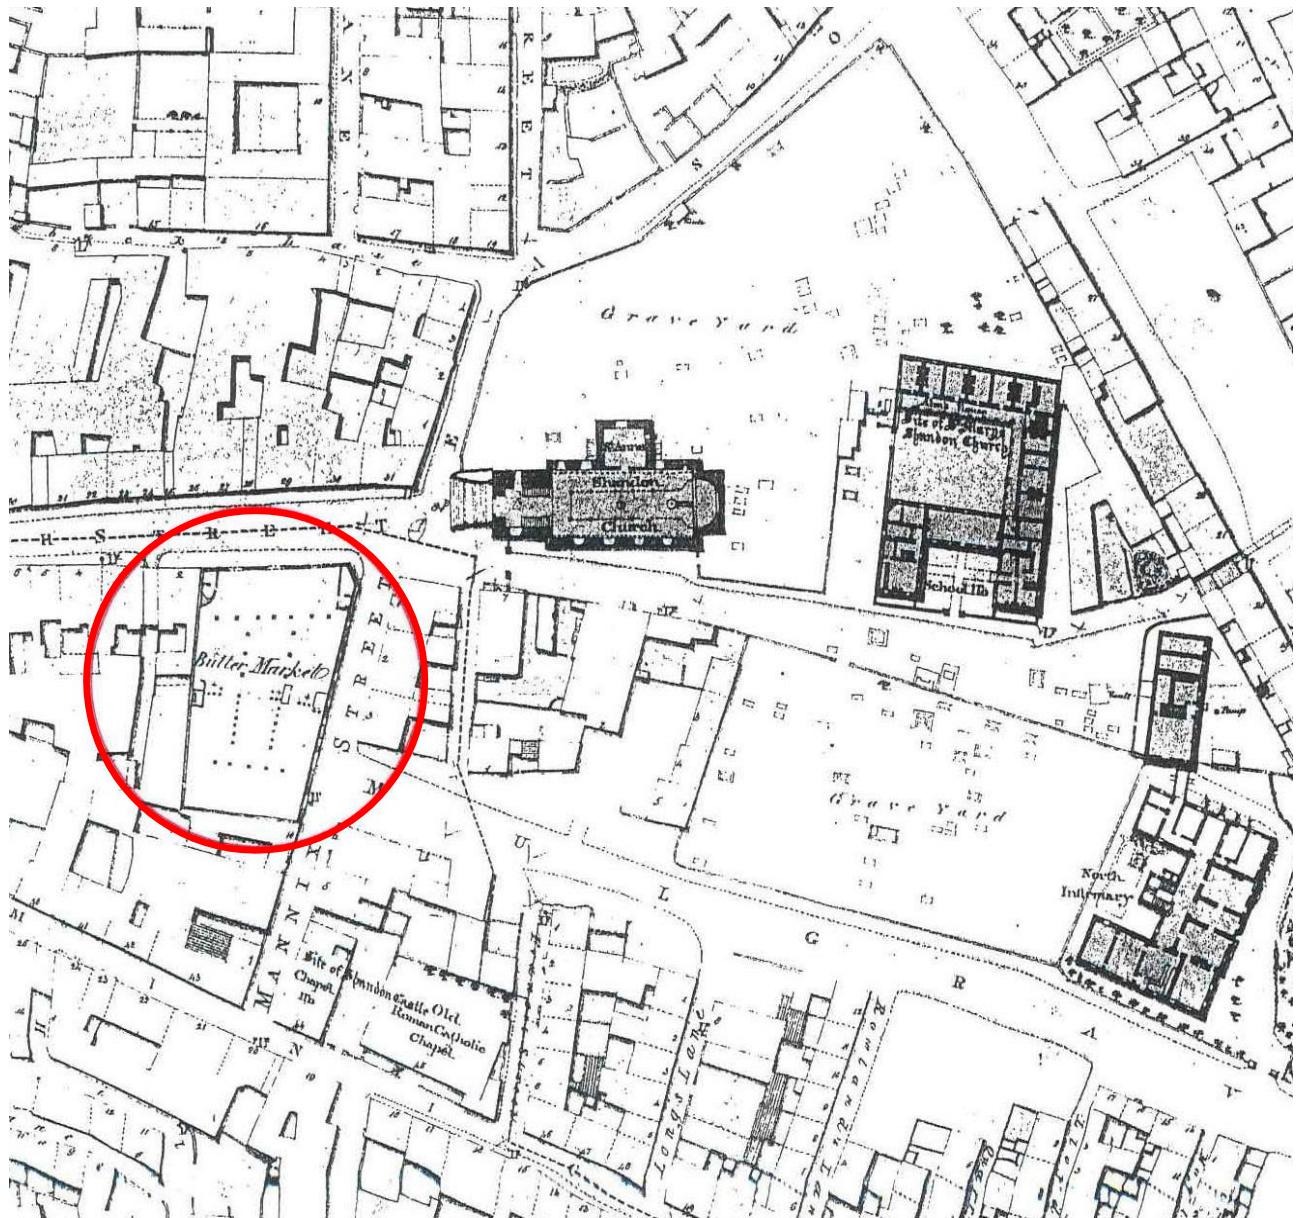
Fig. 4: OS Map Sheet No. XV highlighting the Butter Exchange Market in 1842. Three bays running north-south.

Despite the scale and importance of its dealings, it was not until the early nineteenth century that a unified covered area was constructed. The extent of the original market building is shown on the 1st Edition of the Ordnance Survey (1842) occupying the area bounded by Church Street and Mannix Street. (See Fig. 4)

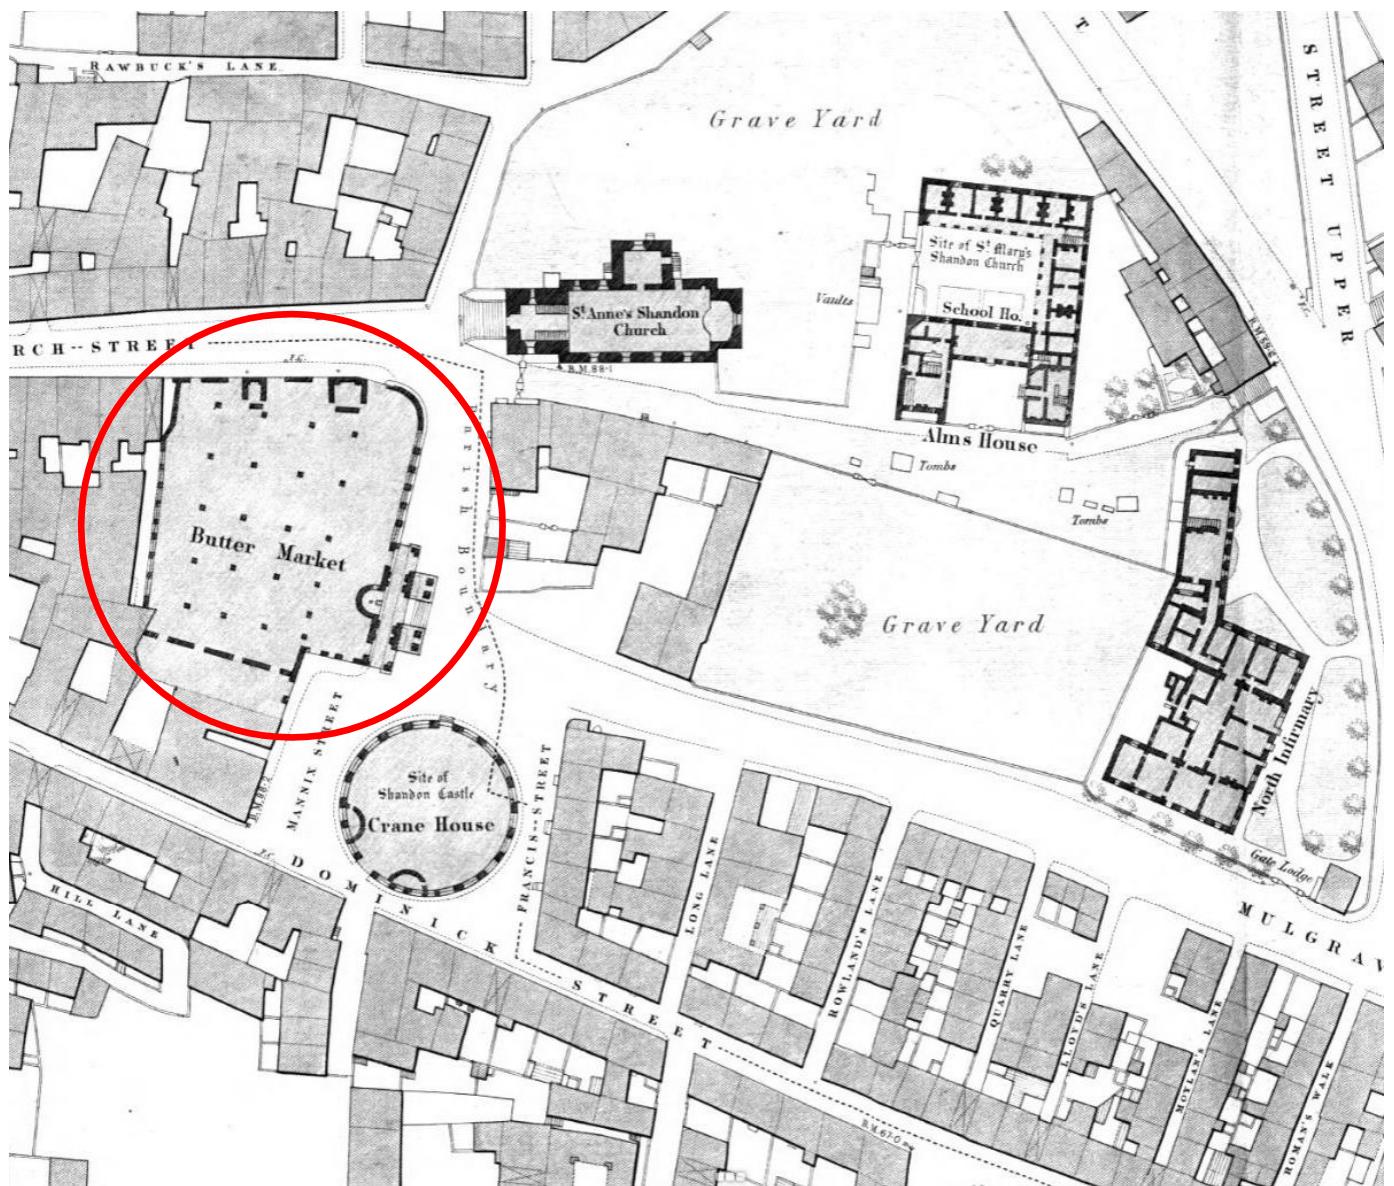
Fig. 5: Extract from OS Sheet No. LXXIV highlighting the Butter Market in 1870. It expanded east and west and had five bays running north-south.

a weighmaster who checked the weights and measures to ensure they were being honestly traded and he lived in the house which formed part of the butter exchange. The accommodation appears to have been located to the first and second floors and had an internal bay window which overlooked the interior of the Butter Market. The extent of Benson designed complex is highlighted in red on the extract from the 1870 Ordnance Survey below. (See Fig. 5)

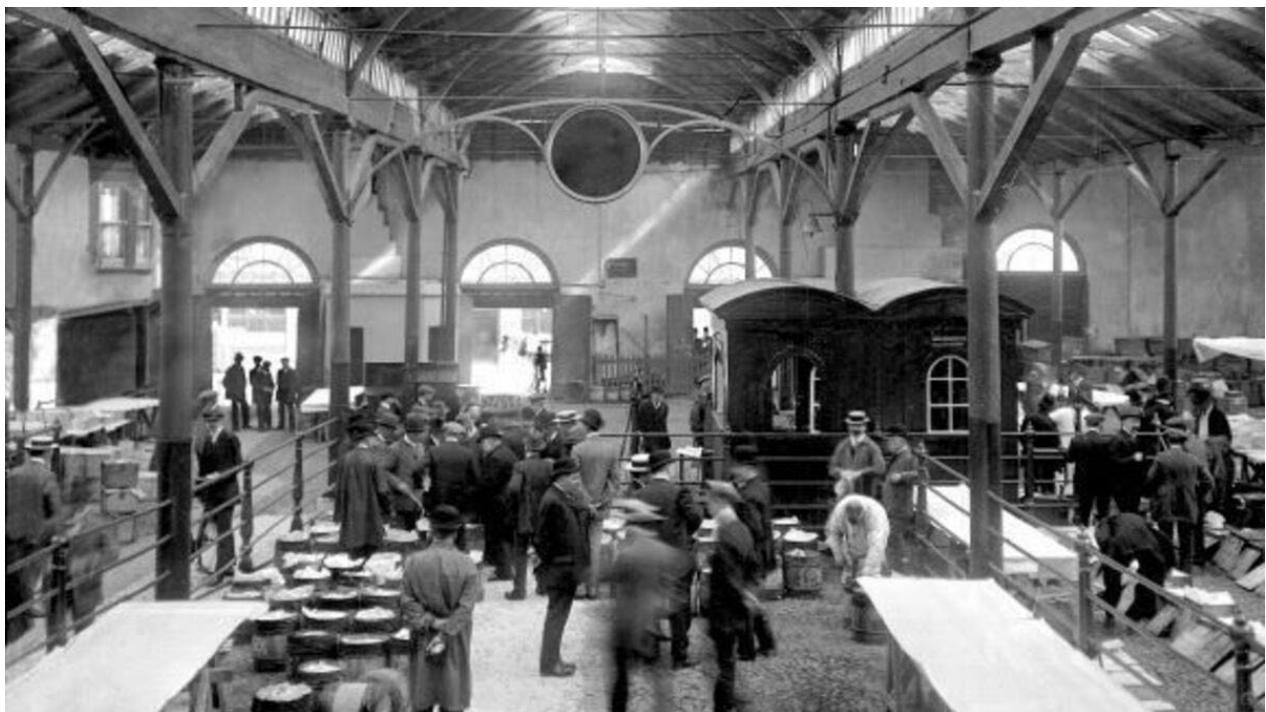
Fig. 8: View of the interior of the Cork Butter Market Exchange showing roof and clerestory glazing. The doors at the rear open to Church Street. This area was destroyed by fire in 1976. Part of the Weighmaster's House can be seen on the left. (Photograph c.1914)

The high-level clerestory glazing on the eastern side of the market hall has been removed – probably when the wall was constructed between the Butter Exchange and the Weighmaster's House.

It is proposed to carefully remove the top part of this concrete wall and to reconstruct the high-level glazing using timber sections of similar size and type as was originally used throughout the market.

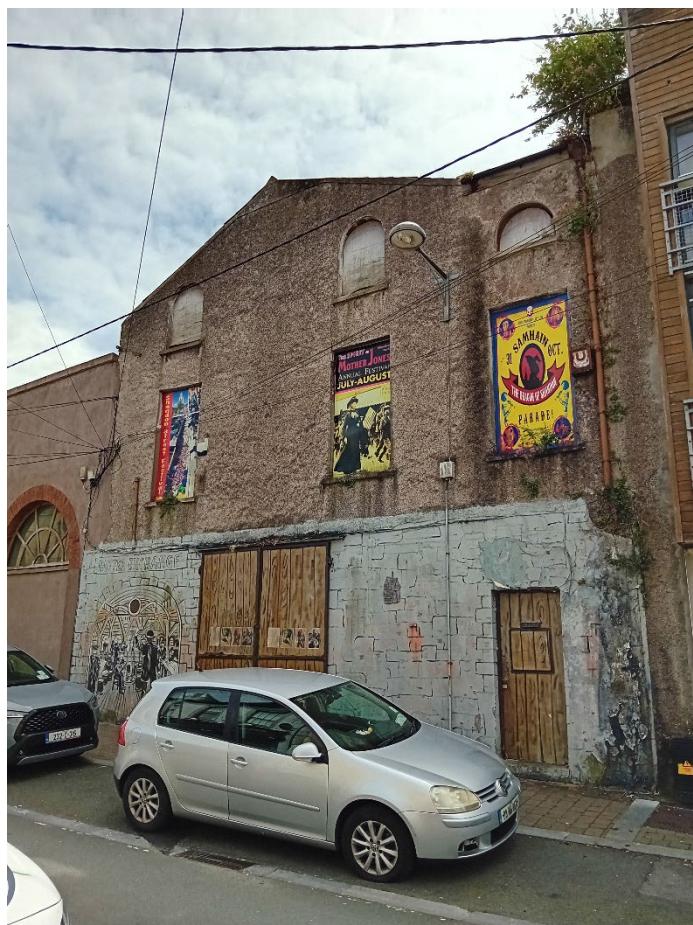
External view of Weighmaster's House (2024) from Church Street. Ground floor double-doors to Butter Market and single door to Stairs leading to Weighmaster's House on two upper levels.

The large opening to the ground floor which provides access off Church Street will be retained as a public entrance to the building, while the smaller doorway to the west will be retained and give access to the upper floors of the Weighmaster's House. The ground floor area of this building, which has undergone many phases of interventions since its original use, will remain as an open plan area providing an entrance lobby and café space.

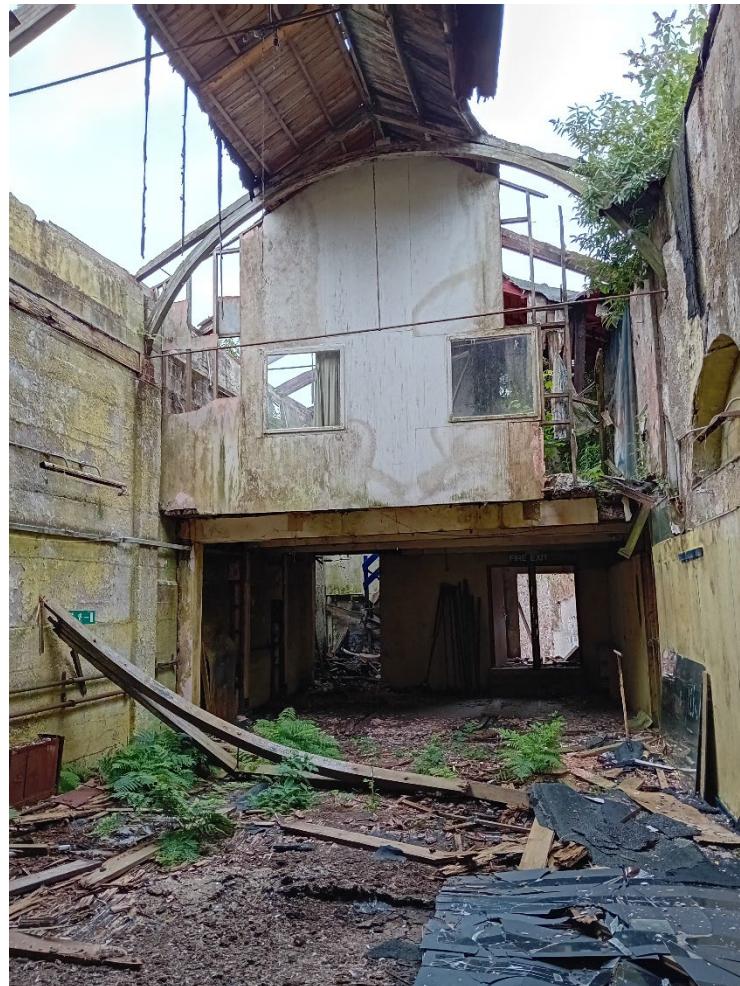
Internal view (2024) of original Butter Market looking south with 1980's additions. The building has been substantially damaged by roof failure.

The existing roof will be carefully assessed and parts of the original trusses retained and repaired where possible and reconstructed where needed as exact replicas of the originals and reinstalled to provide support for the reconstructed roof which will have a slate finish.

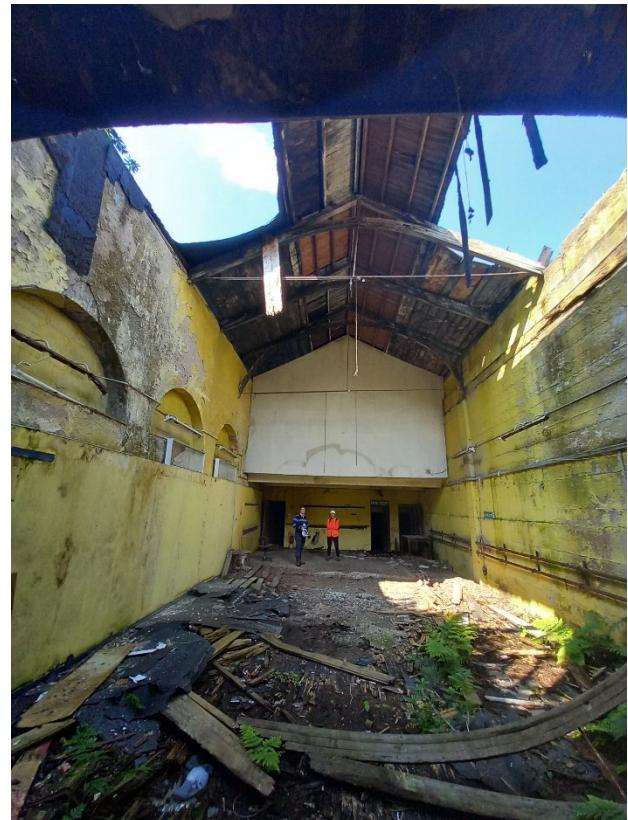
Internal view (2024) of original Butter Market looking north with 1980's additions. The building has been substantially damaged by roof failure. Blocked up lunettes left.

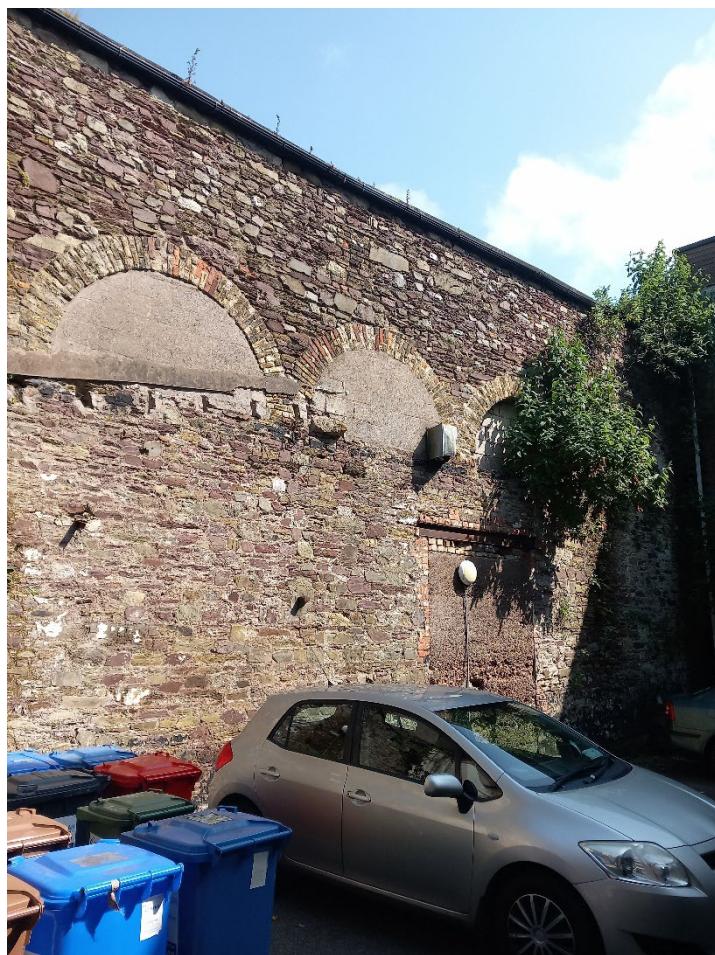
West elevation of original Butter Market with blocked up lunettes.

The architectural significance of the surviving western bay of the Butter Market, and the Weighmaster's House fronting Church Street, is recognised. Although the building is now in poor repair, a number of laminated curved roof trusses original to the John Benson scheme survive and will be used as templates to allow for the faithful restoration of the roof (located to the rear of the Weighmaster's House). Extensive research has provided information on the historic form and materials of the roof which will be restored to best conservation practice, including the slate covering and clerestory glazing. Blocked lunette windows to the western wall of this former Butter Market area will also be reopened and reinstated.

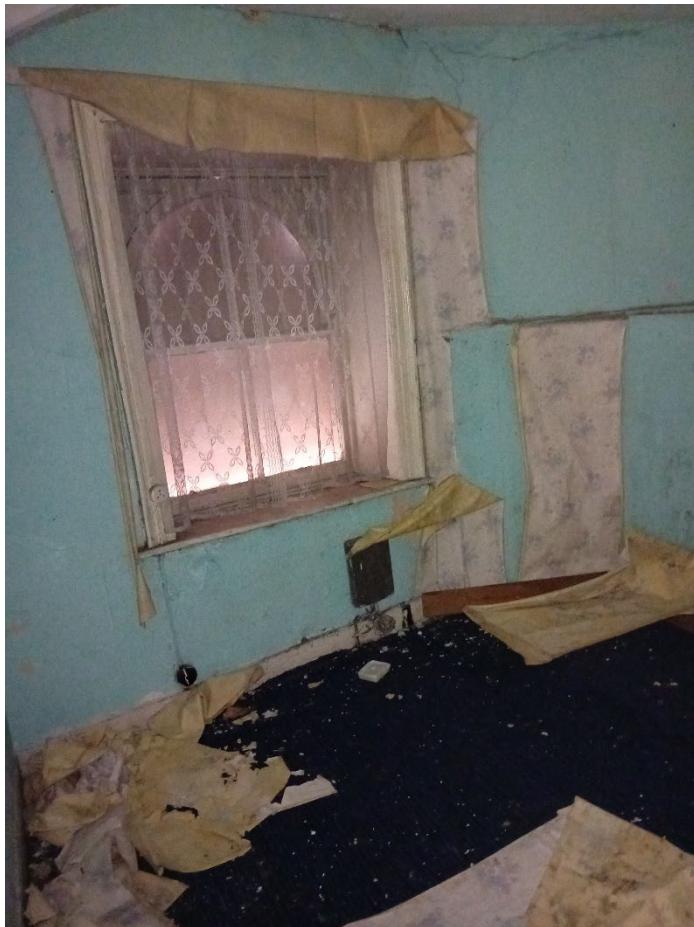
Interior of Weighmaster's House showing original windows at first floor level.

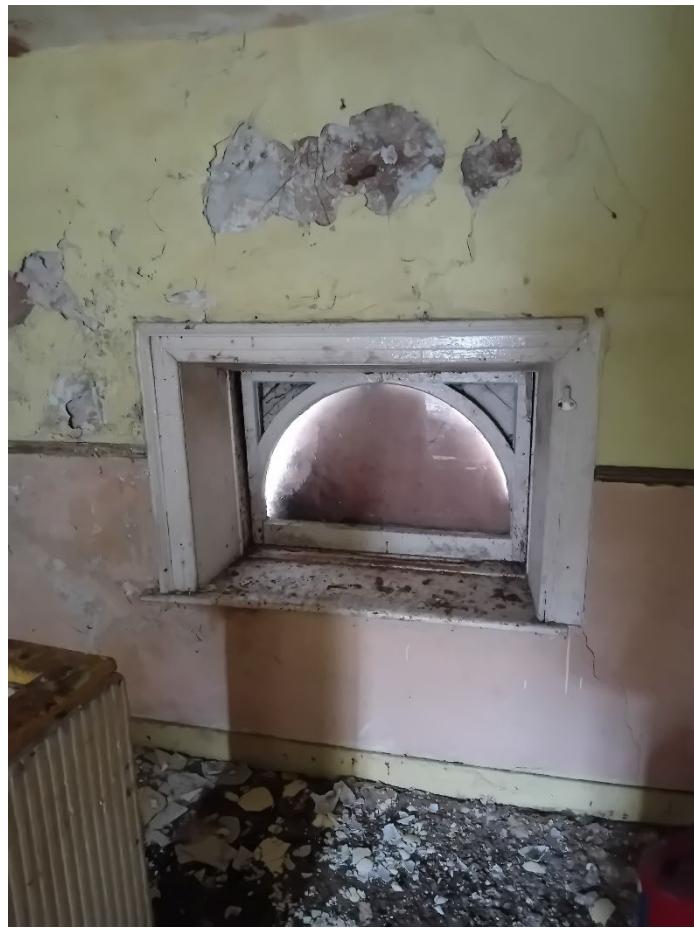
Interior of Weighmaster's House showing original windows at second floor stairs.
