Proposed Residential Development,  
Glyntown, Glanmire

COMBINED STAGE 1 & 2 ROAD SAFETY AUDIT

**March 2025**

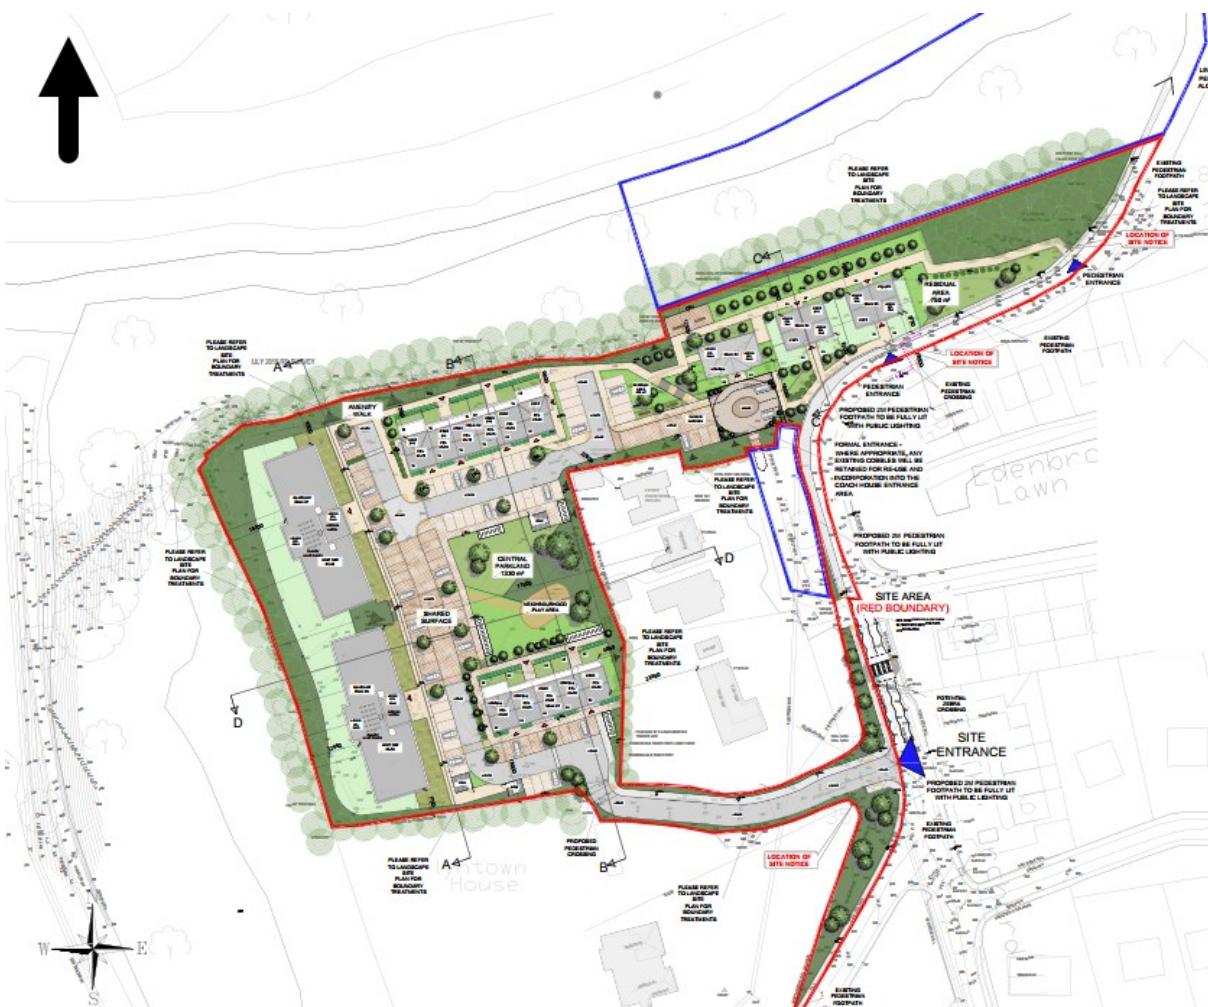
**Figure 1.2 Proposed Development site (Deady Gahan Architects)**

The scheme is to comprise of 80 No. residential units. Access to the proposed development is provided to the south of the site, onto the East Cliff Road. Two separate pedestrian access ways also link the site to the East Cliff Road to the north, with a controlled zebra crossing also shown to the north of the proposed development entrance.

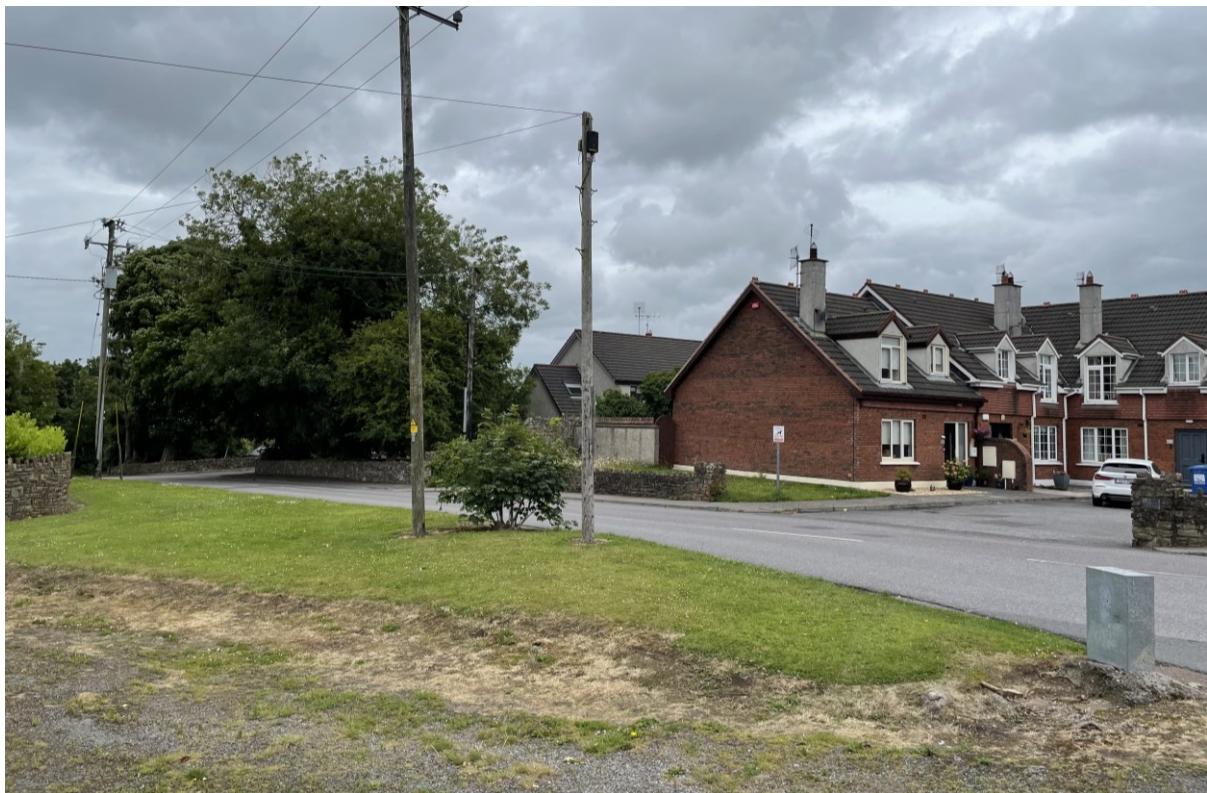
A micro pillar and a number of utility poles were observed at the existing road edge, where it is intended to construct a new roadside footpath. No reference to this pillar or poles is made in the drawings provided to the audit team. The pillar and poles, if not relocated, would represent a hazard to vulnerable road users, particularly visually impaired users and may lead to falls.

**Photo A1** Site boundary along the nearside road edge, looking north.

Relocate all poles and pillars off the proposed footpath to ensure that the footpath space is not restricted.

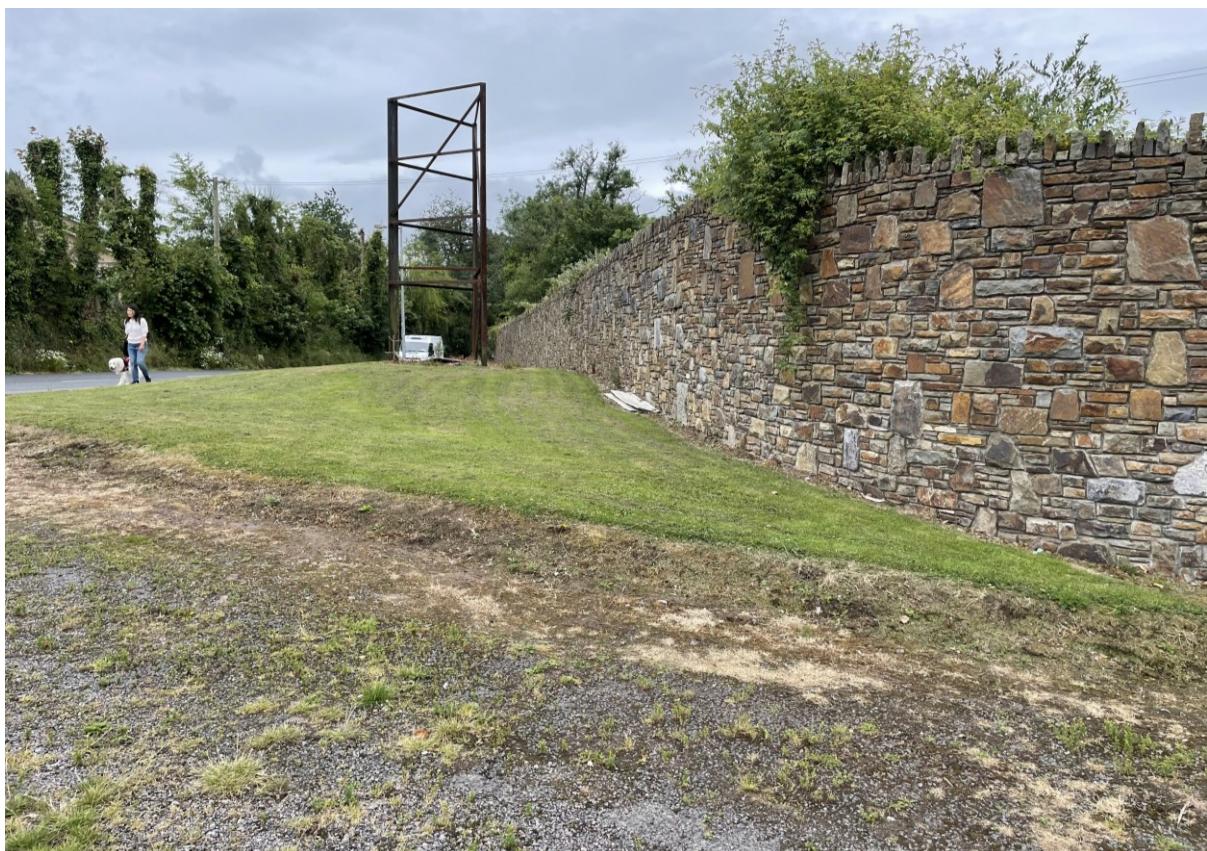
**Photo A2** Site boundary along the nearside road edge, looking south.

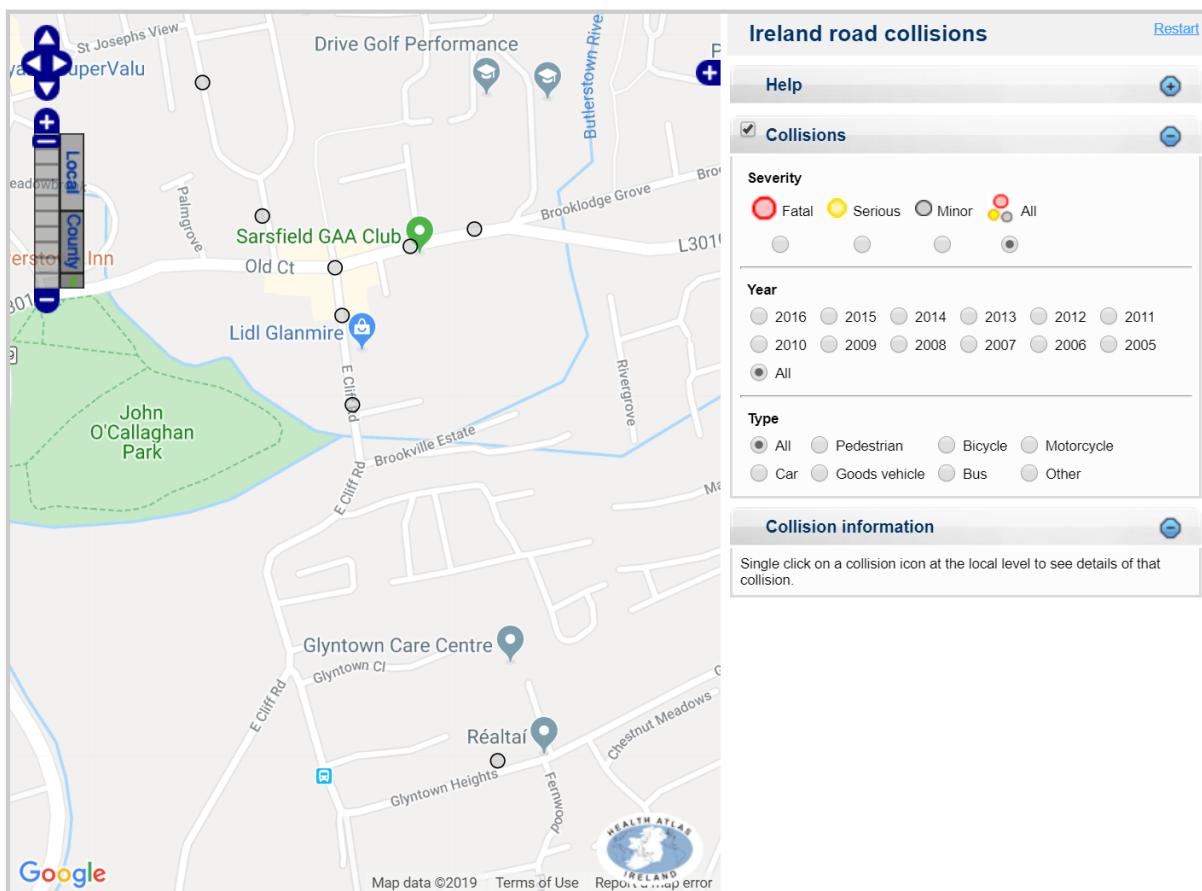
No specific Road Collision data was provided to the audit team. The auditors reviewed the RSA Road Collision Statistics, in the vicinity of the applicant site. No collision data was recorded in the vicinity of the proposed site entrance junctions the period 2005 – 2016.

**Figure C1. Road collision between 2005-2016 (RSA)**
