Glenview House - Blackpool

Conservation Report & Heritage Impact Assessment:

Glenview, Cork

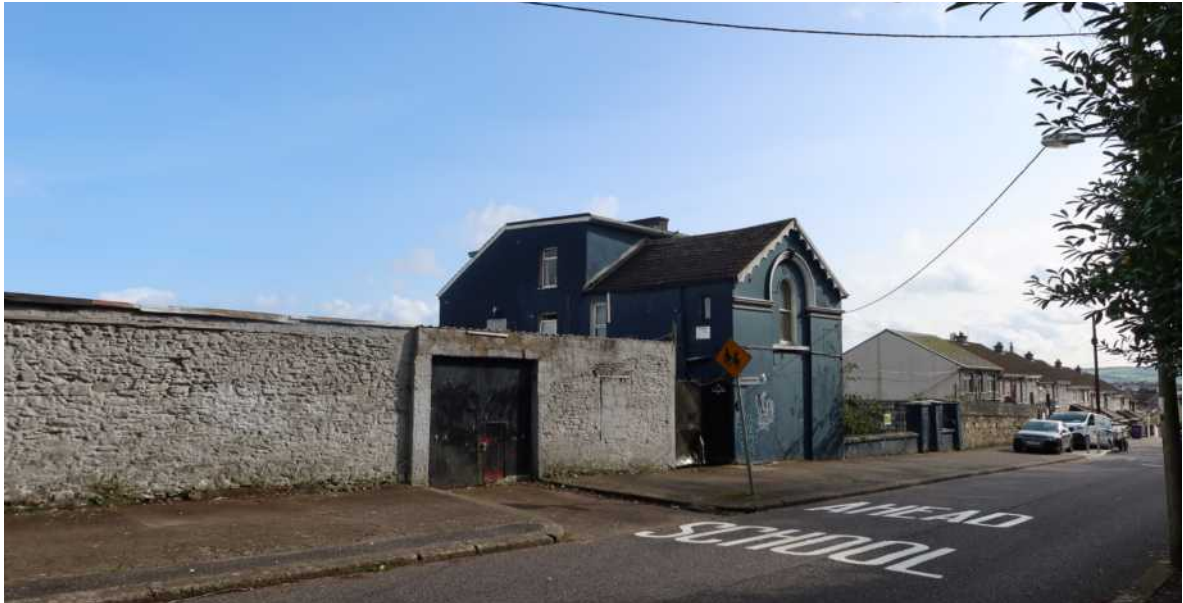
• Fig 6. View of house from North along Redemption Road, with walls of 'outbuildings' alongside.

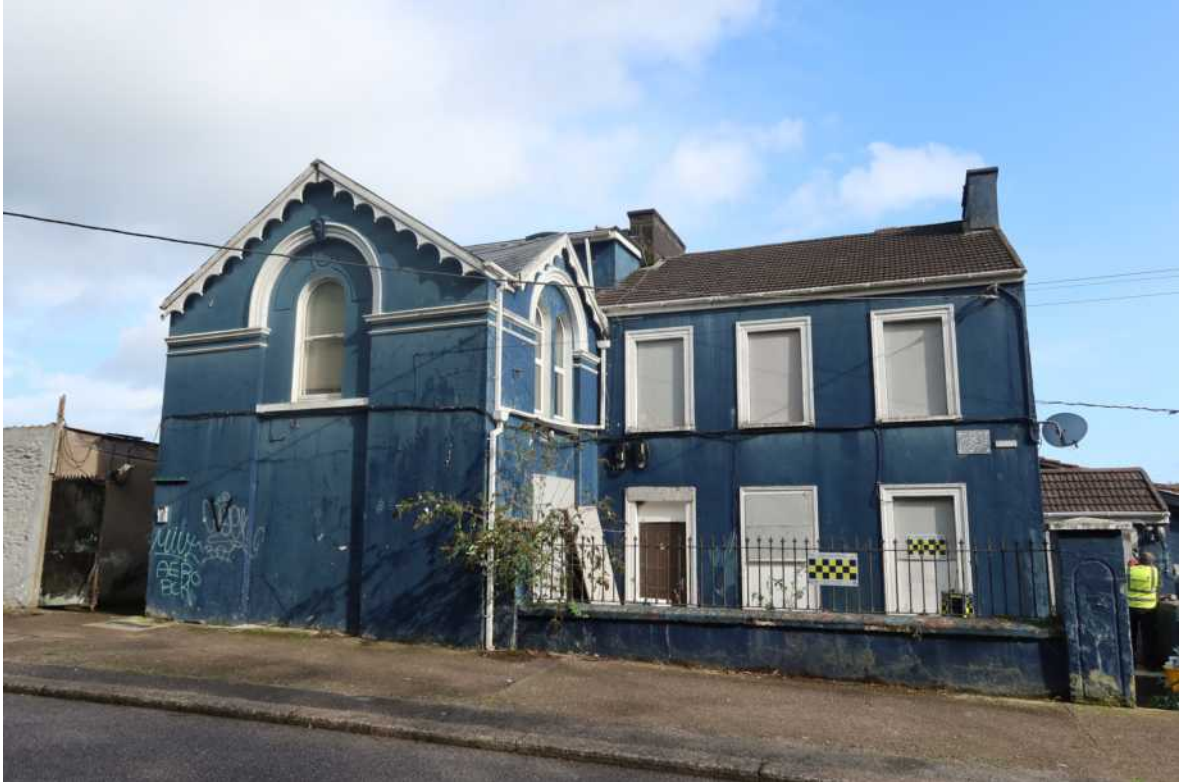
• Fig 9. South West view of house.

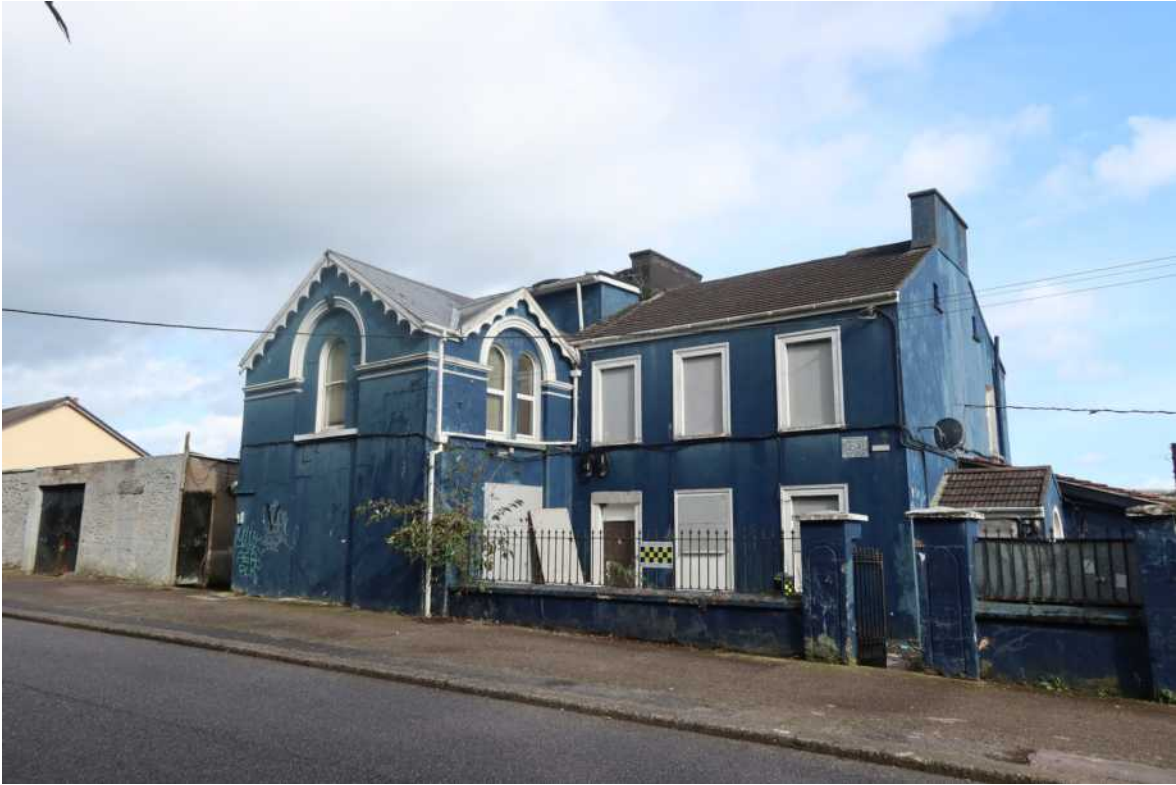
• Fig 10. South West view of house.

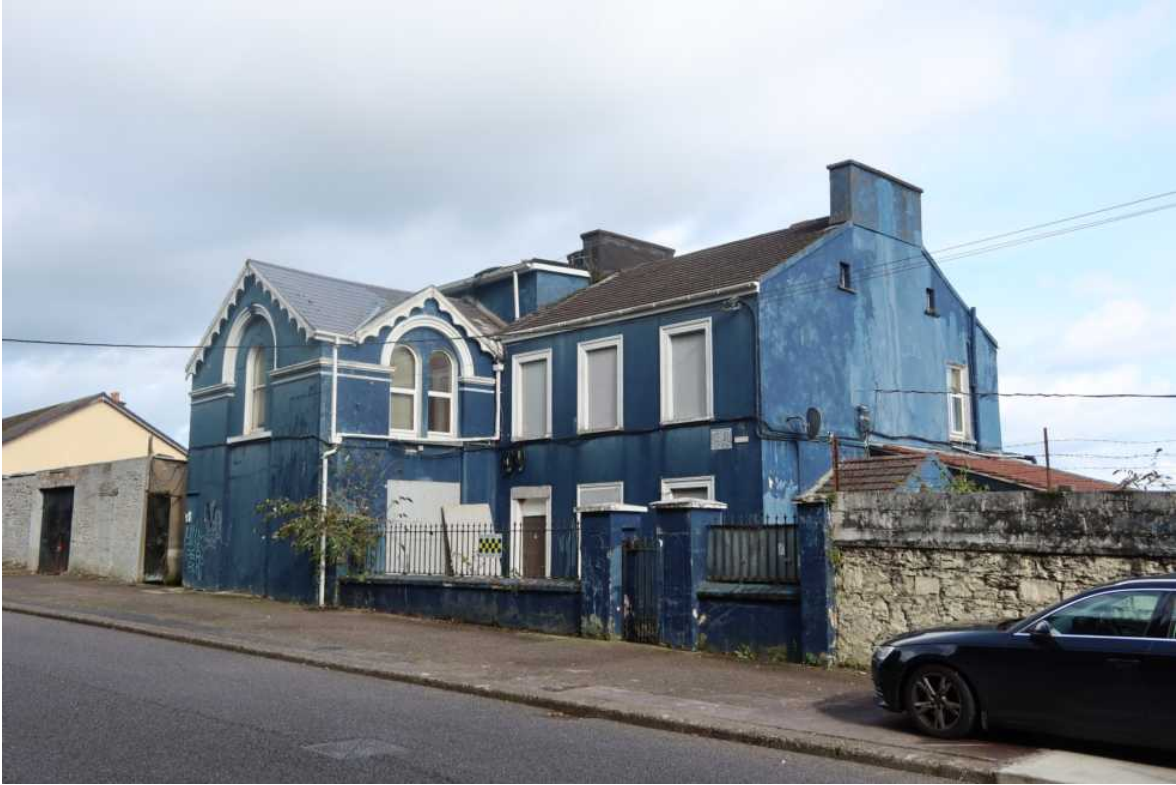
• Fig 11. South West view of house.

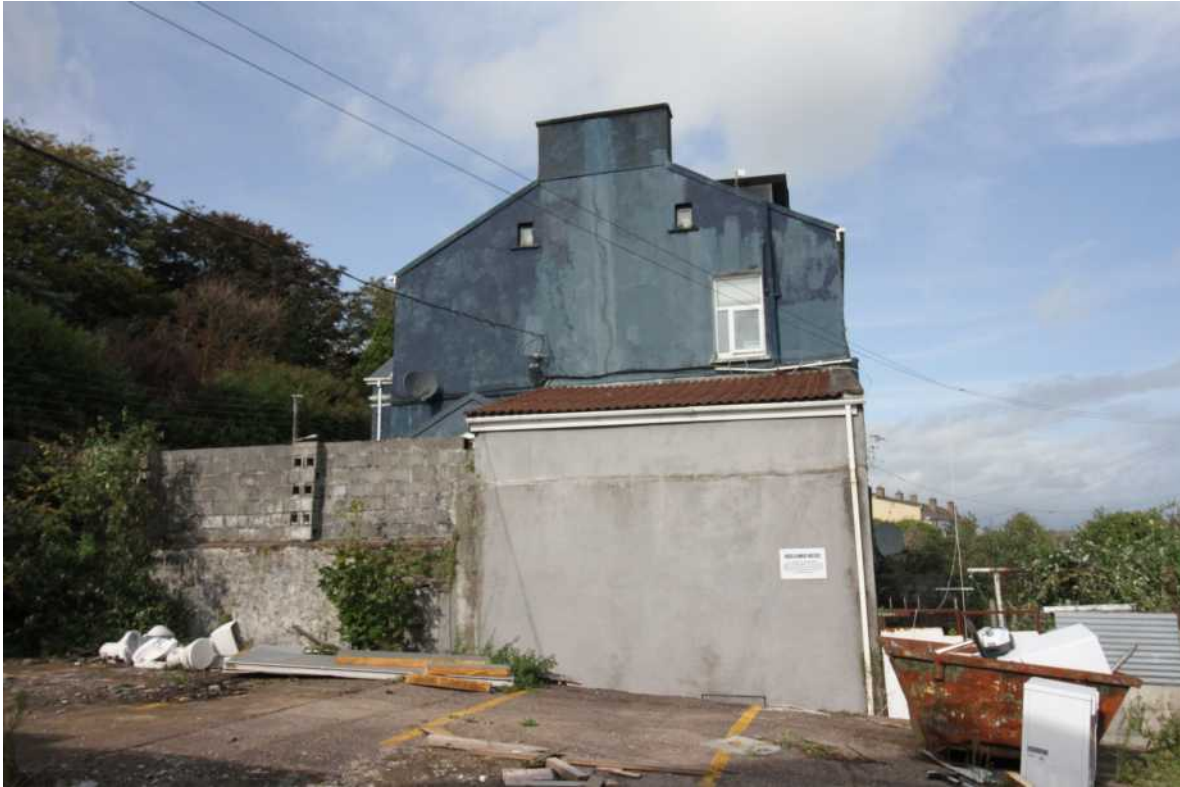
• Fig 12. South end view of house.

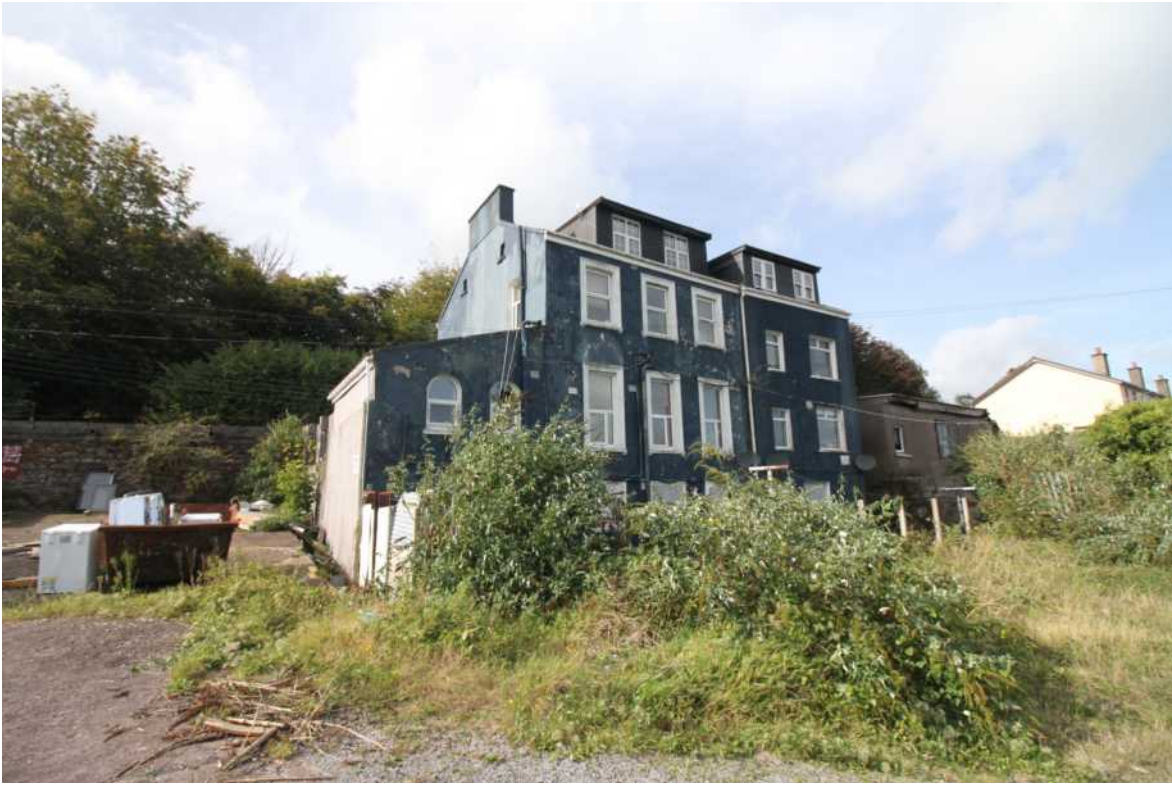
• Fig 15. East South/East view of house.

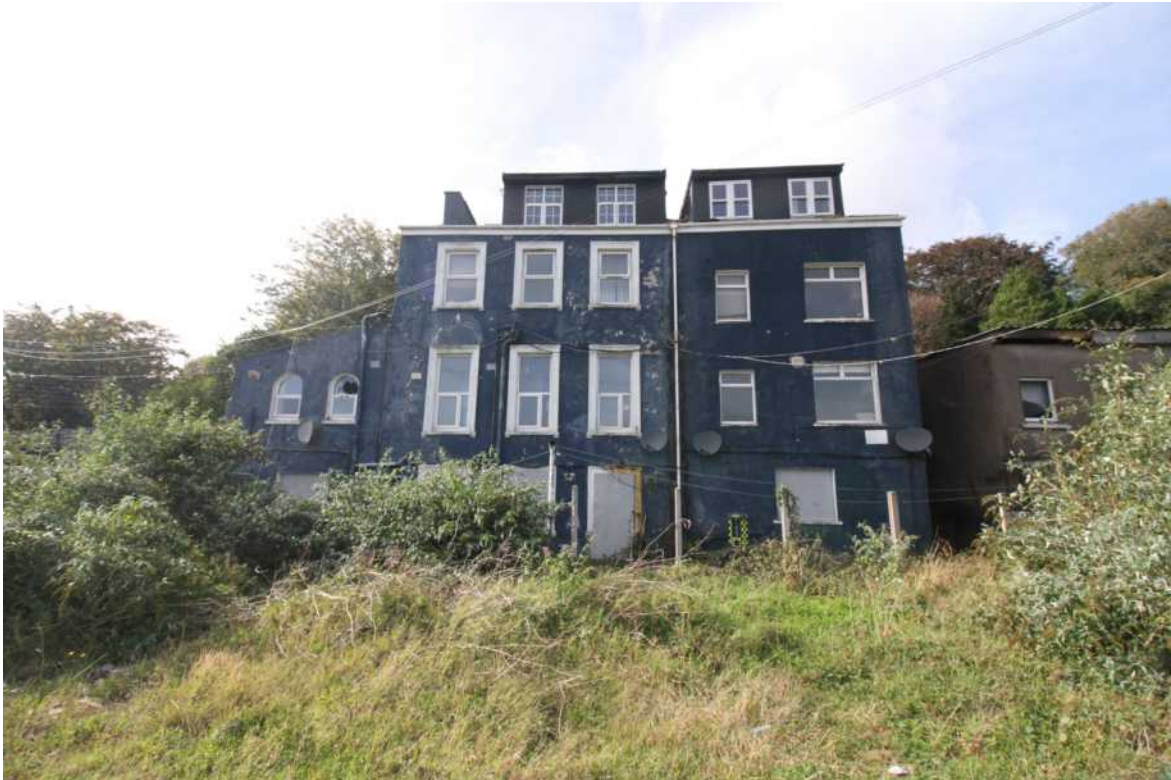
• Fig 16. Eastern view of house.

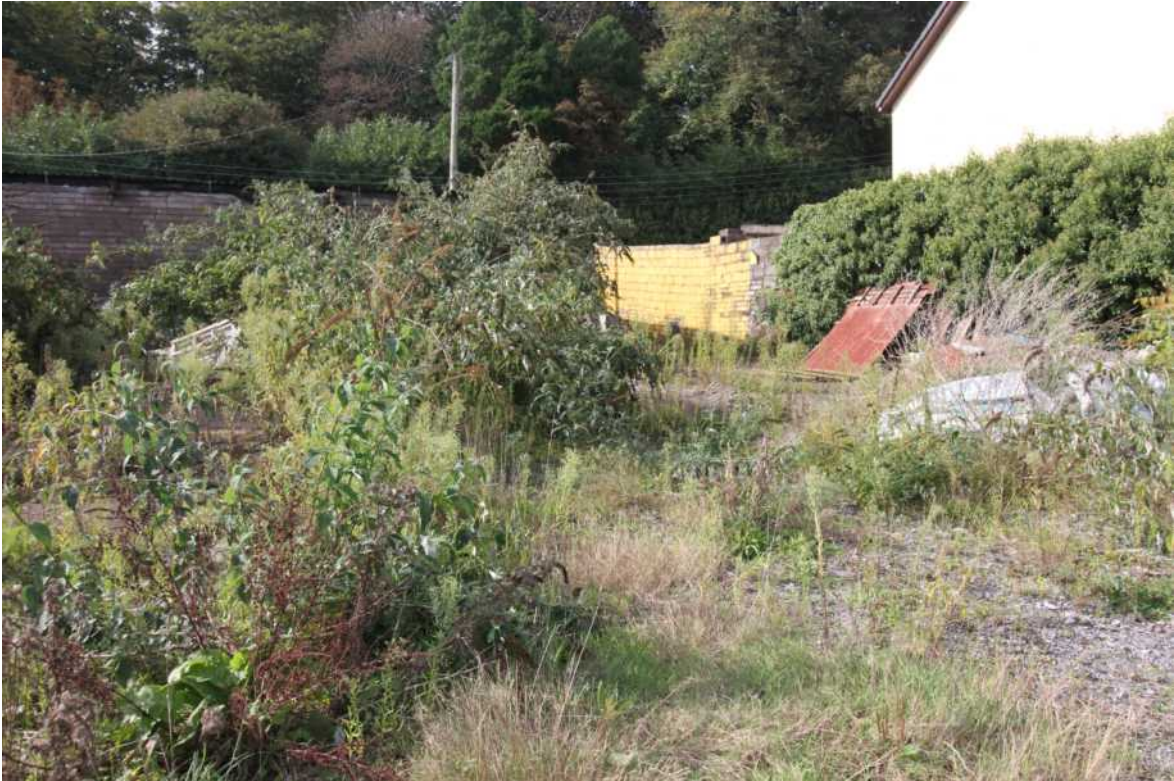
• Fig 18. Boundary to adjoining houses to North and tree screen to Farranferris Educational Campus.

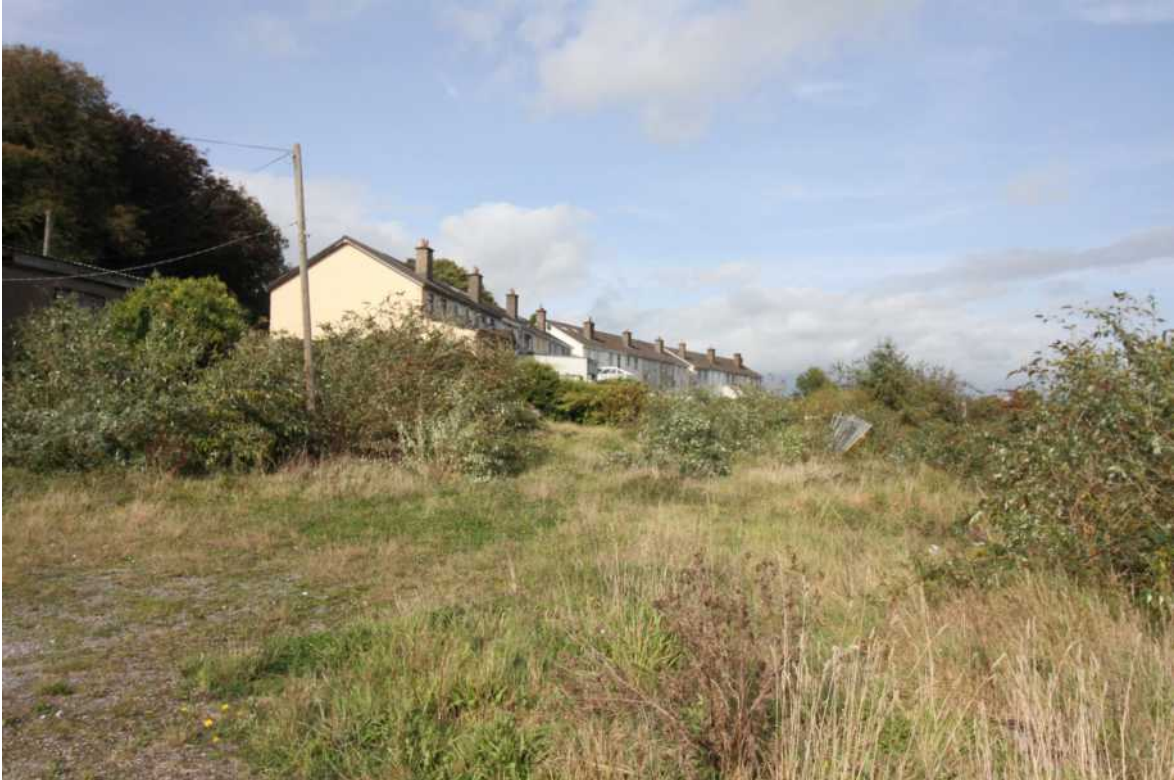
• Fig 19. Boundary to adjoining houses to North and tree screen to Farranferris Educational Campus.

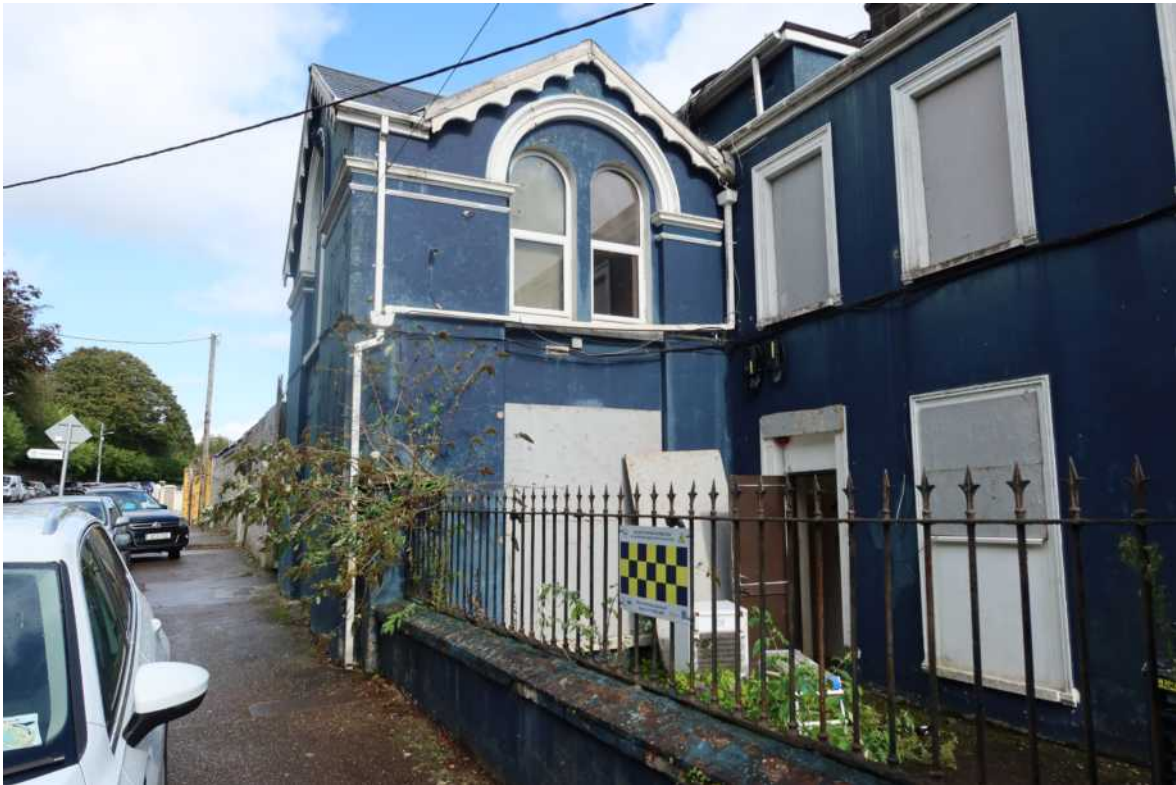
• Fig 22. Wall and railings to South West of house.

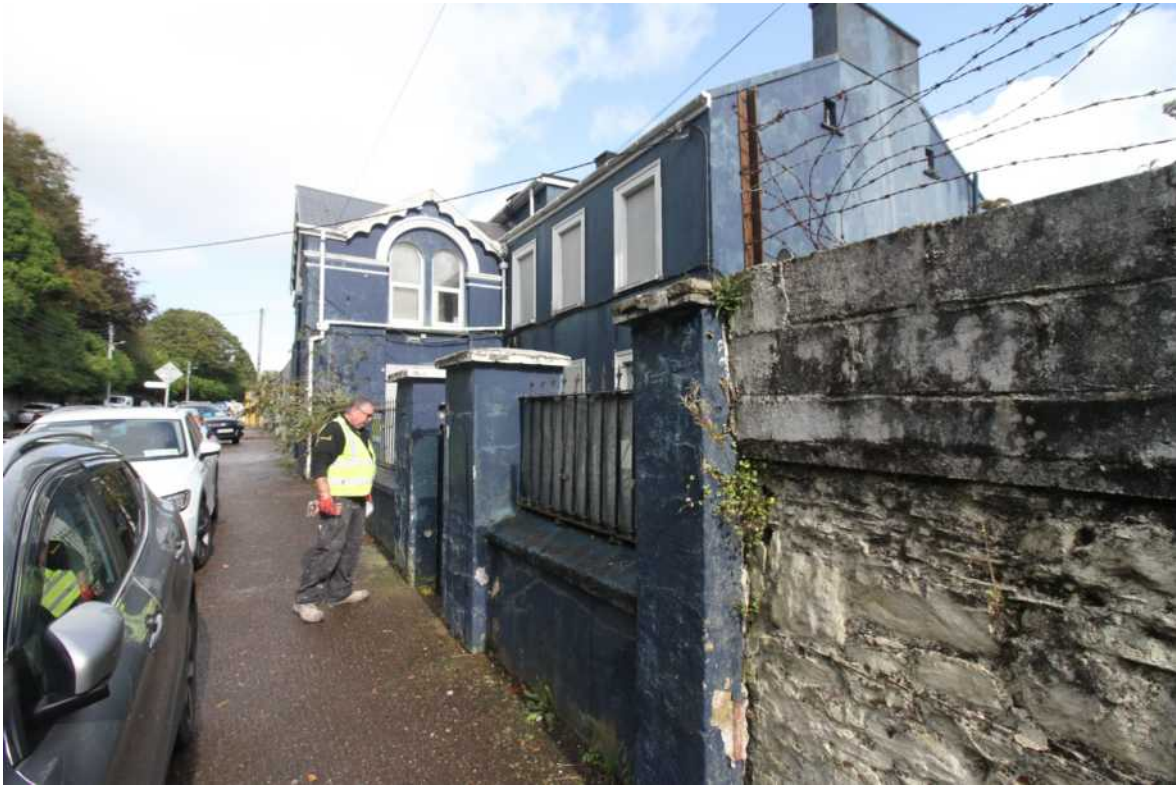
• Fig 23. Wall and railings to South West of house.

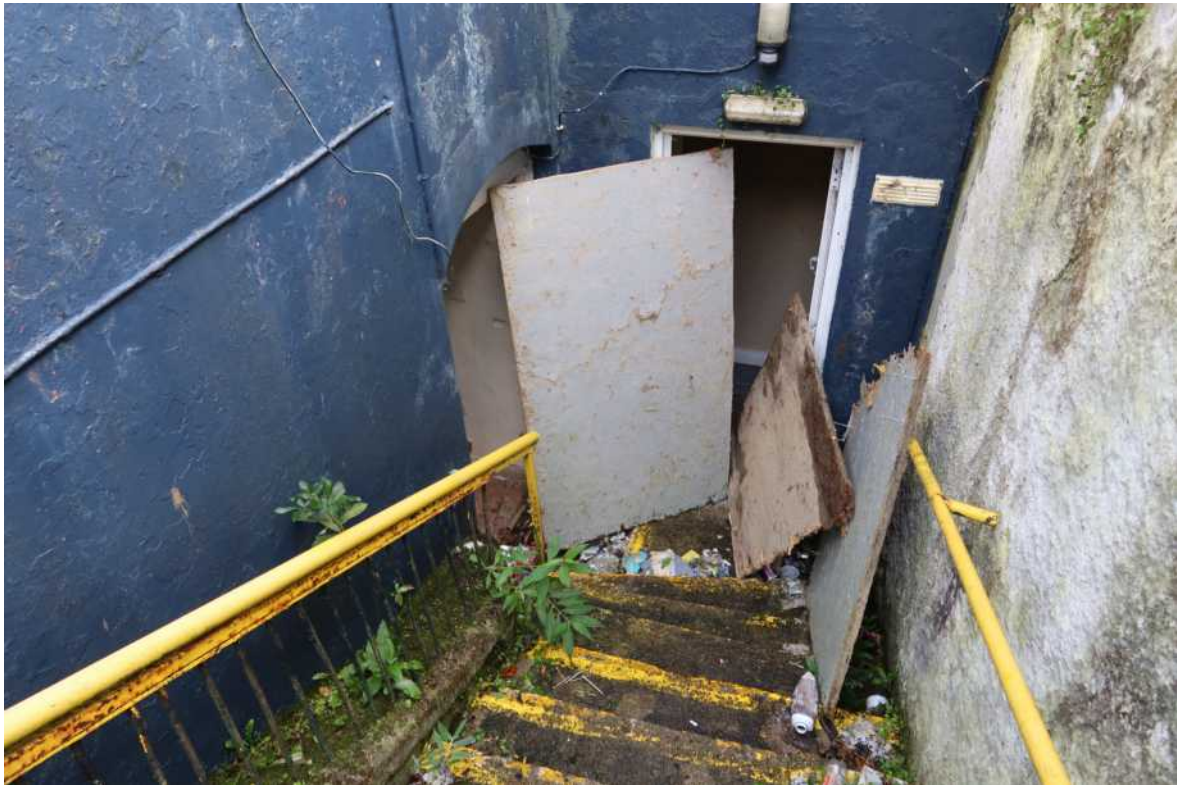
• Fig 25. Doors LGF1 & LGF 2 Lower ground floor South end two apartment entrances.

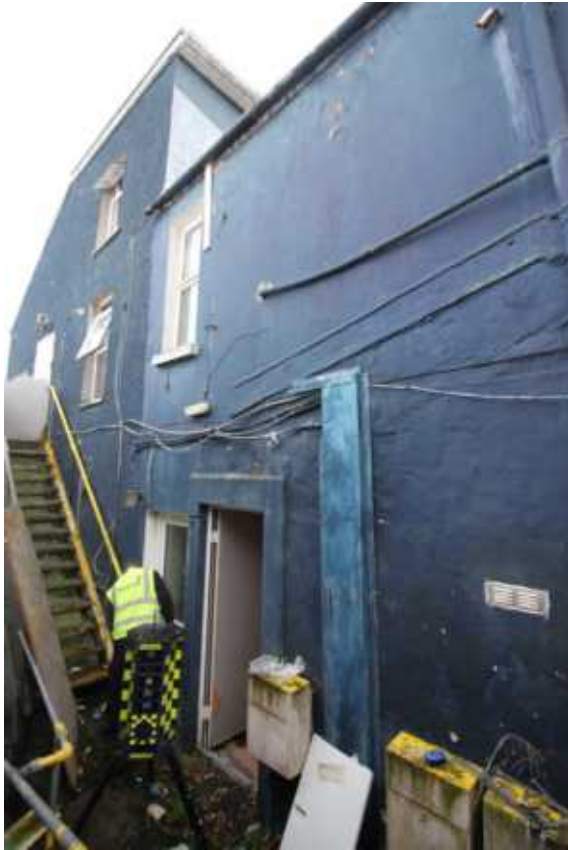
• Fig 26. Door GF 3. Door FF1 above.

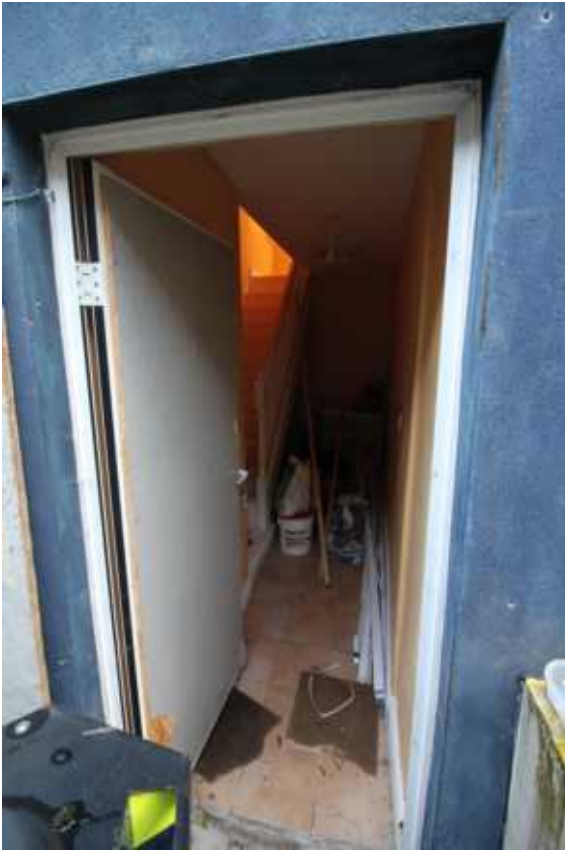
• Fig 27. Door GF3.

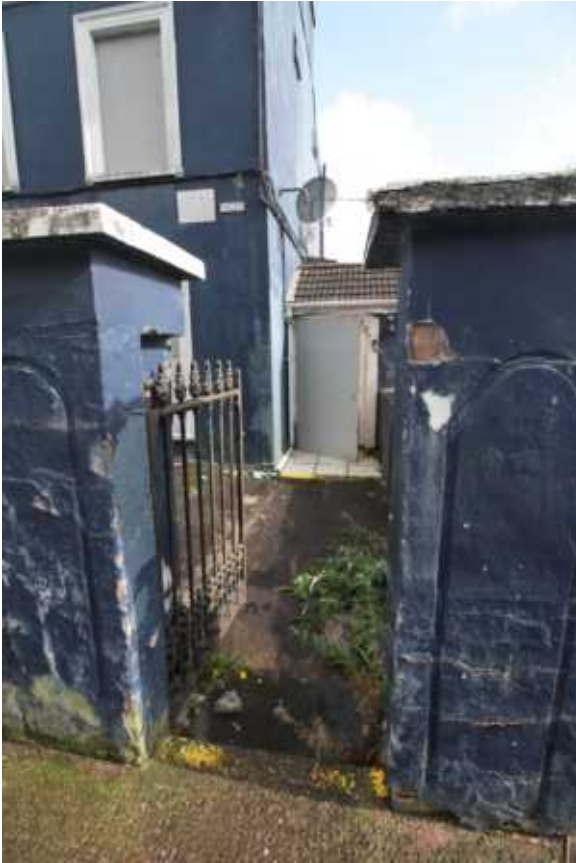
• Fig 28. Door GF1 inside gate.

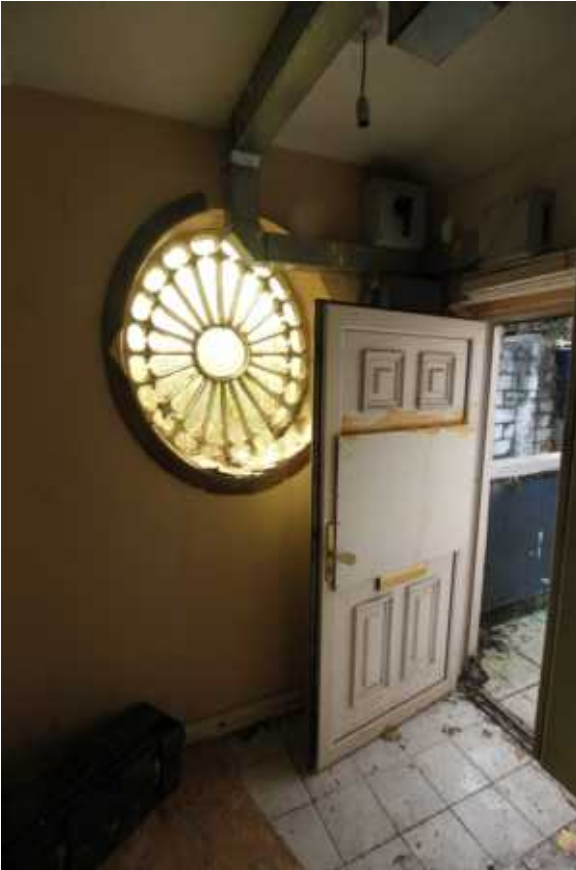
• Fig 31. GF1 inside entrance.

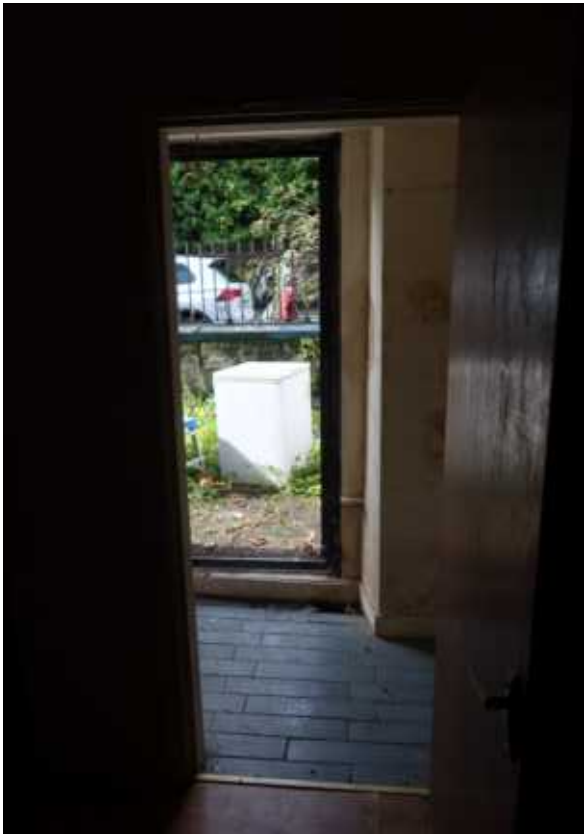
• Fig 32. GF2 inside entrance.

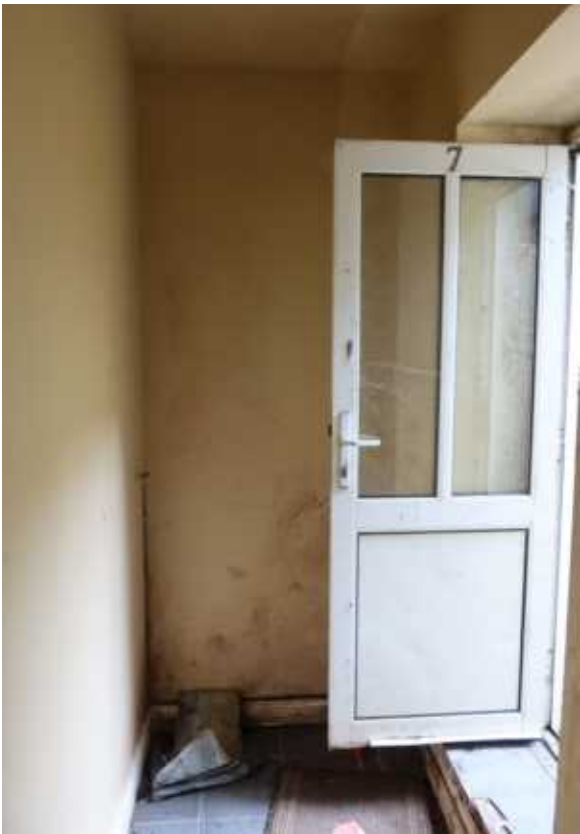
• Fig 33. GF3 entrance.

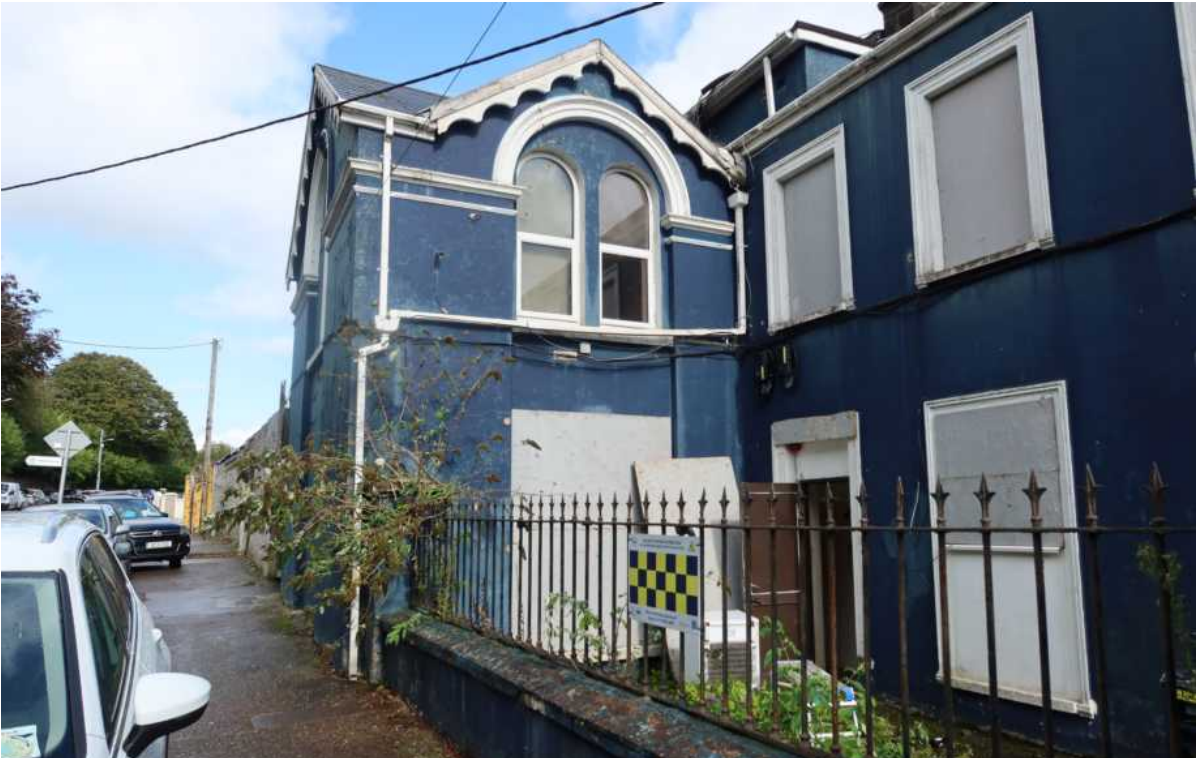
• Fig 34. GF2 entrance, inside railings.
