Glenview House - Blackpool

Conservation Report & Heritage Impact Assessment:

Glenview, Cork

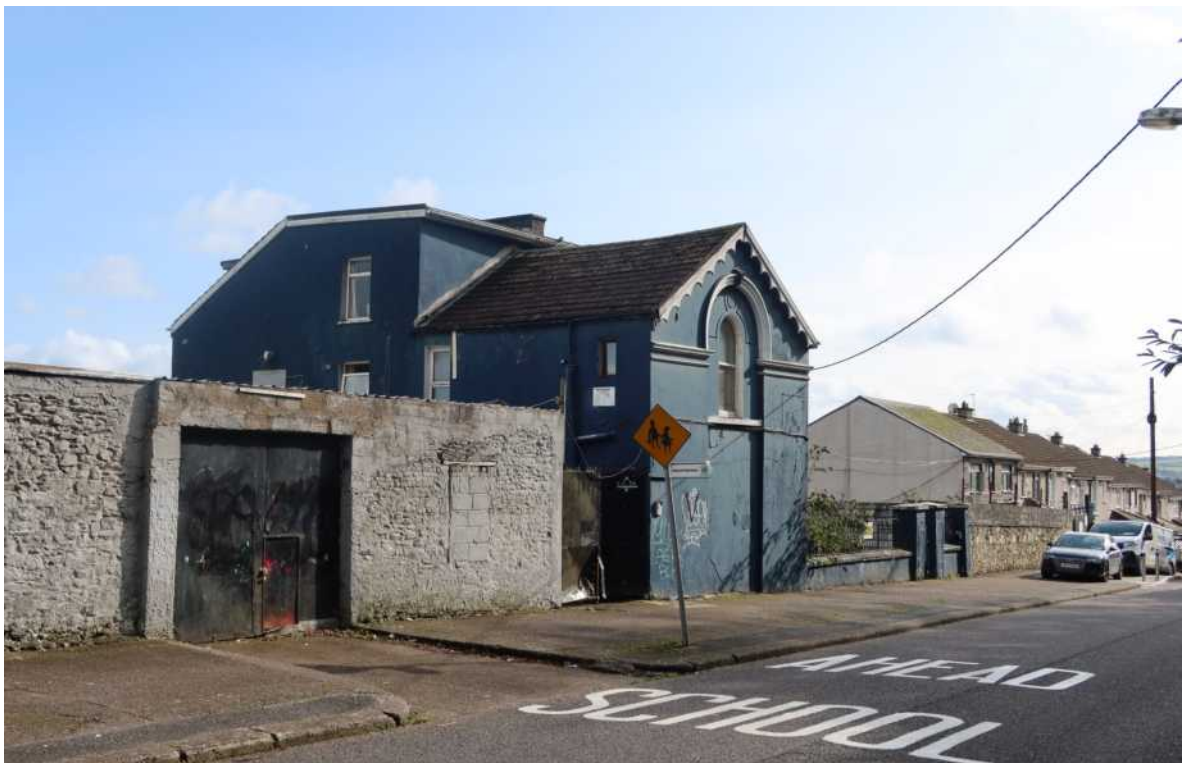
• Fig 7. View of house from North.

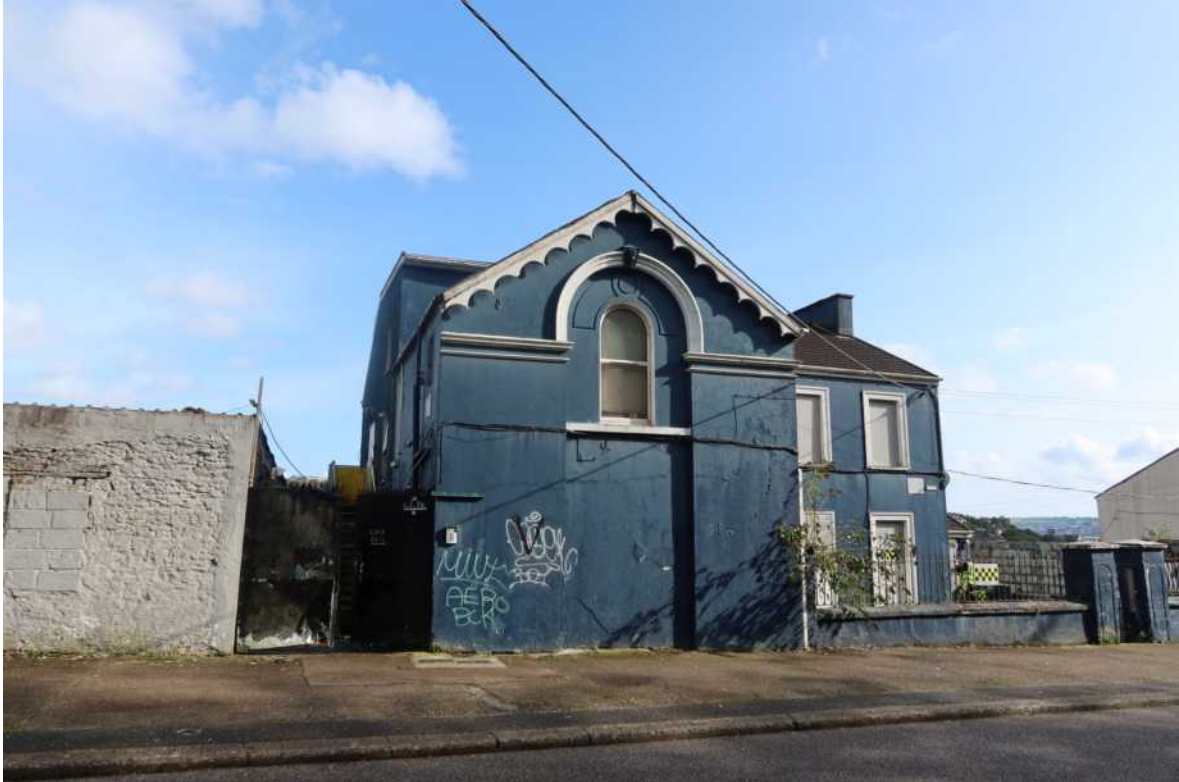
• Fig 8. West elevation of house.

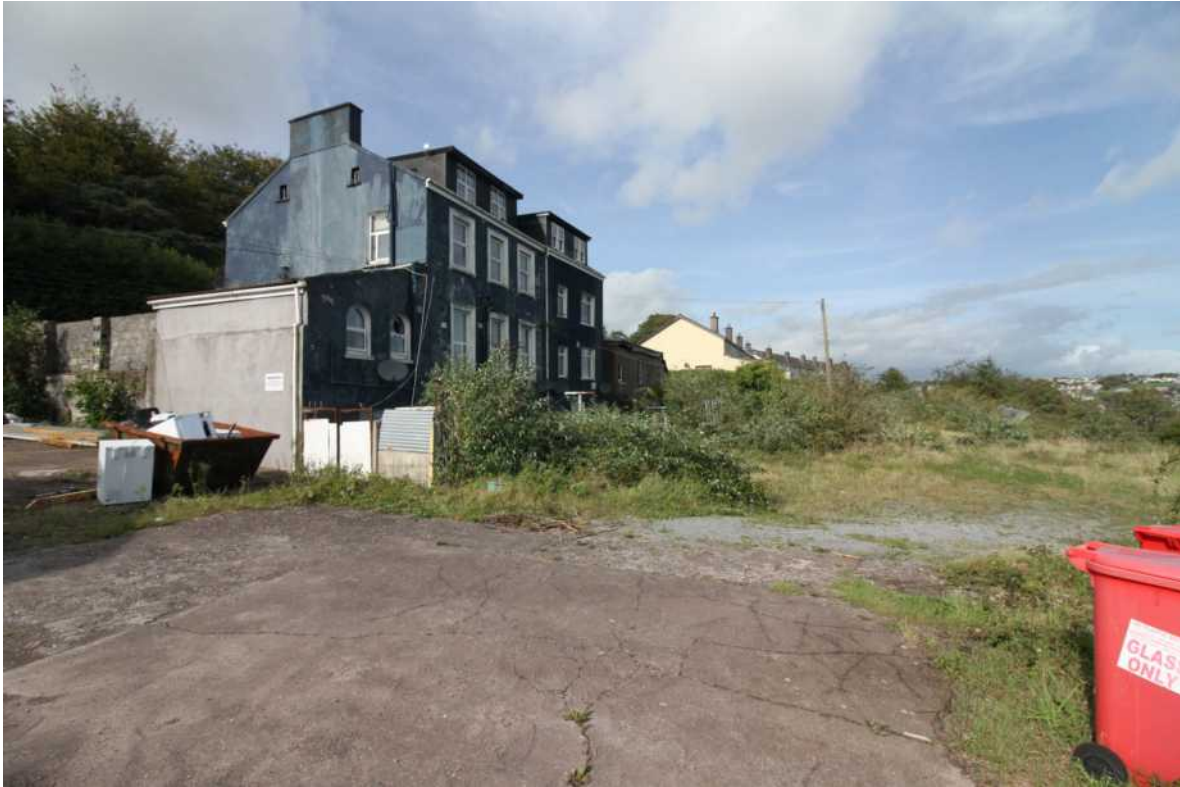
• Fig 13. South East view of house, from site.

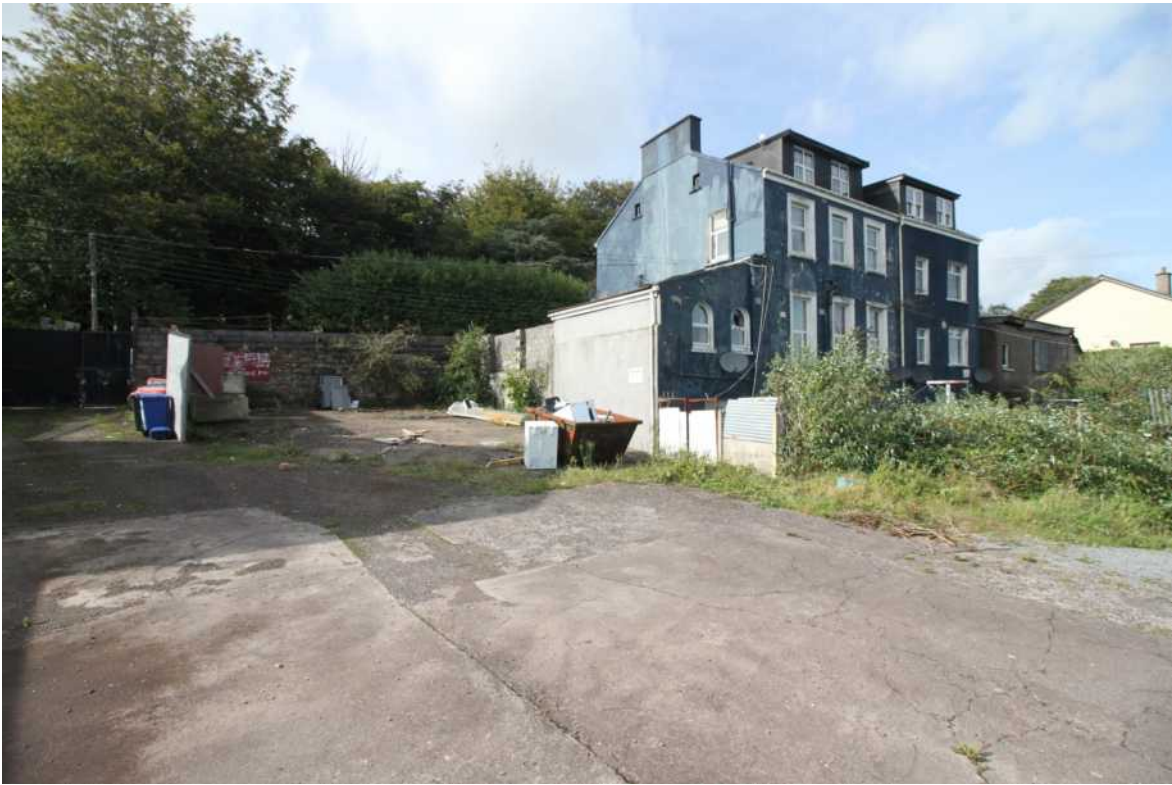
• Fig 14. South East view of house.

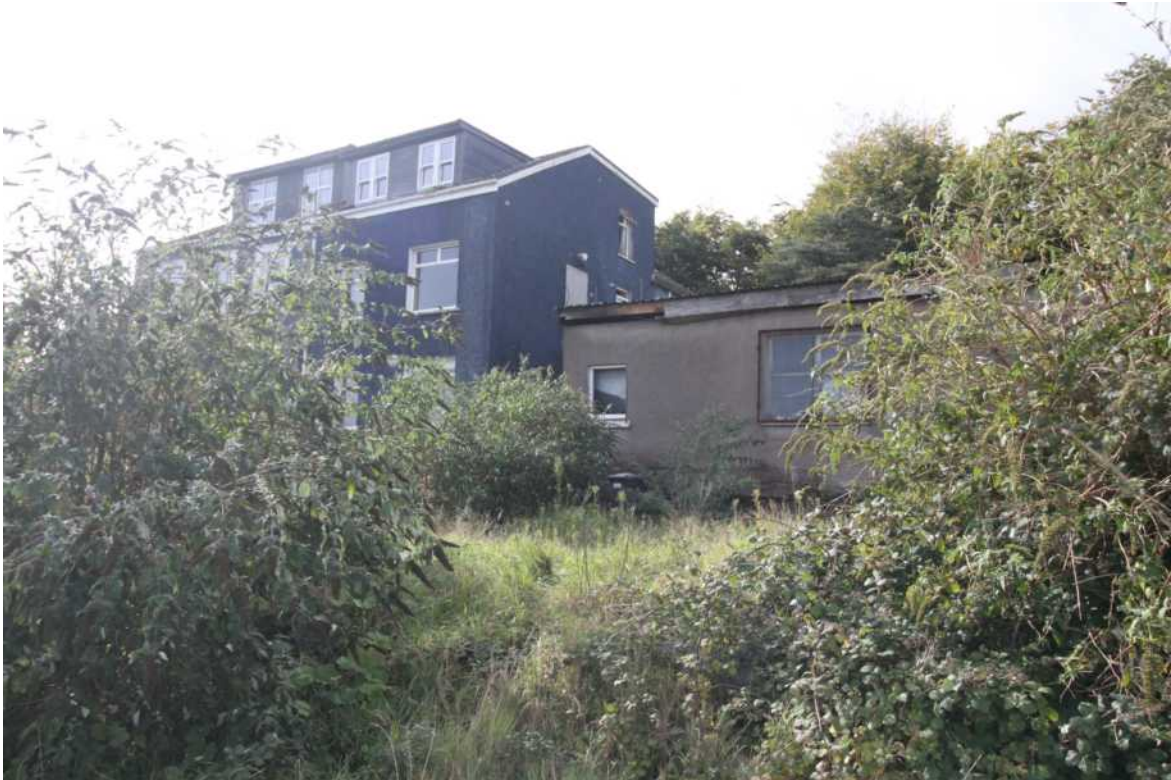
• Fig 17. North Eastern view of house.

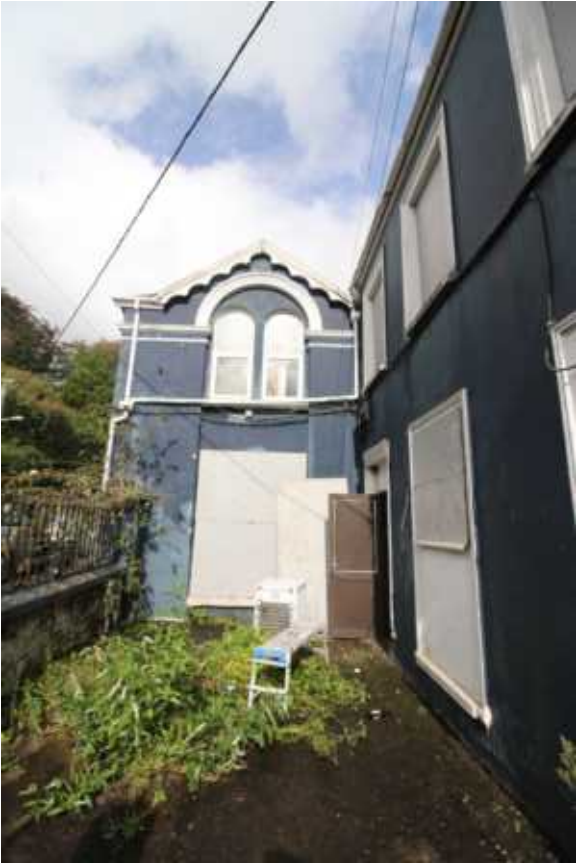
• Fig 29. Door GF2.

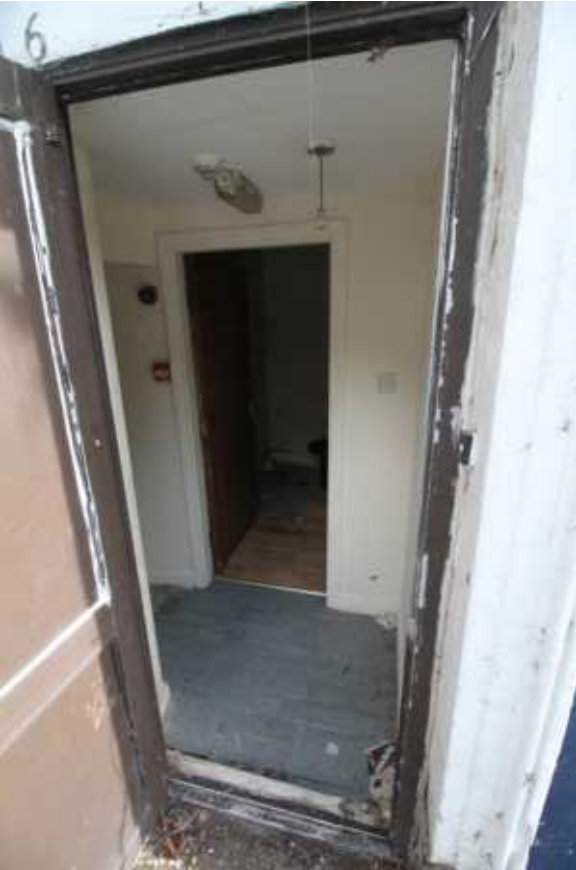
• Fig 30. View down North Gable to GF2.

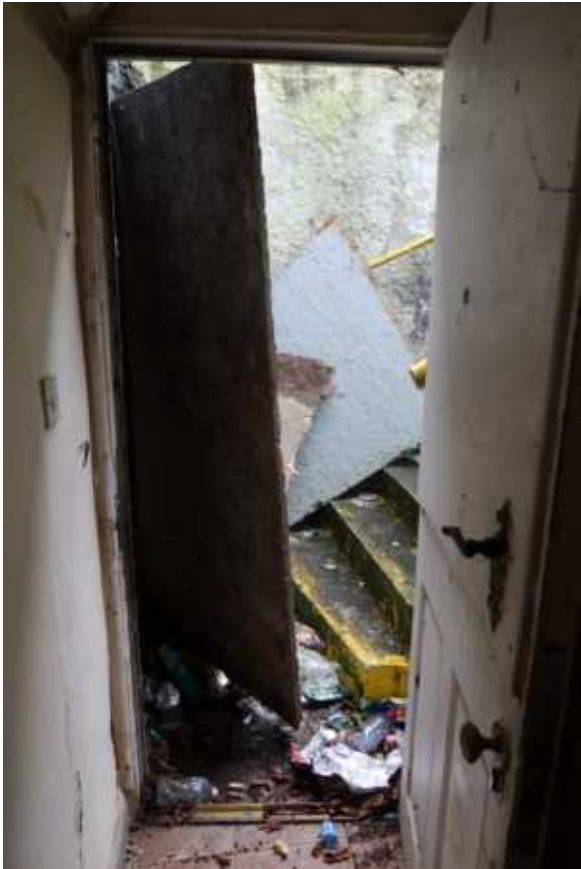
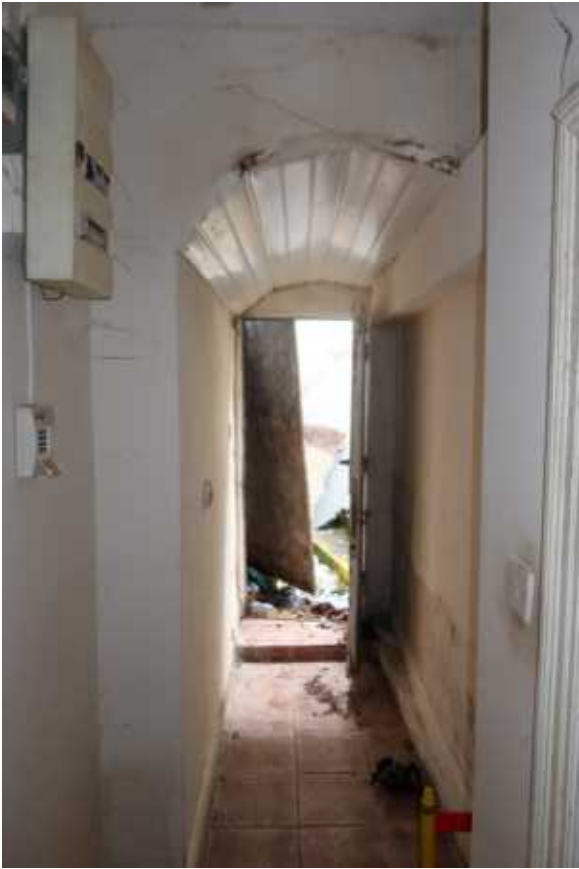
• Fig 35 & 36. Door LGF2.

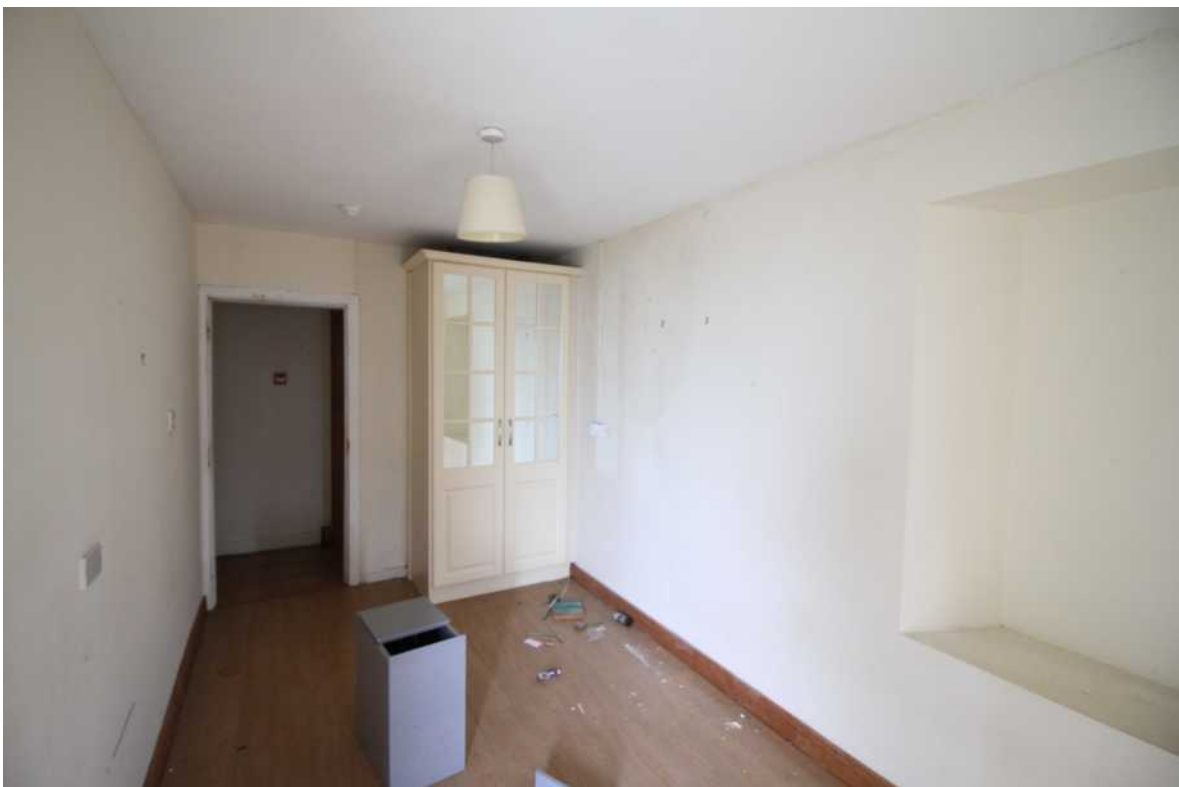
• Fig 43. Bedroom more recently decorated.

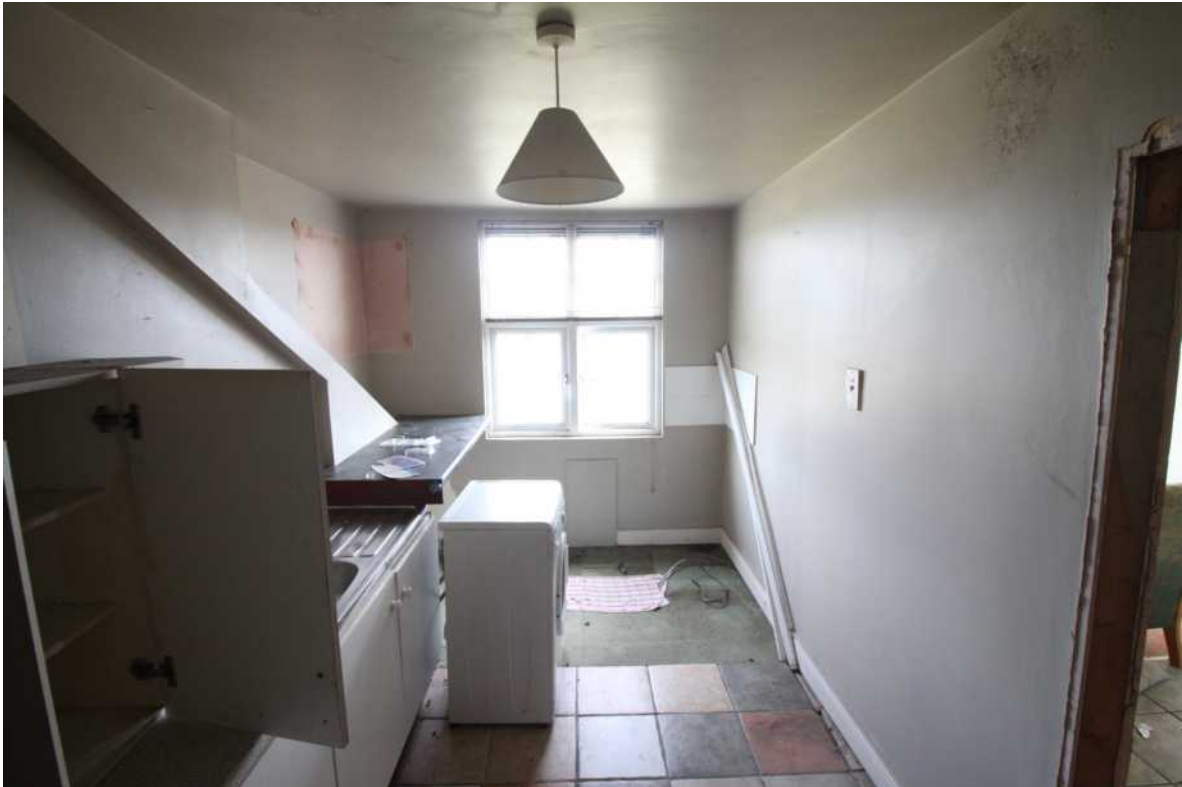
• Fig 44. Kitchen in dormer roof.

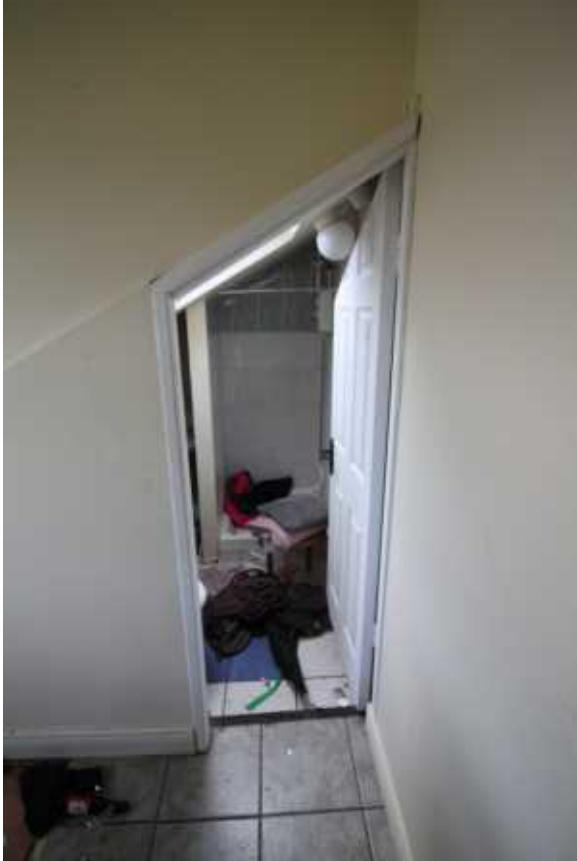
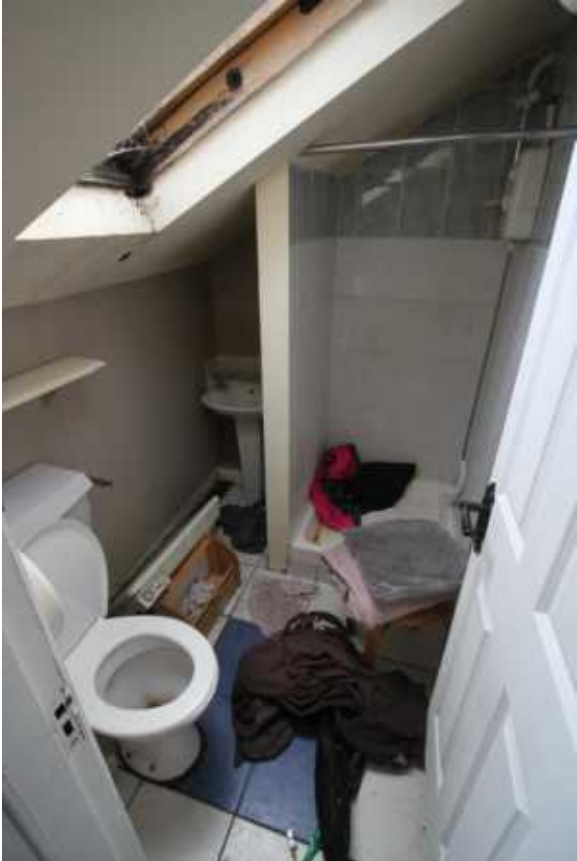
• Fig 47-48. Ensuite/ bathroom off same apartment.

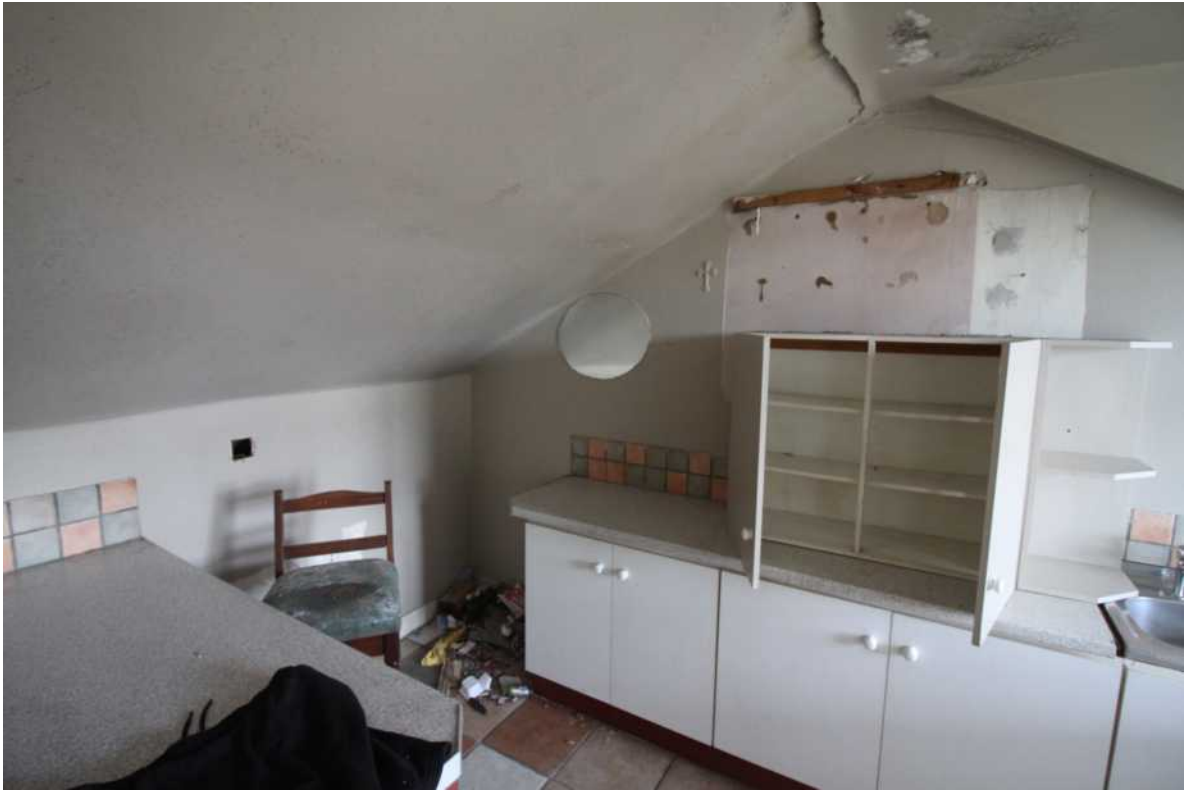
• Fig 49 & 50. Kitchenette first floor rear apartment.

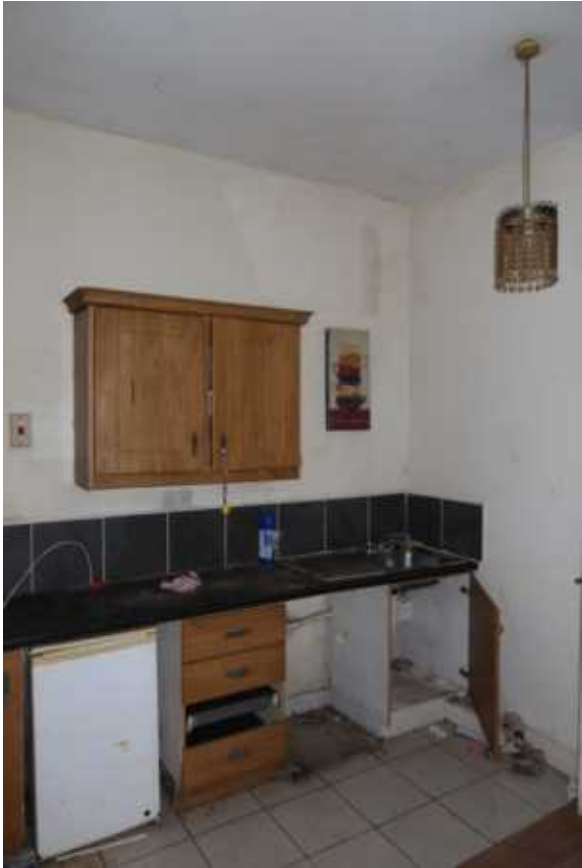
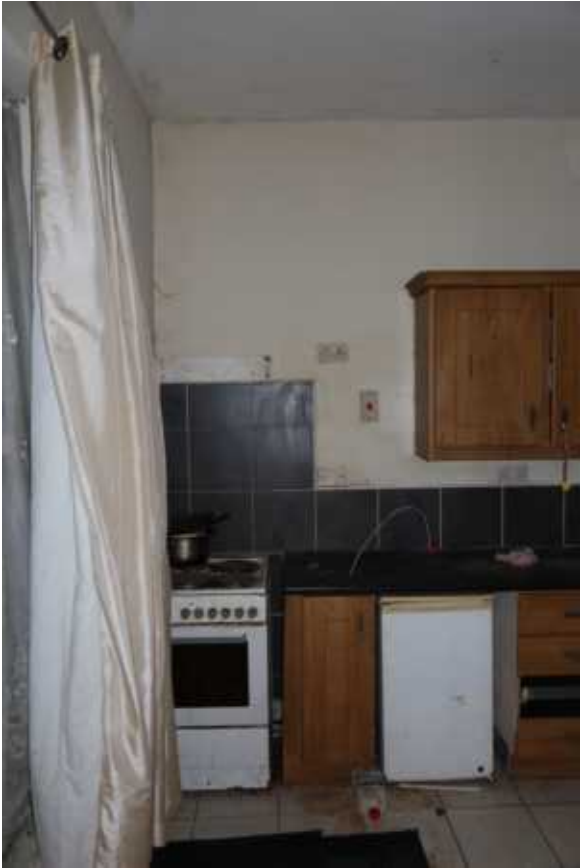
• Fig 51 & 52. Typical kitchenette.

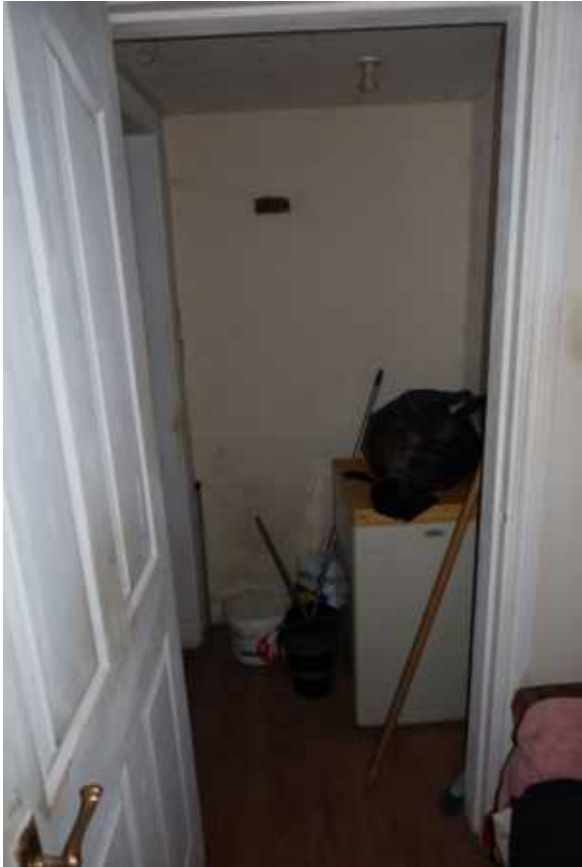
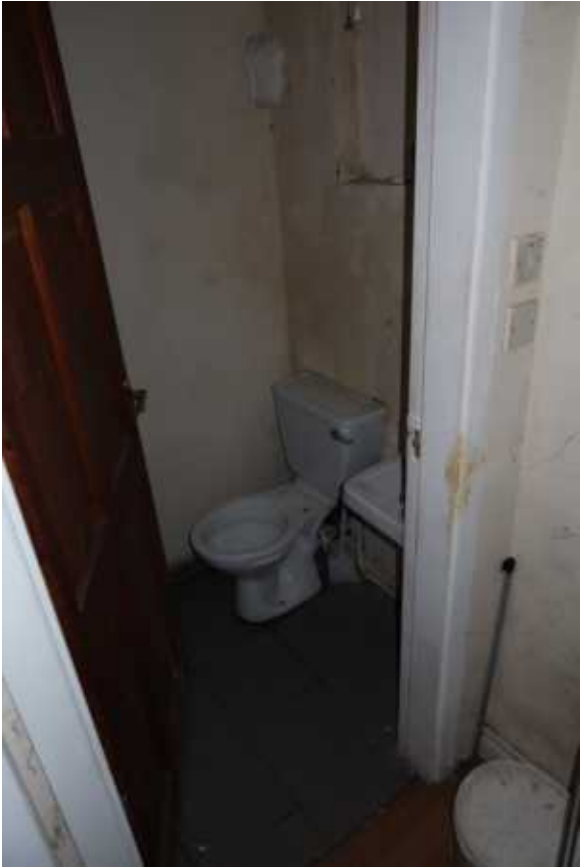
• Fig 53 & 54. Toilet and ensuite.

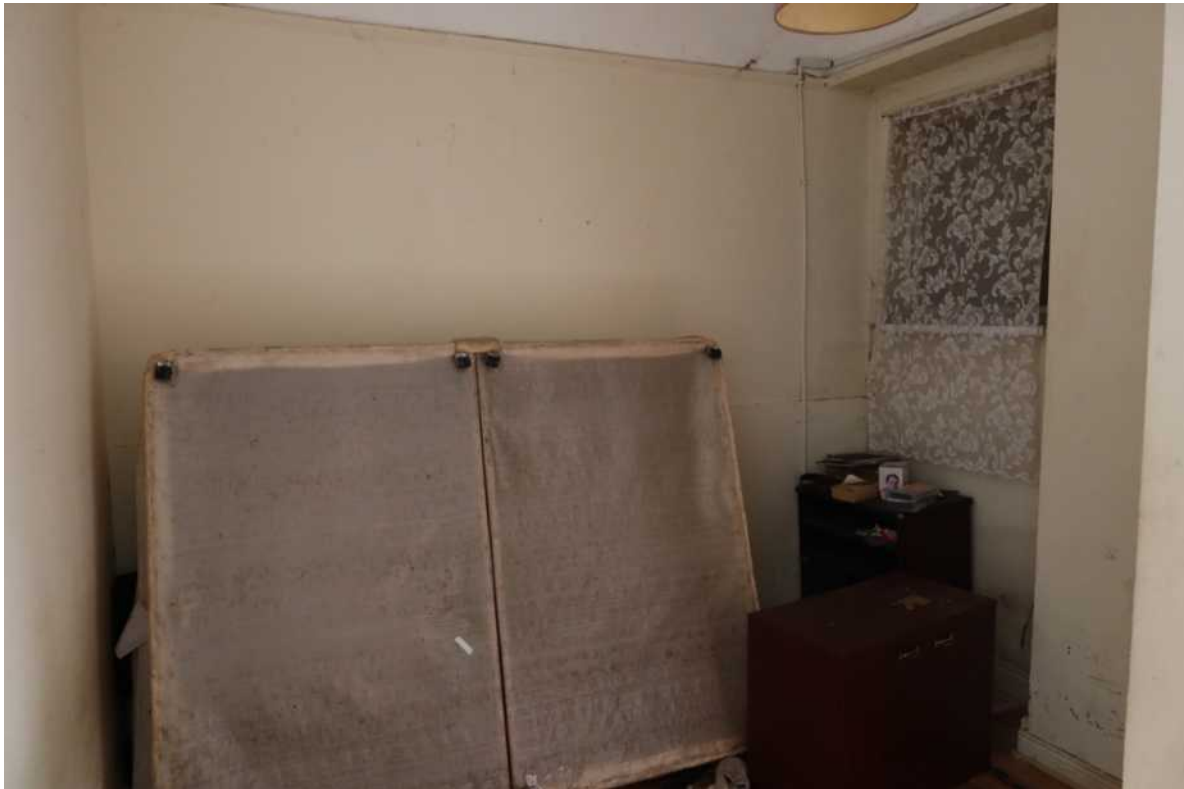
• Fig 55. Bedroom GF2 apartment.

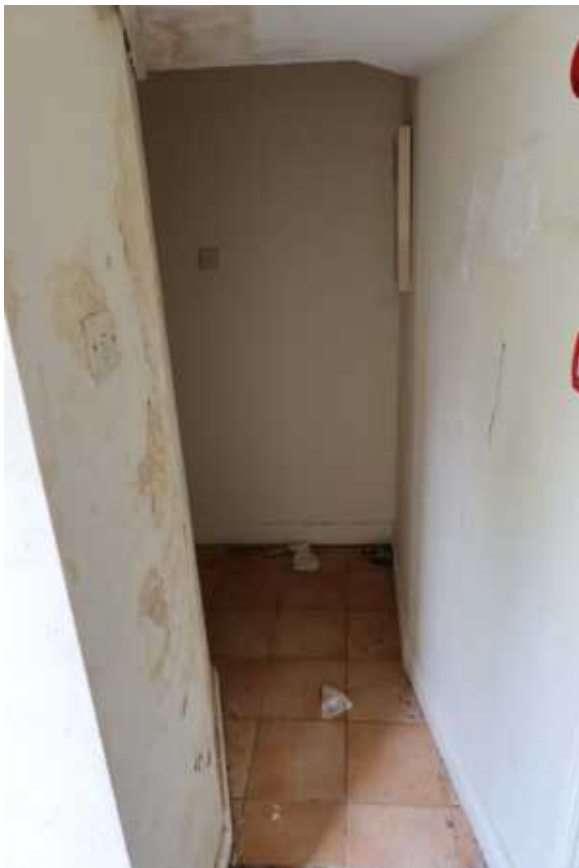
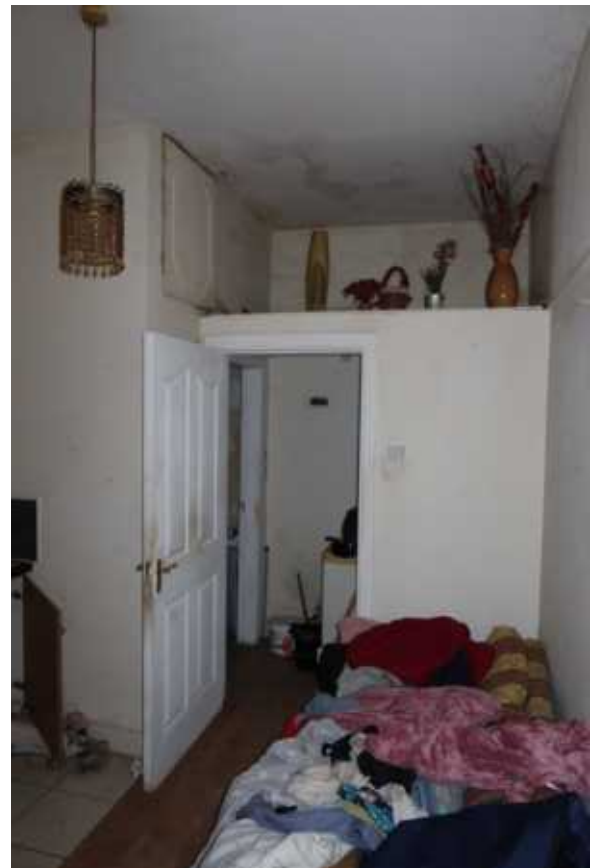
• Fig 56 & 57. Access to bedroom above and kitchen in same GF2 apartment.

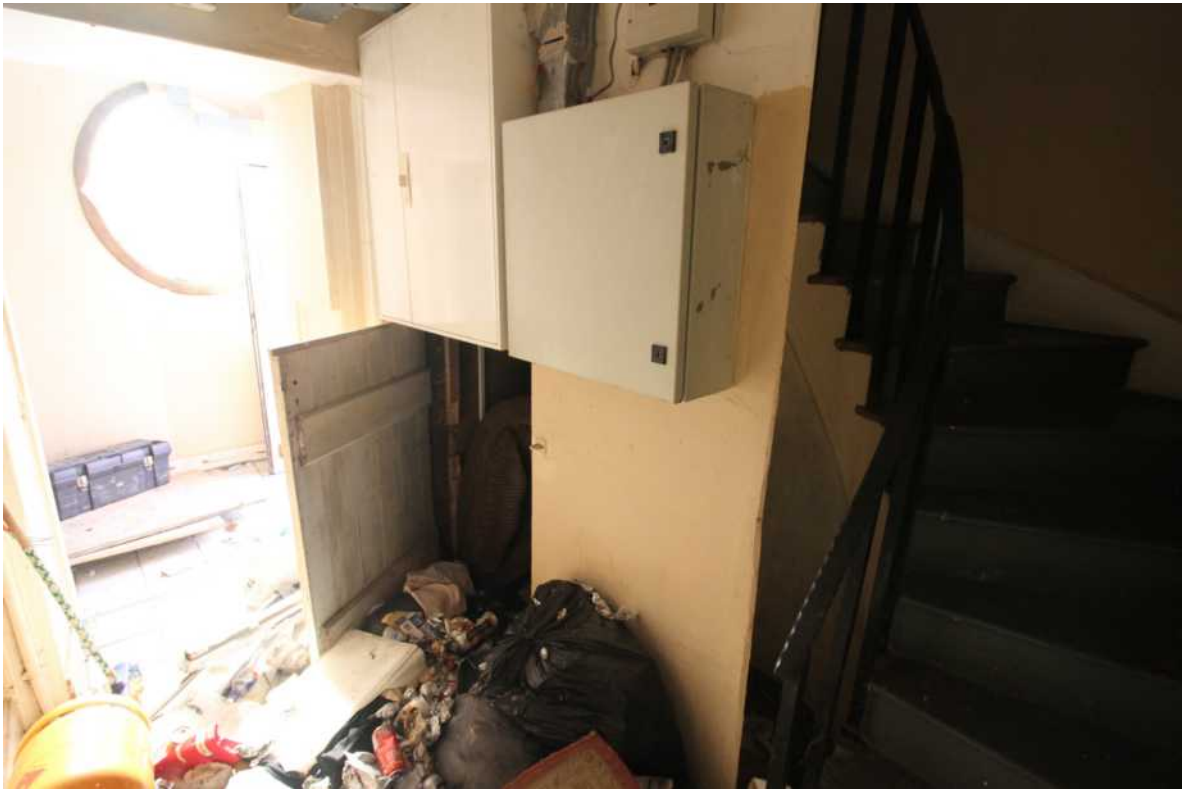
• Fig 58 & 59. Inside GF1 and stairs to FF.

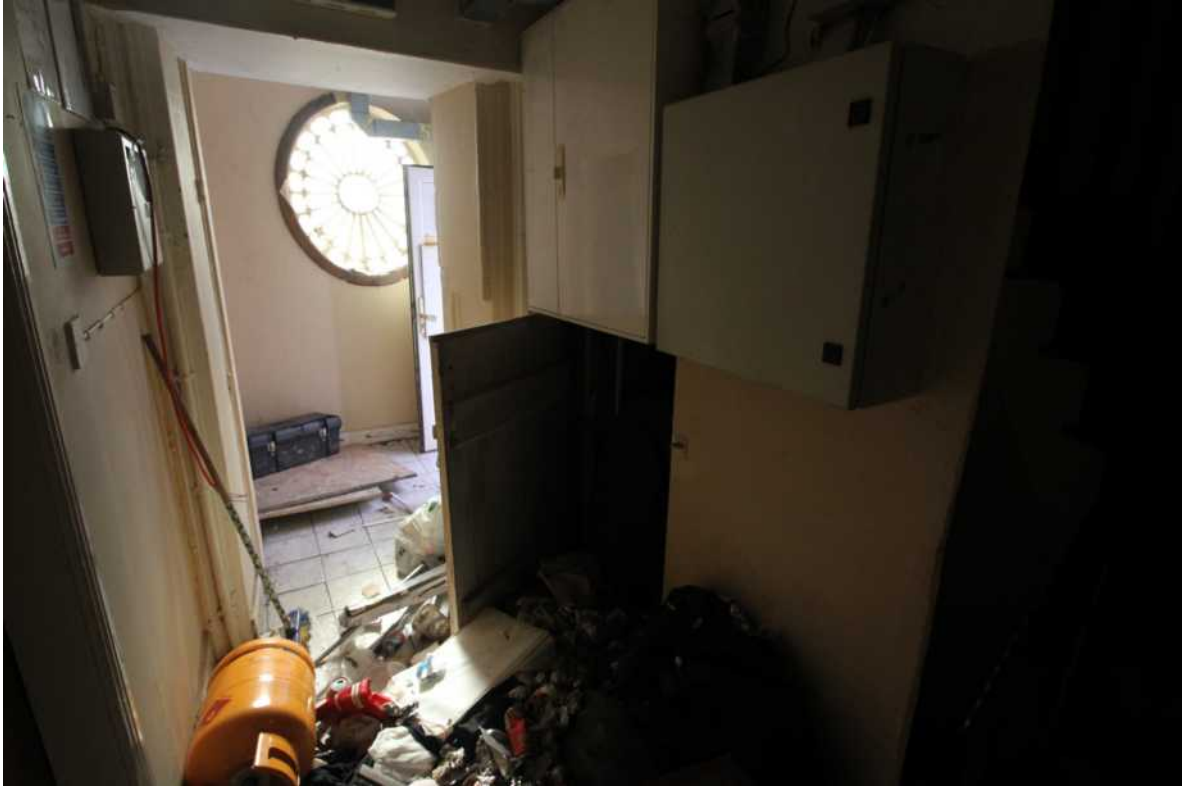
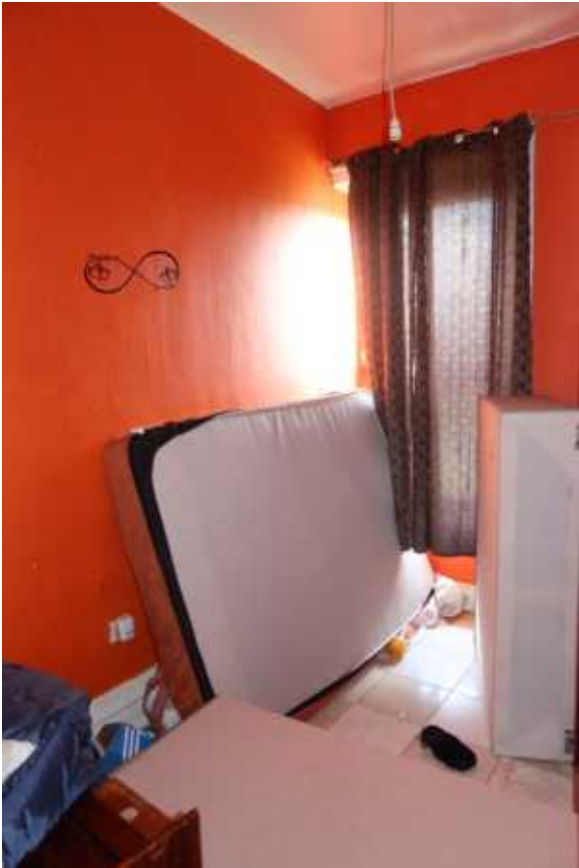
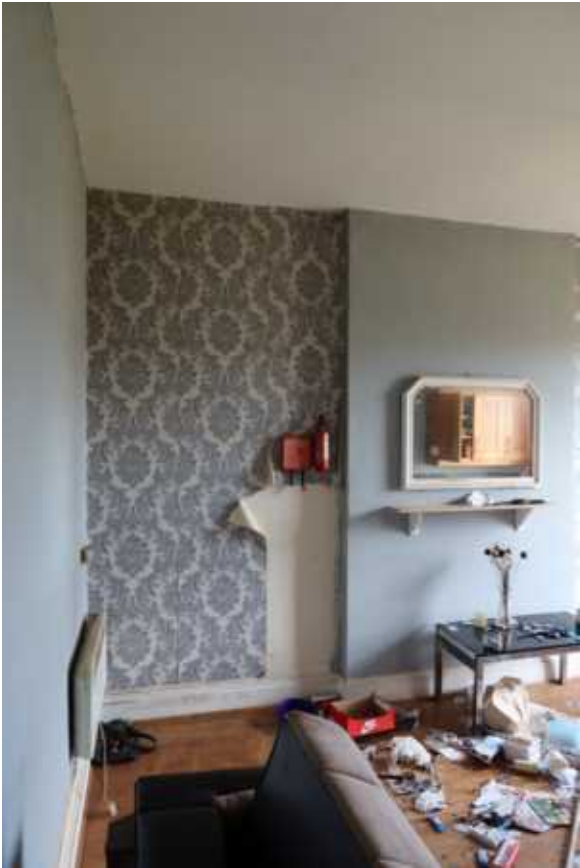
• Fig 60 -63. Living room/ kitchen rear GF apartment apartment.

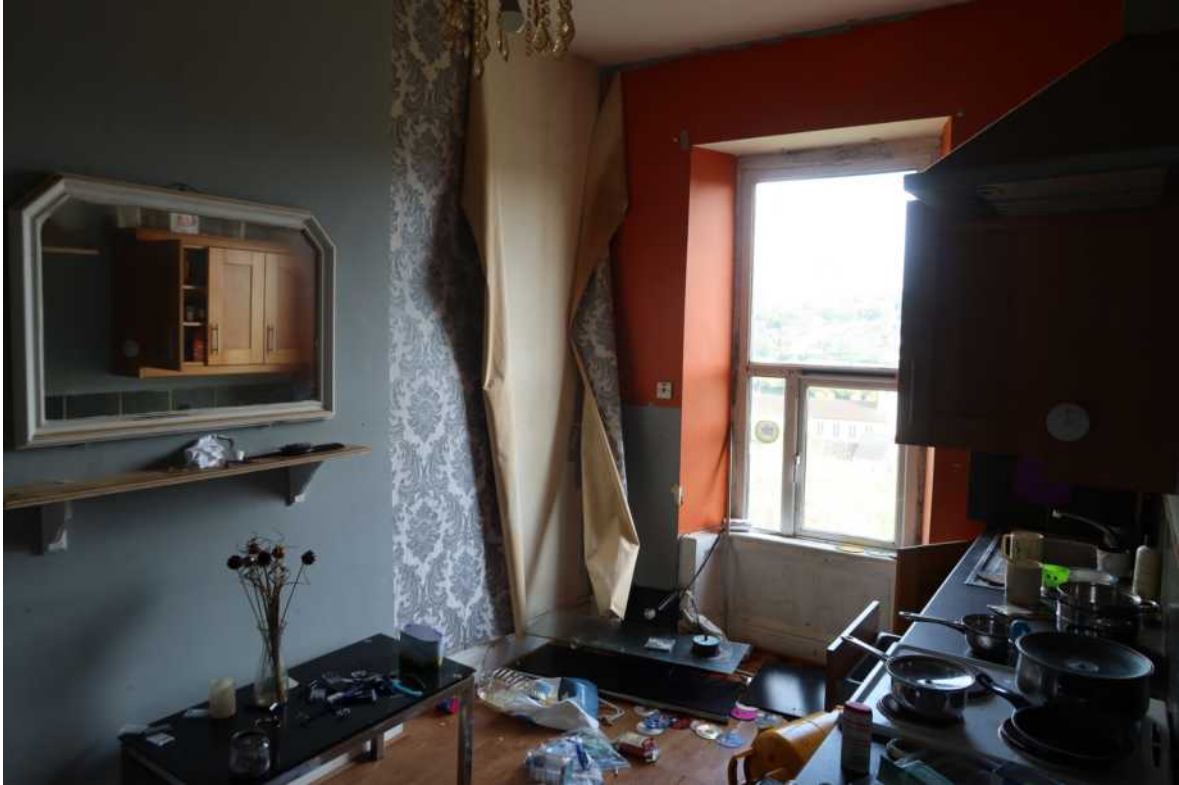
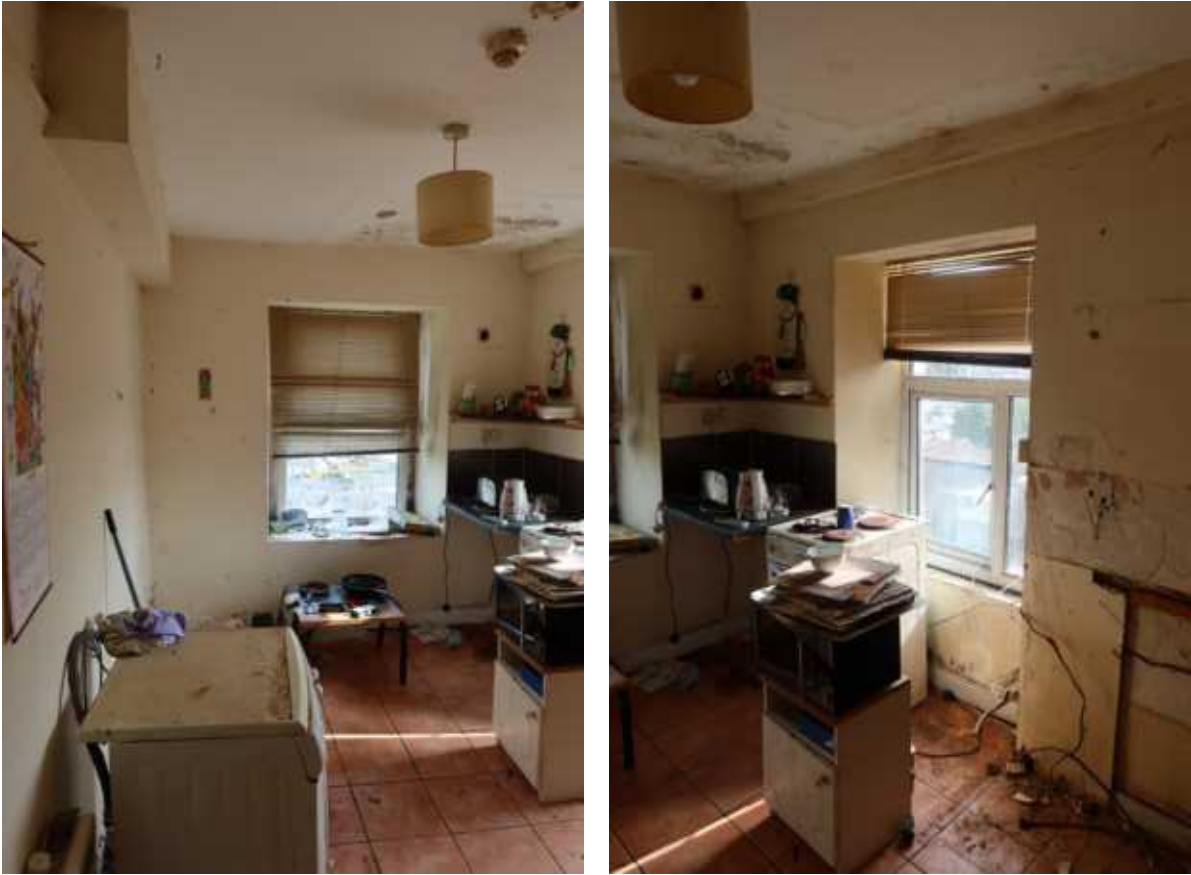
• Fig 64-66. Kitchen, rear upper level GF1 apartment.

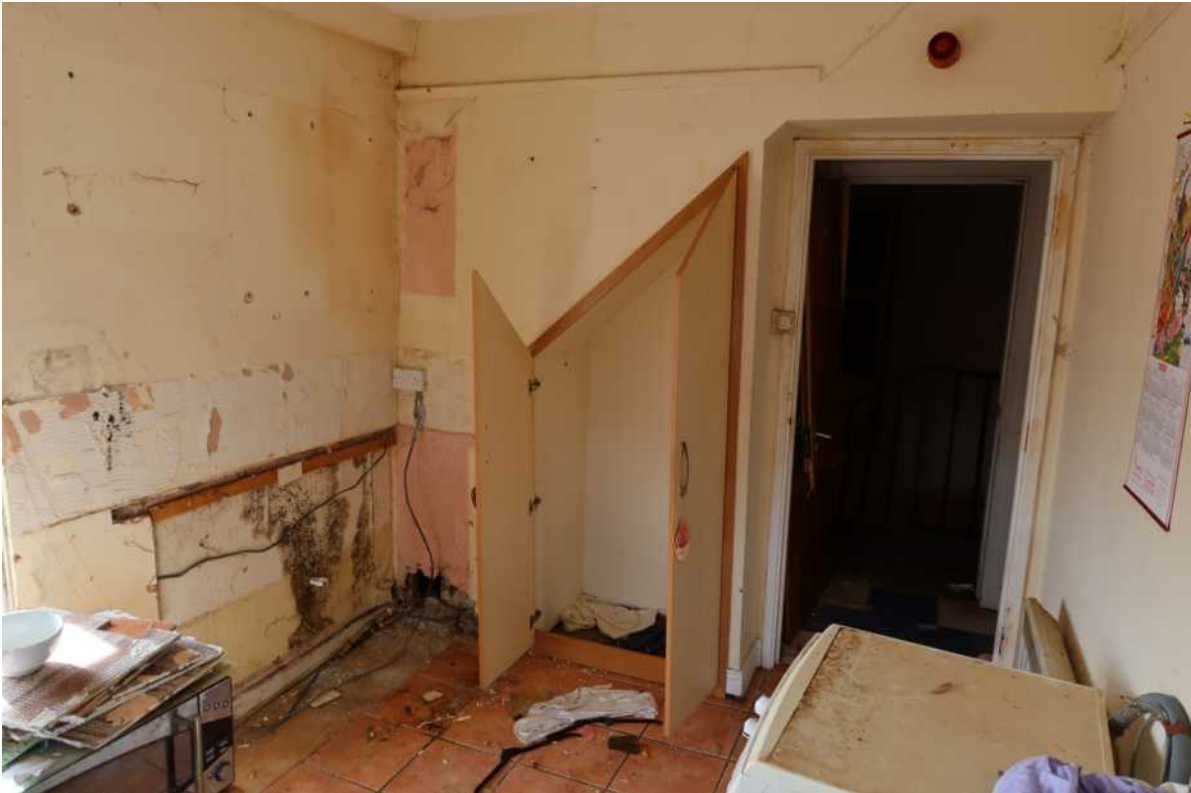
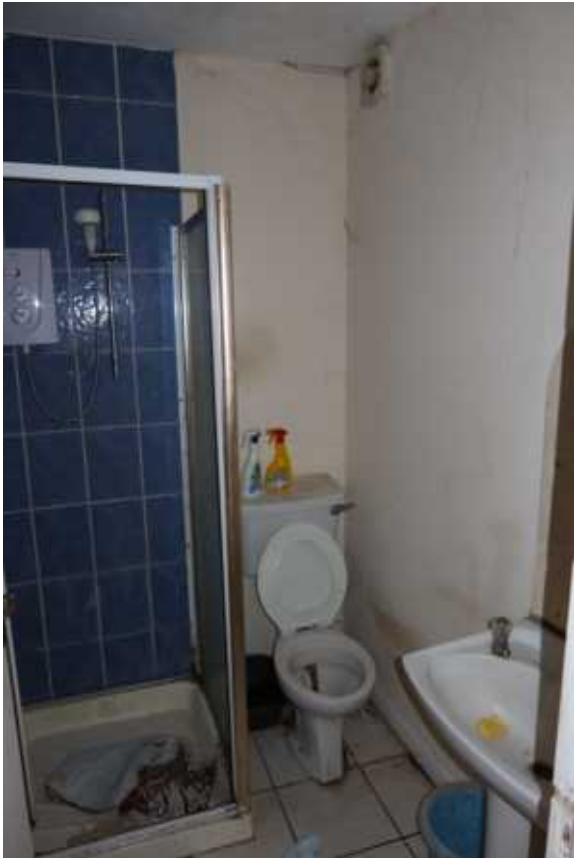
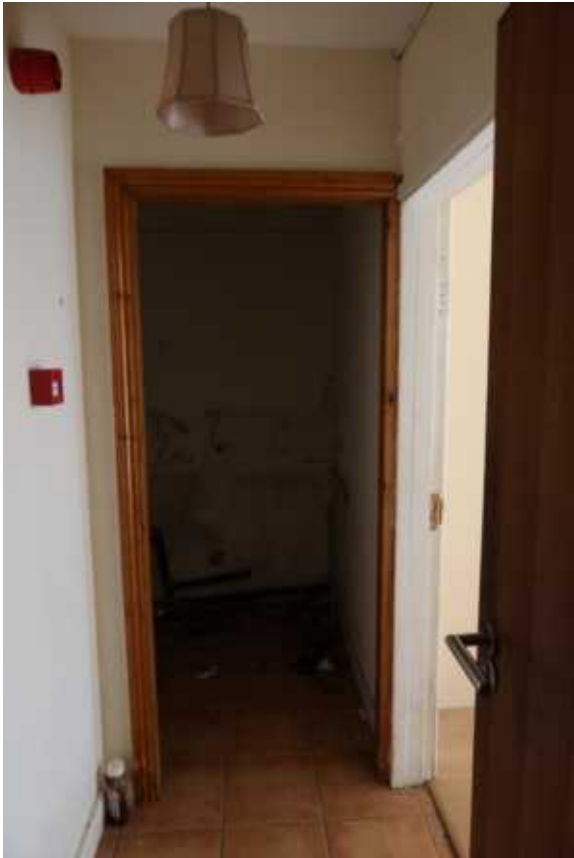
• Fig 67 - 70. LGF apartment ensuite and kitchen.

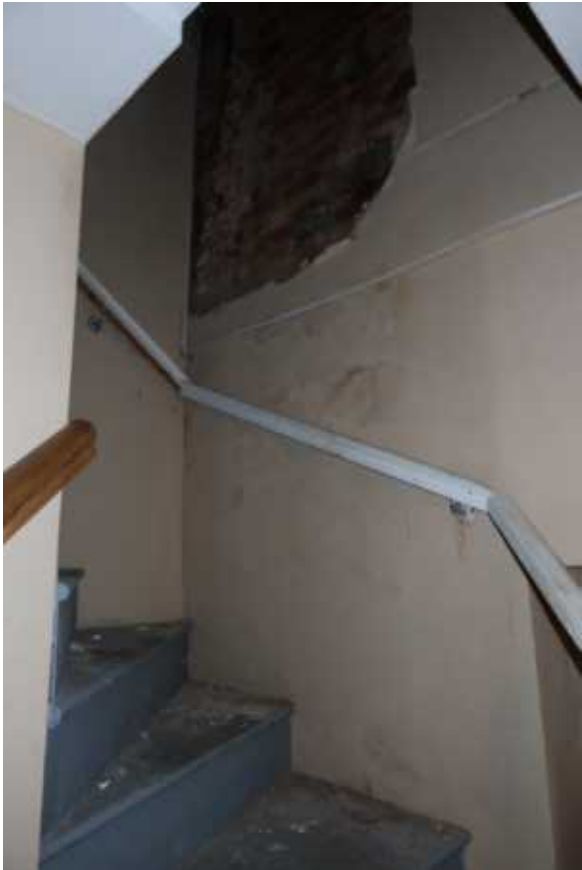
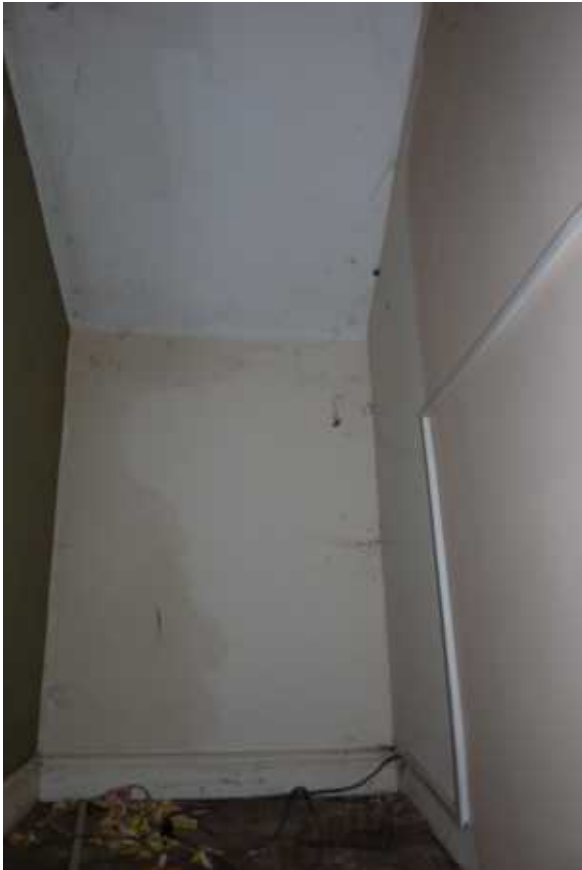
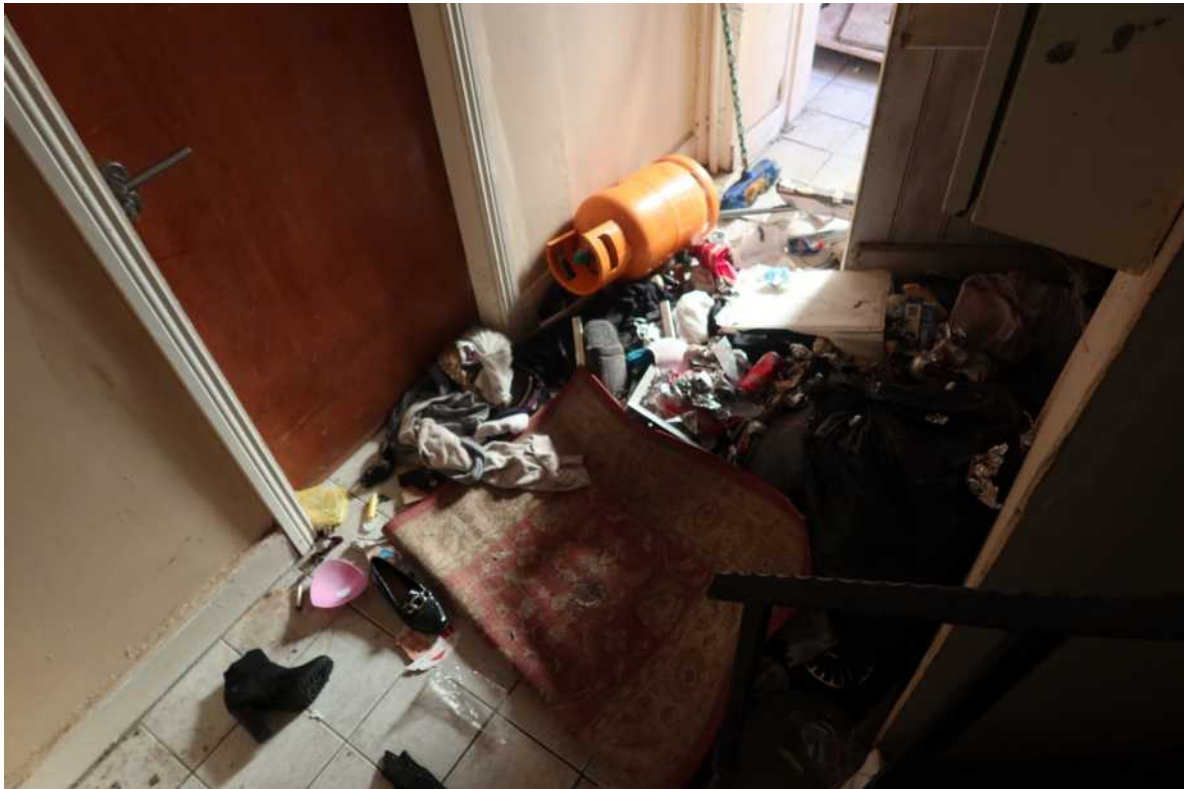
• Fig 74. Apartment entrance hall.
