Glenview House - Blackpool

Conservation Report & Heritage Impact Assessment:

Glenview, Cork

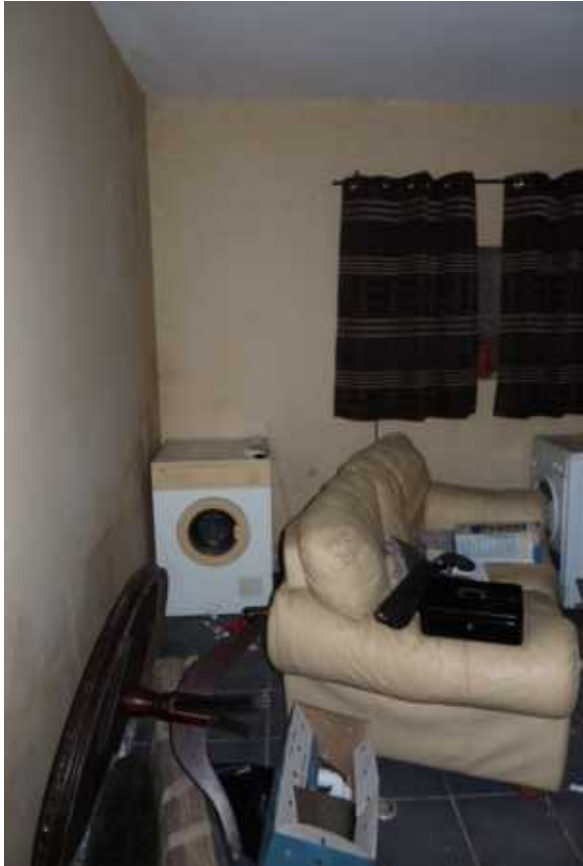
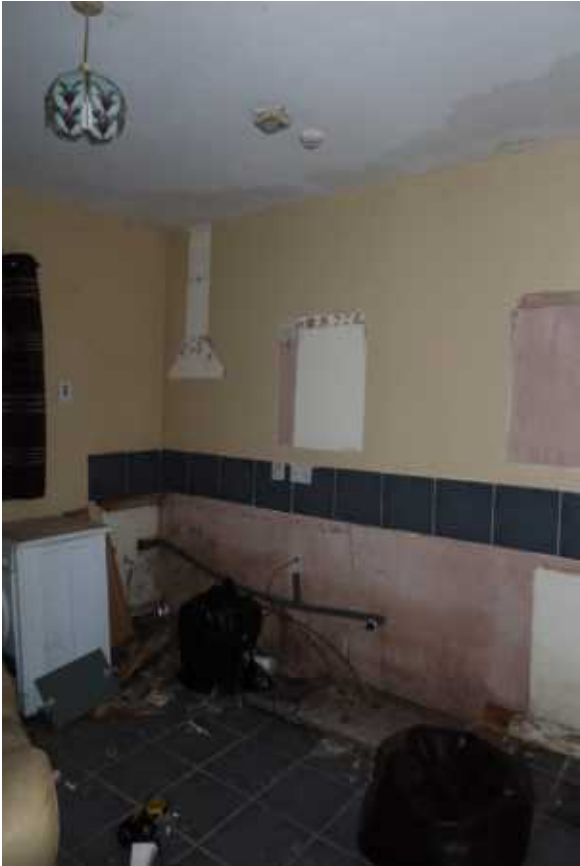
• Fig 75-76. Kitchenette LGF apartment

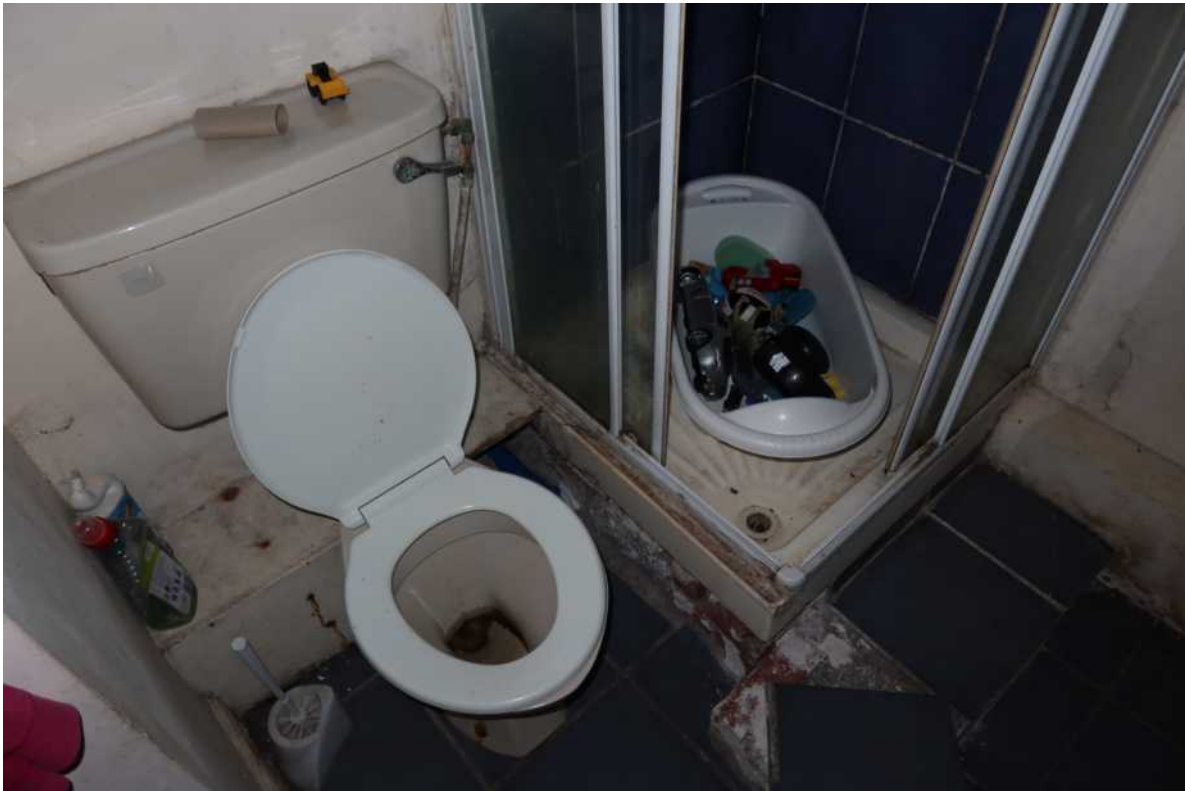
• Fig 77 - 78. LGF Apartment Ensuite.

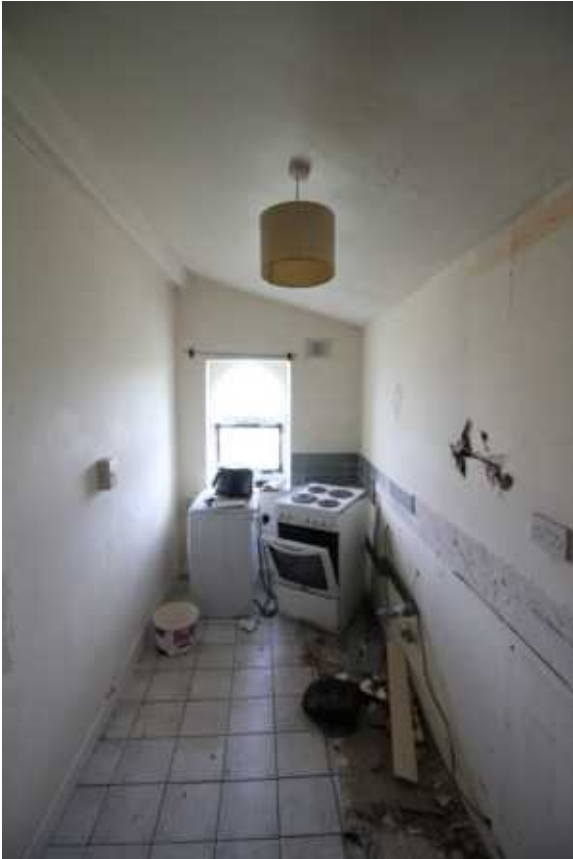
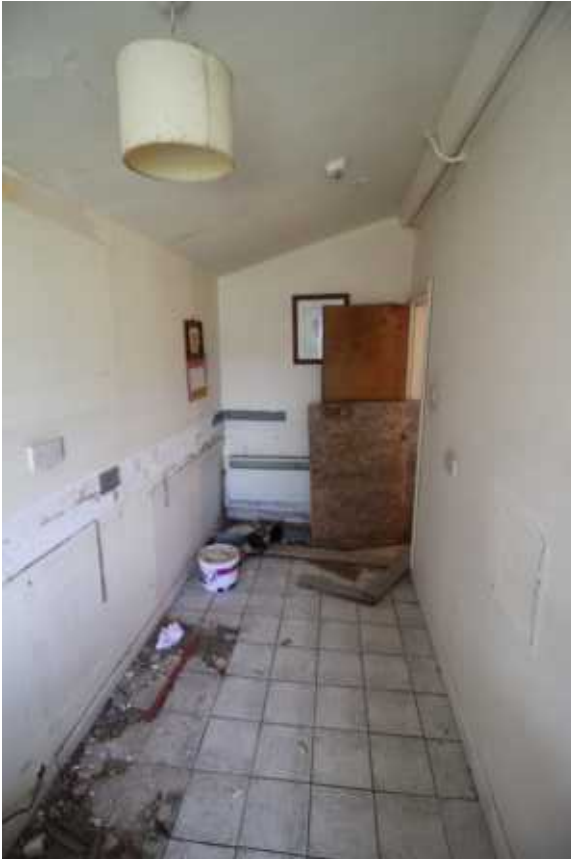
• Fig 83 - 86. Apartment GF2 typical views.

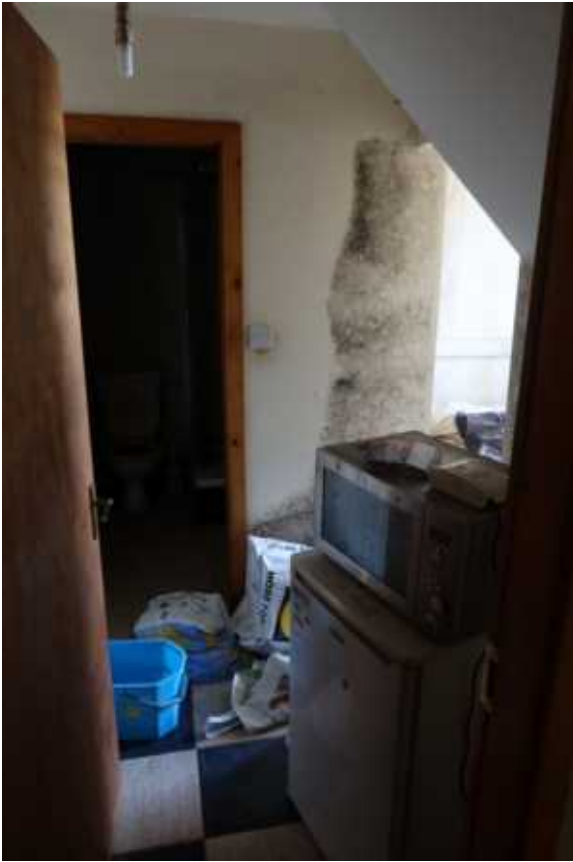
• Fig 87 - 88. Apartment GF2 kitchen.

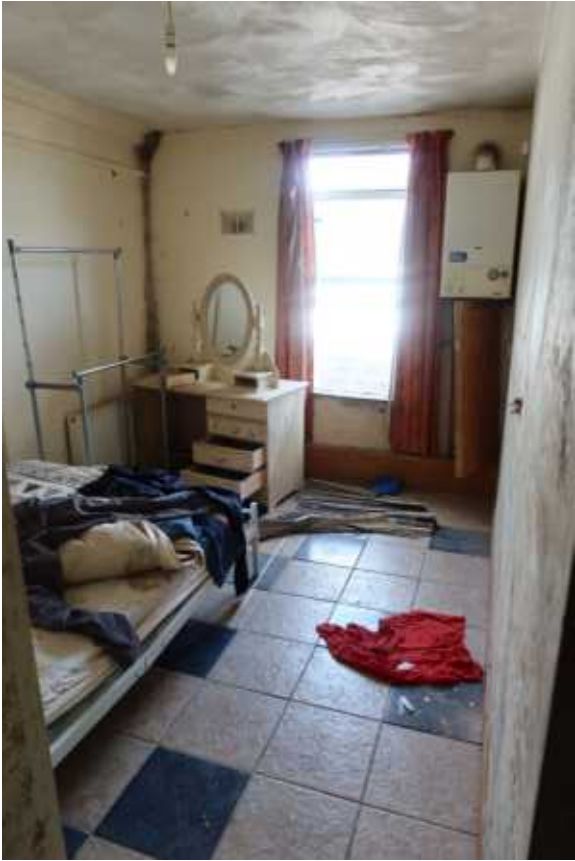
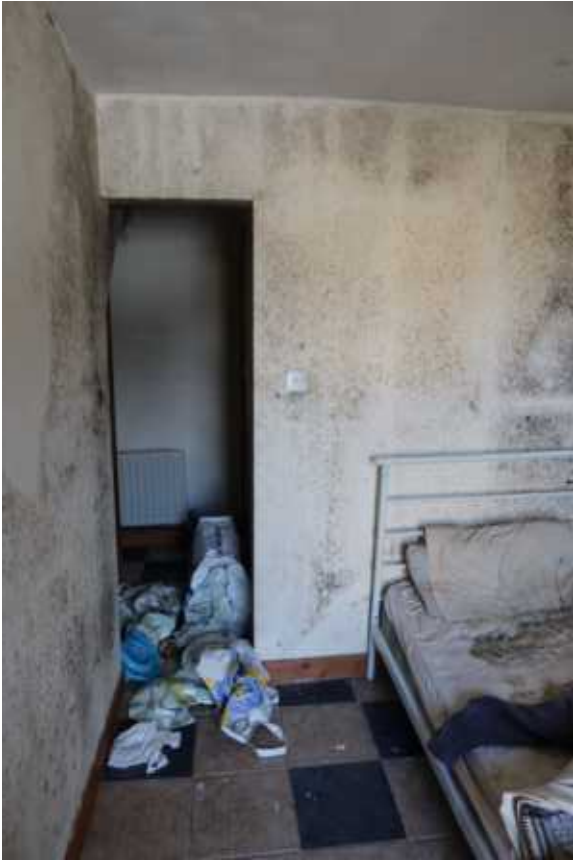
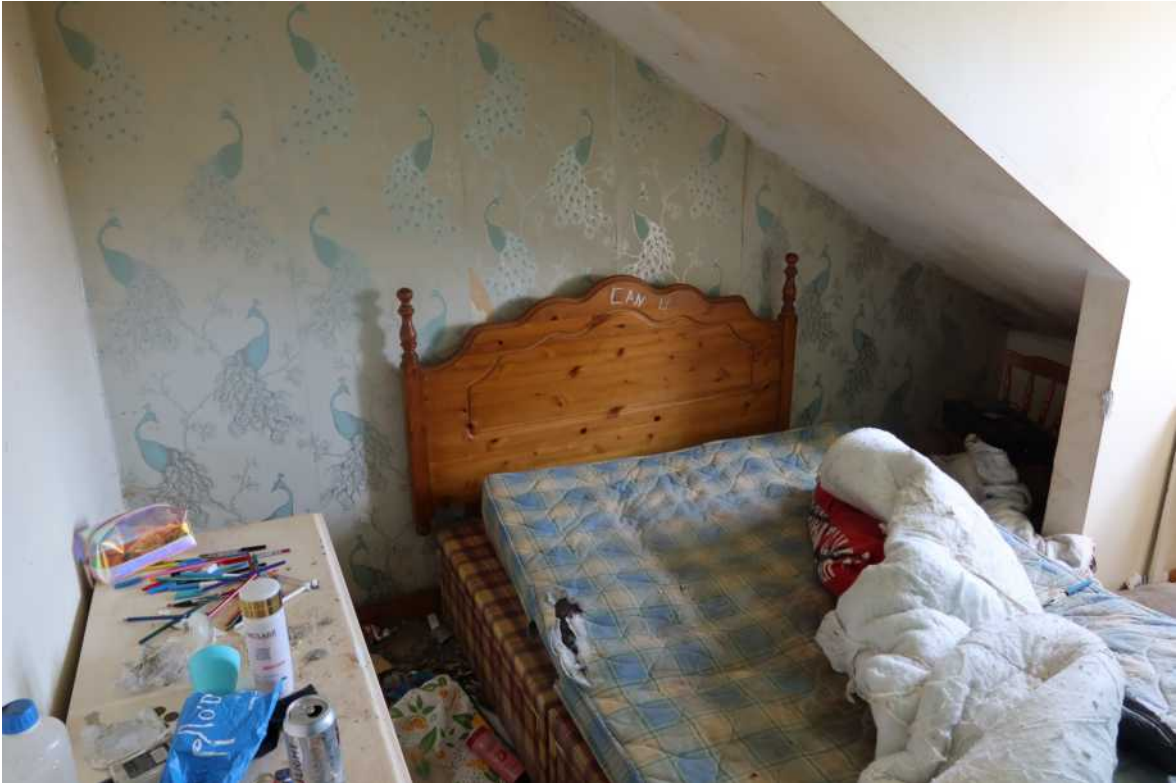
• Fig 89 -92. Typical apartment interiors and damp/ mould issues .

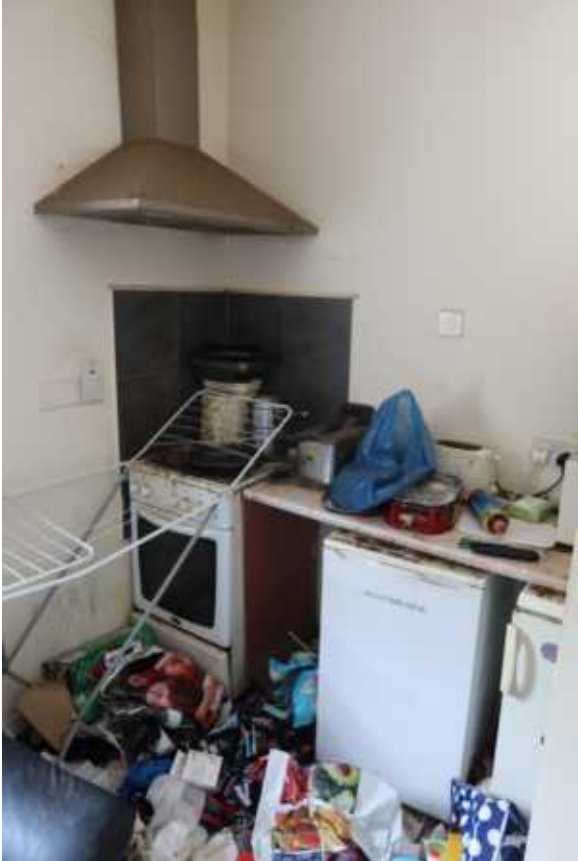
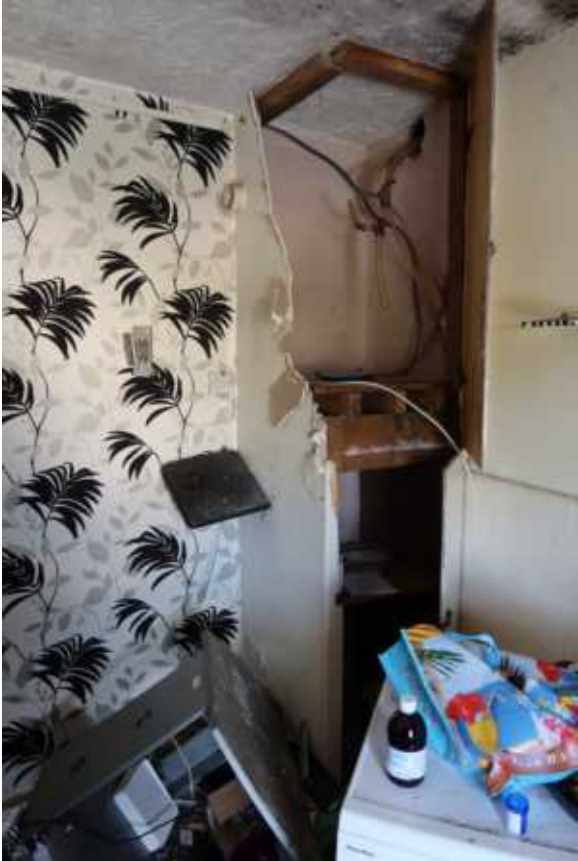
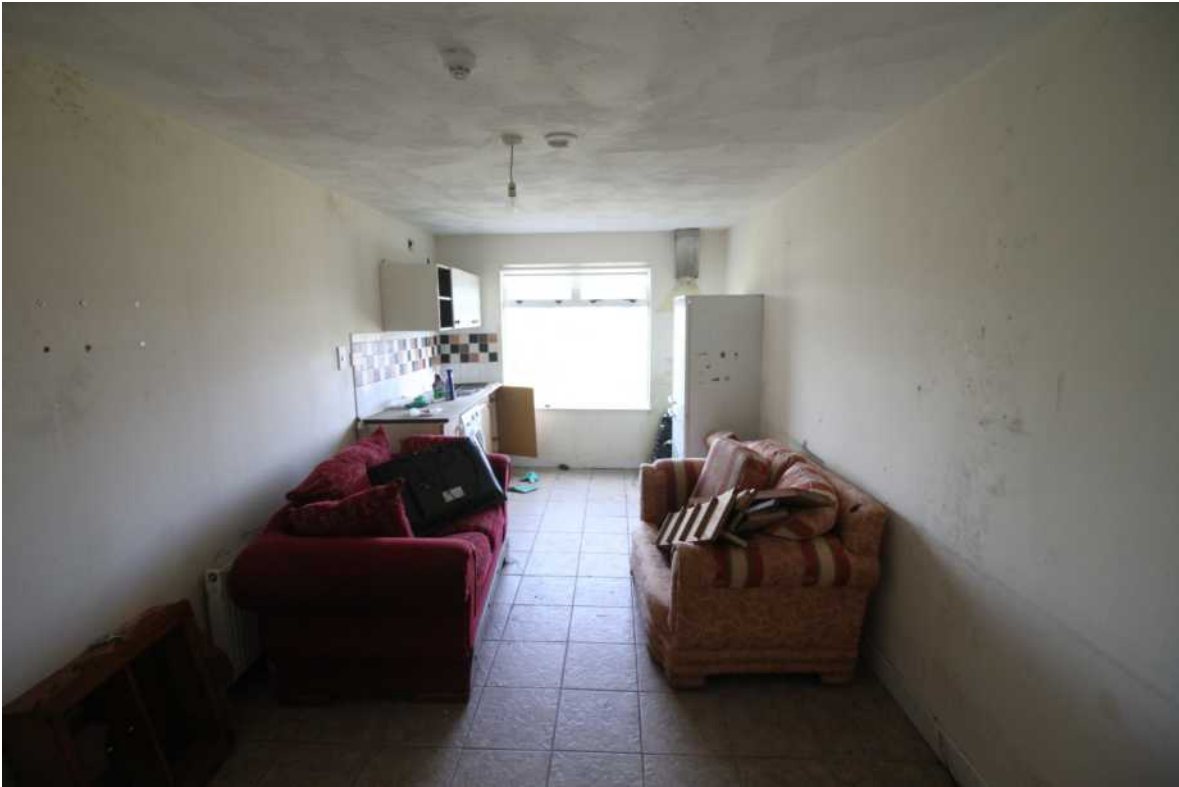
• Fig 93 - 95. Bedroom and kitchen below - typical.

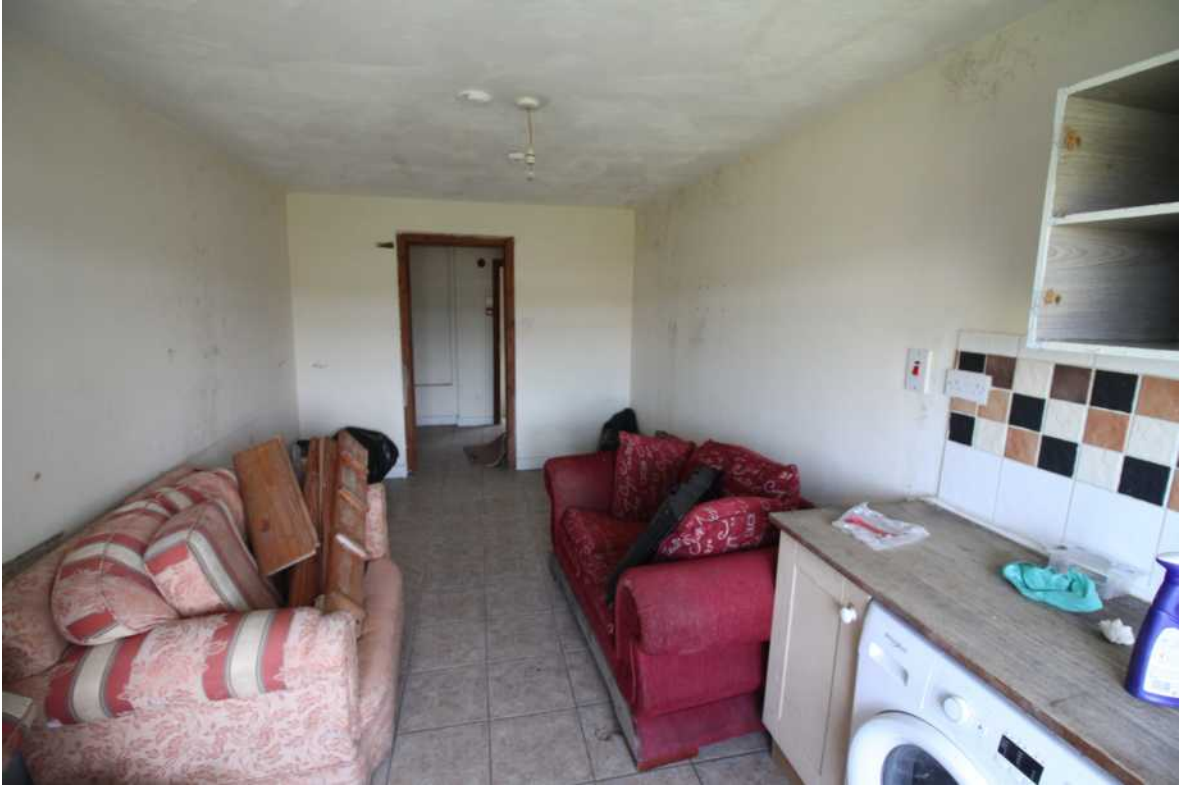
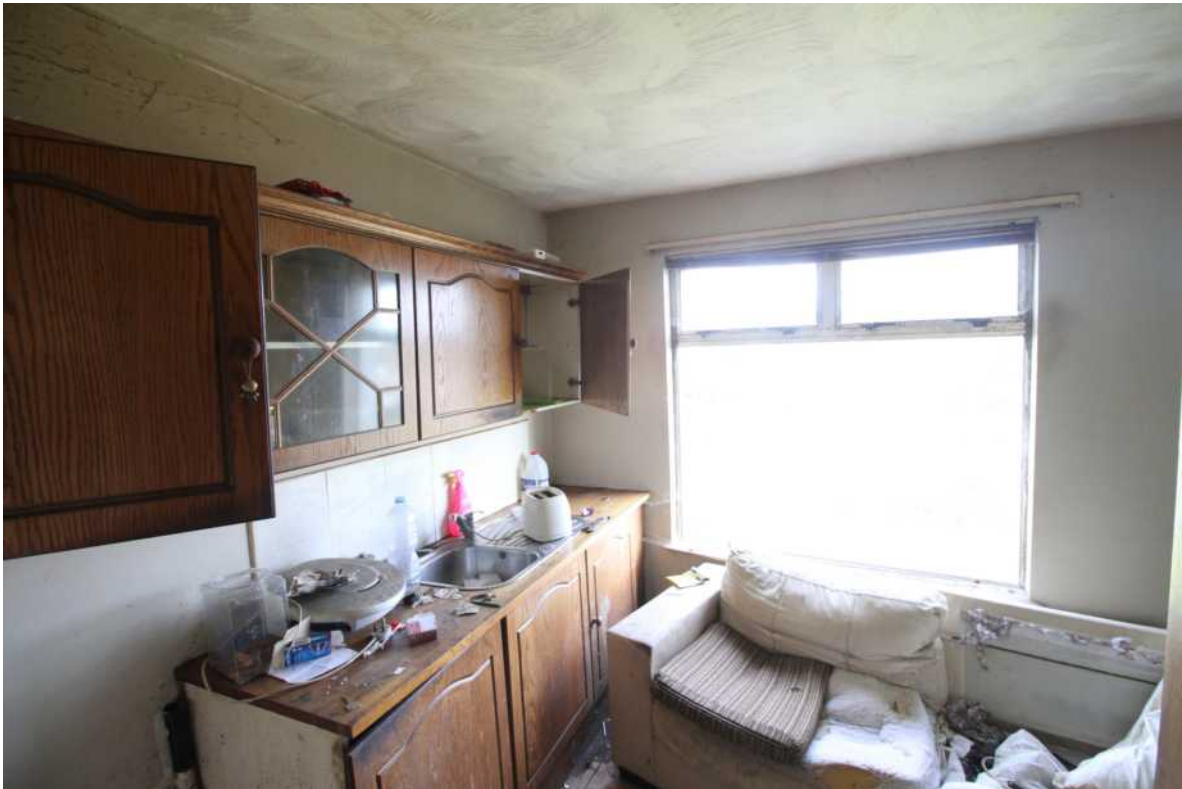
• Fig 96 & 97. Kitchen rear GF Apartment North end.

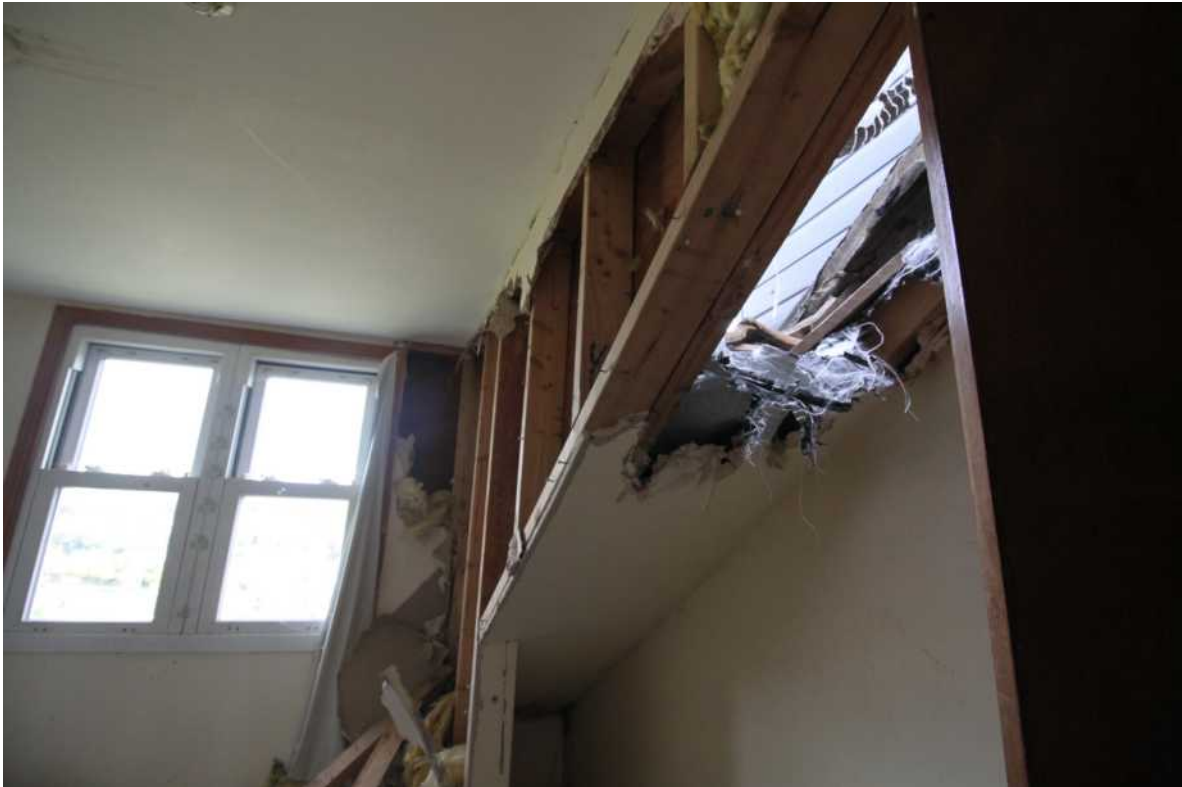
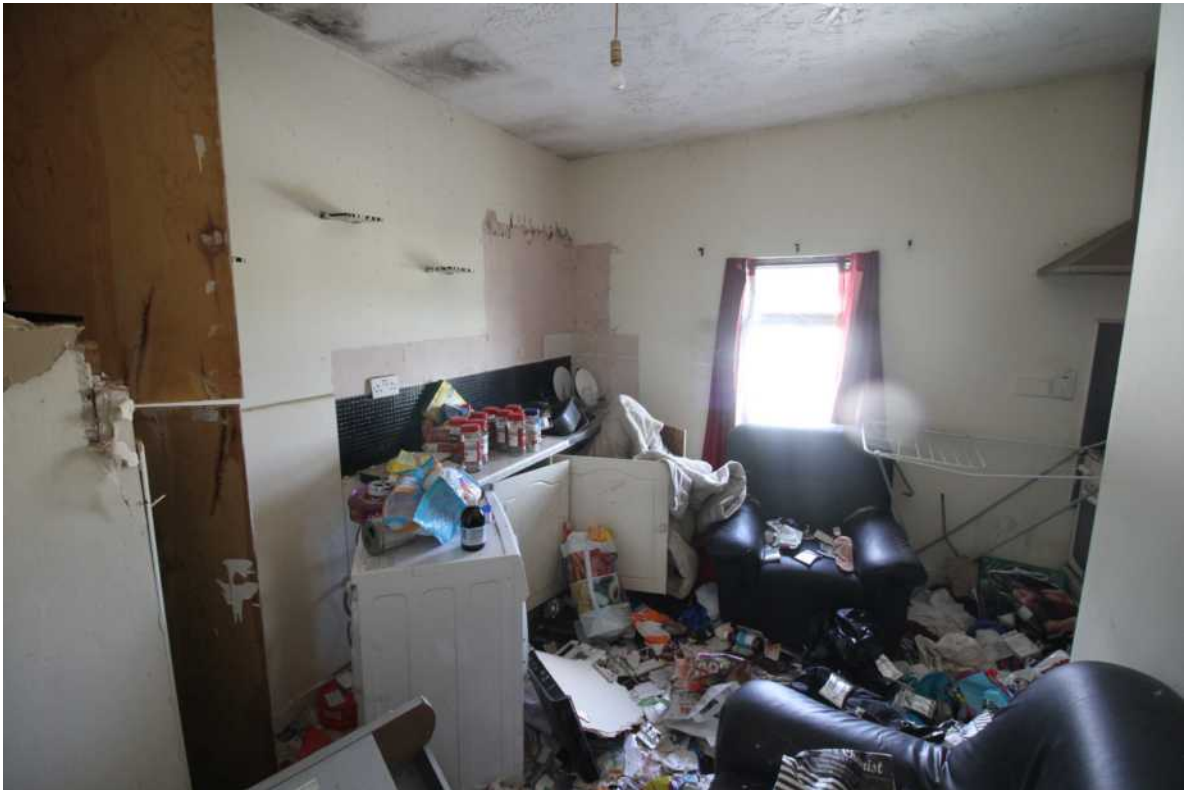
• Fig 102 & 103 Bedroom Top level rear apartment with roof failure.

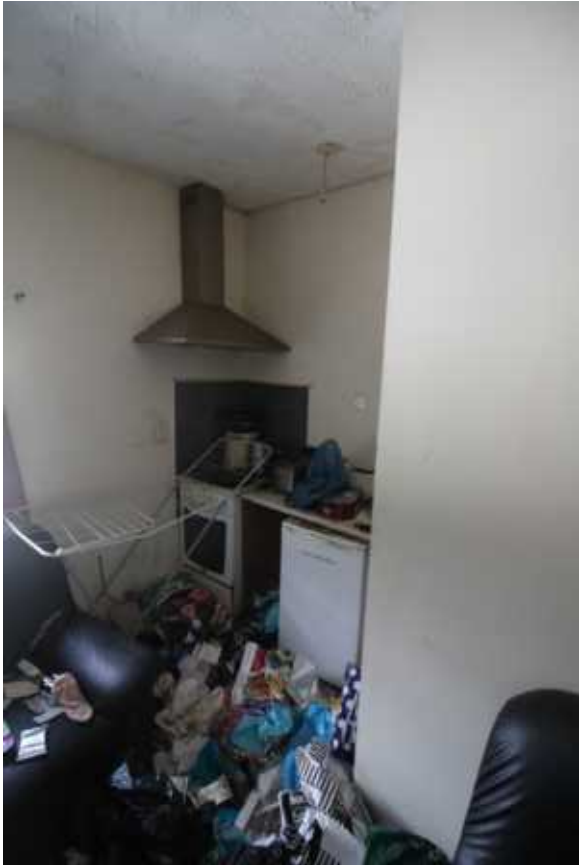
• Fig 104 - 106. Kitchen same apartment.
